THE UNIVERSITY OF STIRLING CAMPUS

Conservation Plan

Simpson & Brown Architects

October 2009

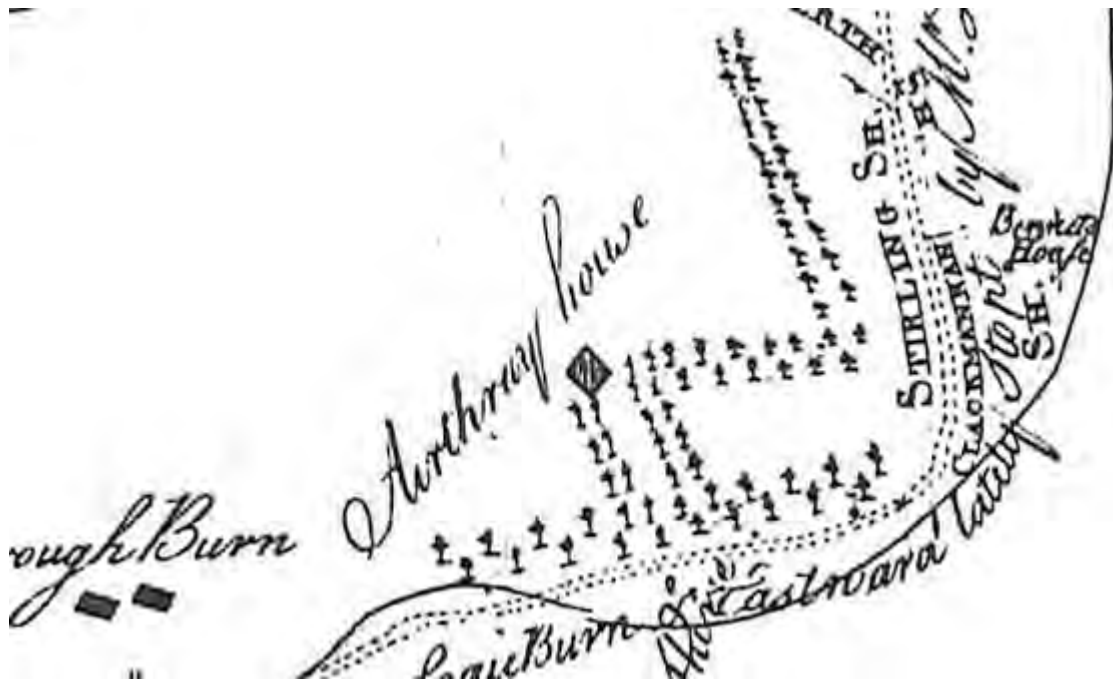
Figure 8 Detail of Plan of Airthrey Roads, Farquharson 1769 NLS

The only other indication of the estate's appearance before the time of Robert Haldane is a map showing alterations to the roads carried out in the 1750s and 60s (figure 8). This map shows the removal of the old road between the villages of Pathfoot to the west and Logieburn to the east of Airthrey, which had passed relatively close to the landowner's house (shown as a dotted line). By the mid to late 18th century it was becoming common practice for landowners to increase the distance between themselves and their tenants by any means available, including moving villages, redirecting public roads, and constructing new boundaries.

This plan shows formal avenues to the south and east of the house, with the house itself a simple block. Robert Haldane (at Airthrey 1759-67) had made his fortune with the East India Company and invested in his family home at Gleneagles and Airthrey on his return – living at Airthrey. Court records state:

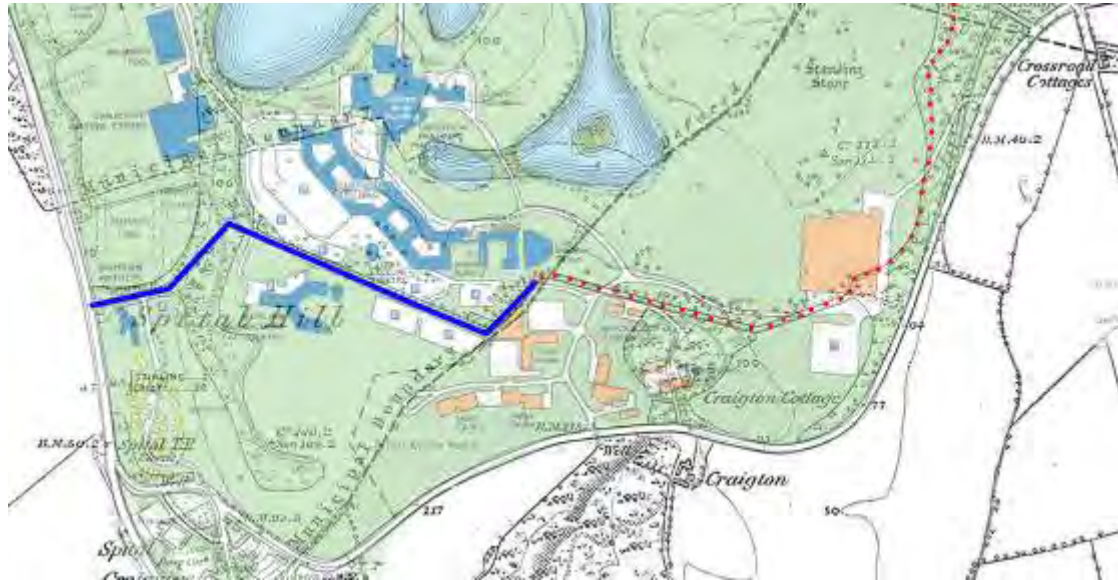
Figure 10 Current campus plan overlaid on 1865 1st Edition, with Haldane's 'New Road' indicated in blue where the pattern survives, and dotted red, where it is lost or partially lost S&B

regular and mostly straight stretch of this road (figure 10), an unusual feature in the otherwise wholly serpentine and picturesque layout. The footpath between the car parks to the west of the Cottrell Building and the chalet accommodation at Pendreich Way follows approximately the route of the 'New Road' to the then village of Pathfoot.

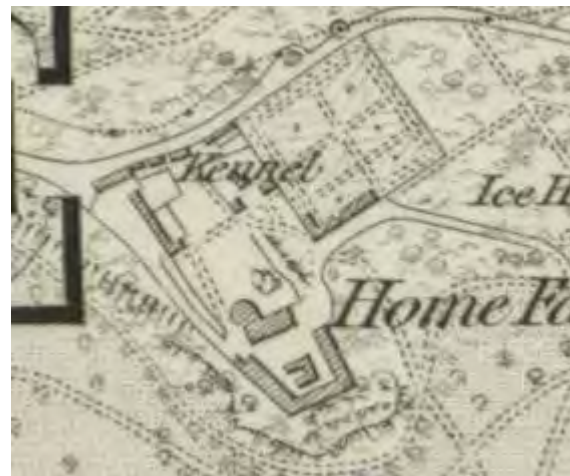
Figure 14 1st Edition OS map showing steading 1865 NLS

The 1865 OS map (figure 14) shows that the main building by this date was a three-sided courtyard containing a smaller C-shaped building, with a separate block to the north having a round horse gin to turn a mill.

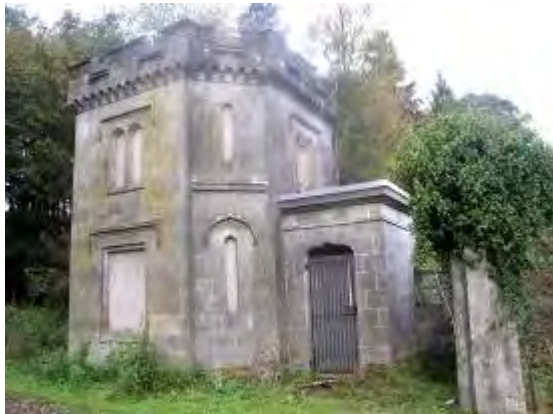
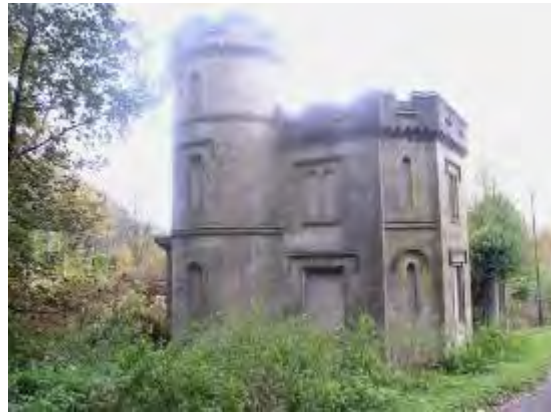
Figure 16 East Lodge from south west 2009

Figure 17 East Lodge from north west 22009

Abercromby employed the local architect William Stirling to build two smart new lodges to his estate, one at each end of the approaches from west and east. No plans or historic images of the buildings are known to survive. The West Lodge is shown on the 1st Edition OS 1865 (figure 19). It was demolished in the 1960s to make way for the new University entrance. The East Lodge survives (figure 16-17). Stirling designed similar lodges for Monzie Castle.

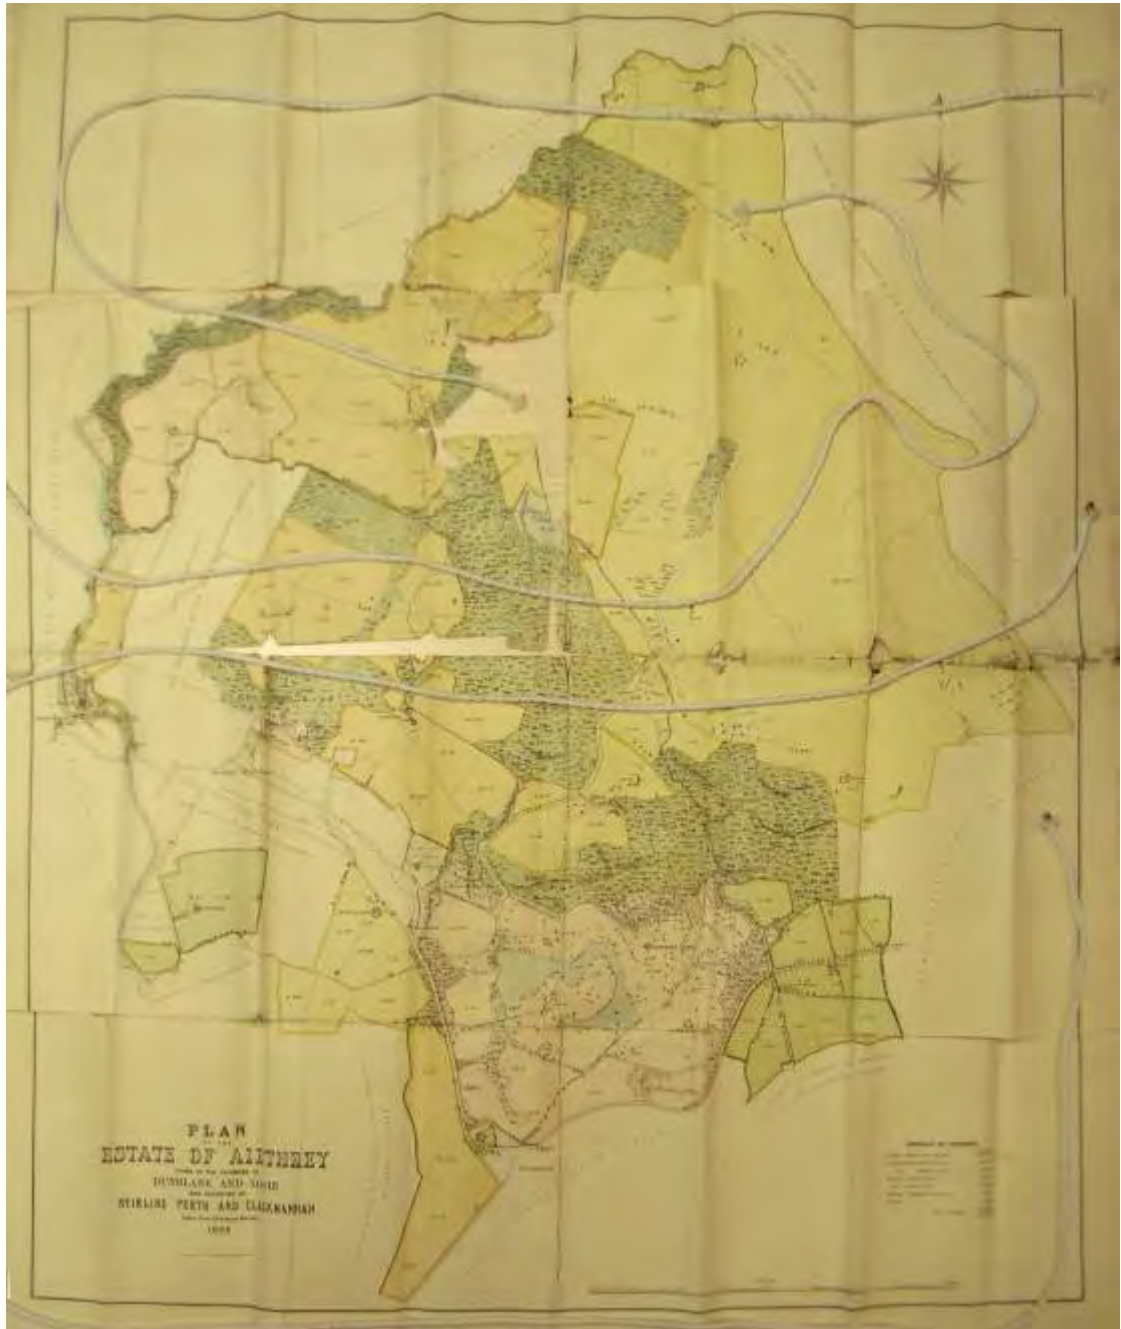
Figure 21 Plan of the Estate of Airthrey 1885. (White line weights to hold map flat) *UoSA*

A description of the estate is recorded in a sales particulars of 1885¹⁷, which includes a plan of the estate (figure 21). At this date, the total estate was about 3100 acres imperial, including farms. The policies are shown in pink, to the south of the plan.

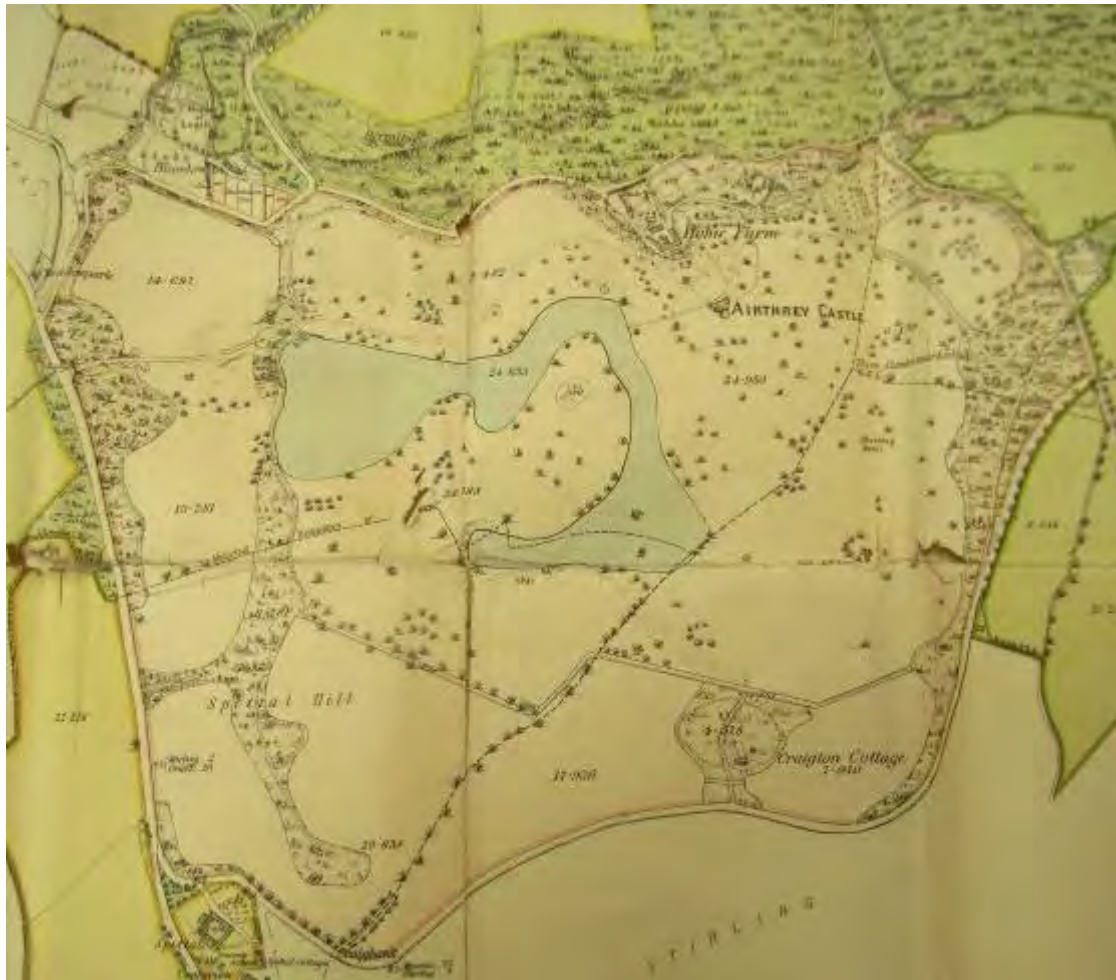
Figure 22 Detail of estate plan showing policies 1885 UoSA

This plan shows a slight development of the policies in a more Victorian taste. In particular, just to the south of the house a circular border with shrubs is shown, with a single tree planted very closely to the west (figure 23). Neither of these features appears on the 1880 photograph of the building.

Two small islands are shown on the loch, and there appear to be slightly more trees than on the 1865 OS. The OS Gazetteer of 1883 described the park as of ‘*remarkable beauty, commanding superb views of the Ochils and the plain beneath them*’.

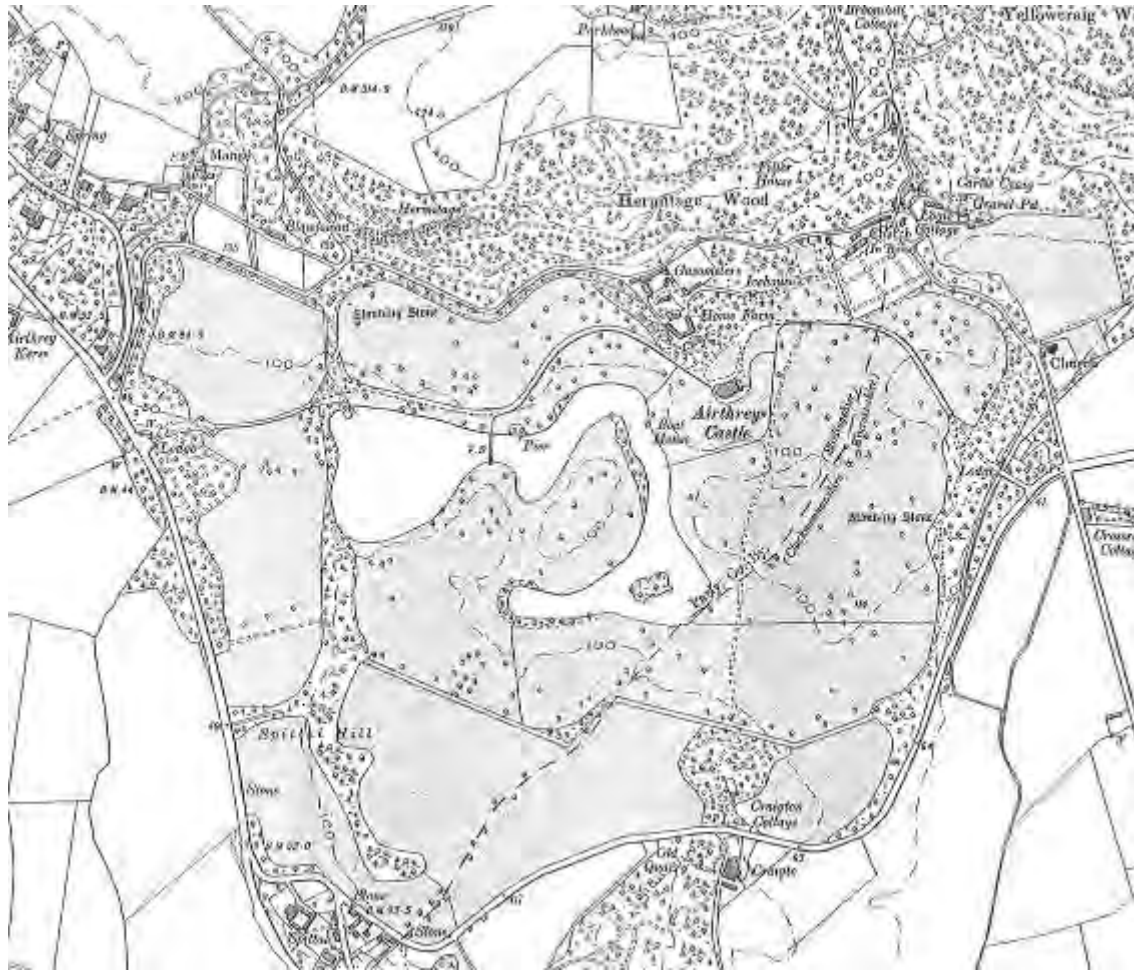
Figure 25 Polices shown on 2nd Edition OS 1899 *NLS*

The 2nd Edition OS map of 1899 (figure 25) shows that the island was increased in size, and a boathouse, pier, and footbridge were constructed at the water's edge. In the pleasure grounds to the north east of the house and west of the walled garden conifers were planted to form an arboretum, and a well was added at the foot of the

crag housing the stable block, close to where a small waterfall fell from the crag housing the stables and offices. These were fashionable improvements, which did not undermine the conception of the picturesque landscape.

The island in the loch was planted with varied species to form interesting reflections in the water. Trees were planted in two belts at the western edges of the loch. A track running between the East Approach and Craigton Cottage in the south of the policies is shown on this map. It was later removed and does not appear on the 1923 OS map.

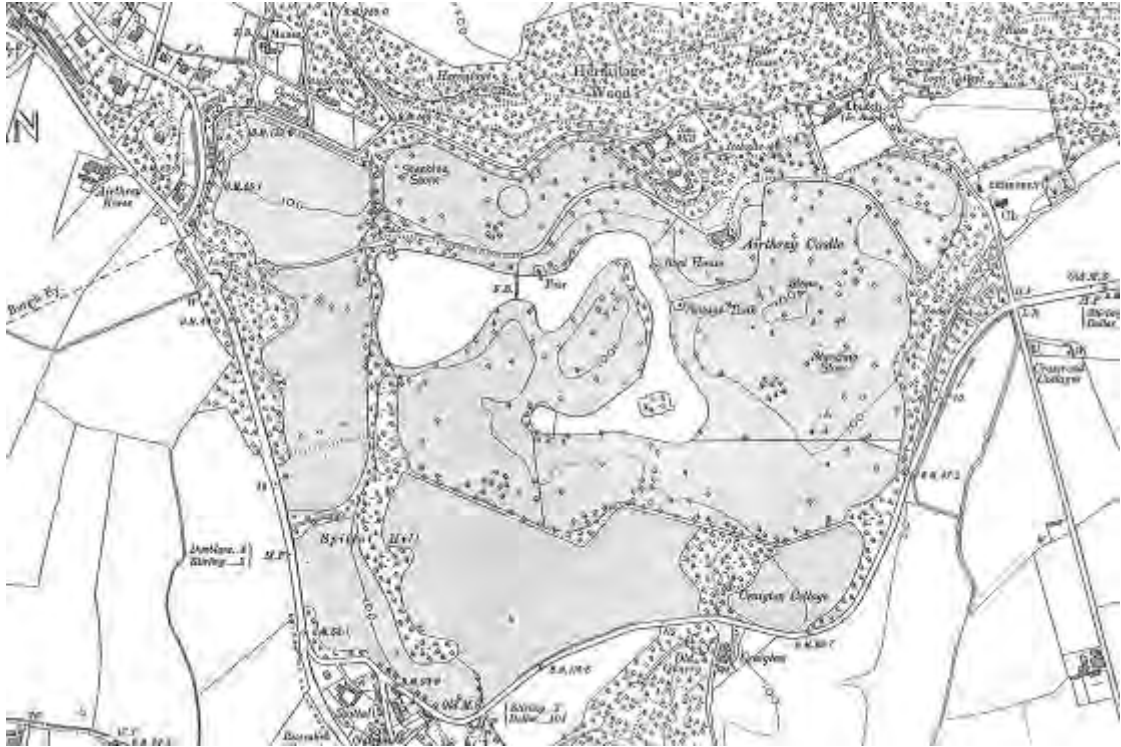
Donald Graham died in 1901, and his widow and Trustees inherited the estate. The 1923 OS map (figure 26) shows little alteration to the estate, apart from the addition of a Sewage Tank. The 1922 inventory noted the following estate buildings: Boat House, Garage, Harness room, and Racquet Court.

Figure 26 1923 OS map NLS

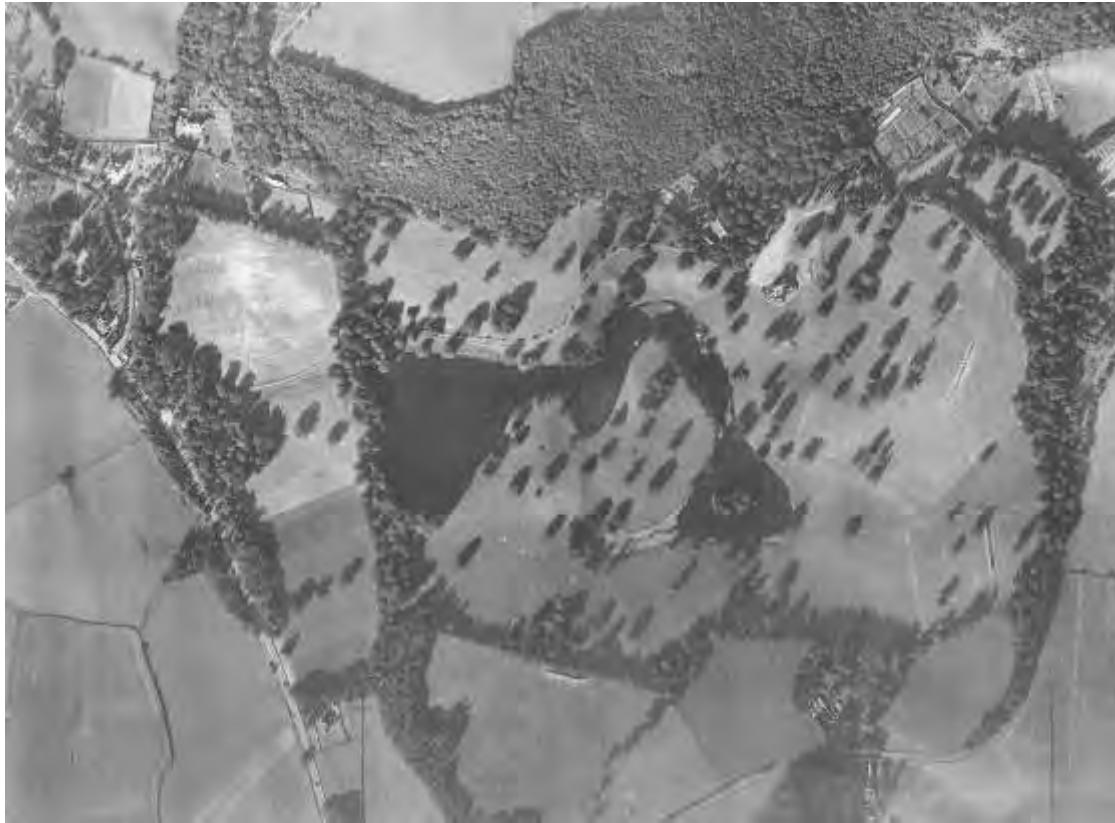
Figure 27 Aerial photograph of Airthrey policies September 1947 NMRS

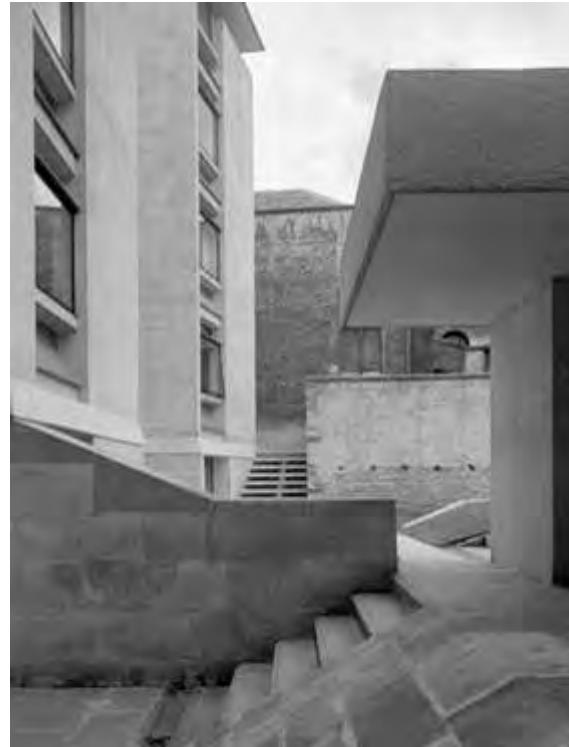
Figure 45 Powell and Moya accommodation blocks built at Brasenose College, Oxford. *English Heritage NMR*

Powell & Moya 'were commissioned "to fit in, squeeze in, as many rooms as you can without being antisocial about it" into a backyard full of bicycles. They showed that a British firm could build an accomplished modern design that also harmonised with its historic surroundings'³⁸. Cottrell mentioned that 'this is the sort of thing he'd like to do for Stirling'.

The complex elevations, and the rich materials (Portland stone and lead cladding) of these building, however well liked by Cottrell and Richards, was not something within reach of the University of Stirling's budget.

The accommodation blocks, completed in 1961, were listed by English Heritage at Grade II* in 1998.

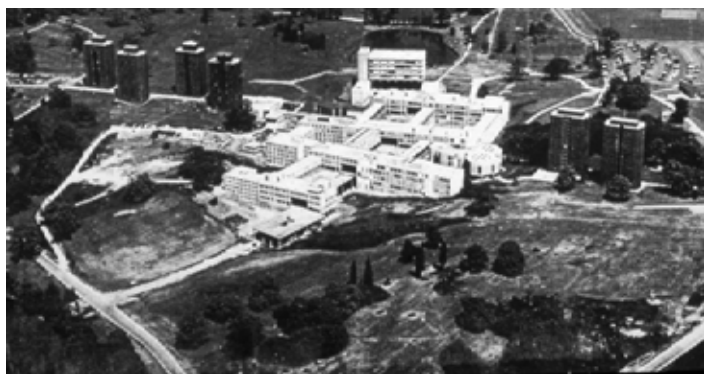
Figure 48 Oblique aerial view of the University of Essex

Figure 48 shows the contrast between the low-rise central buildings and the residential towers.

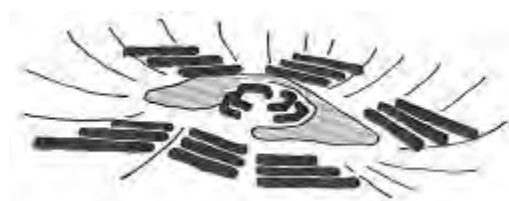
Figure 51 1968 schematic diagram showing how the University should develop around the loch. UoS

One of the first clear decisions to be made was that the University would be built around, and centred on Airthrey Loch (figure 51).

(further west), the principle is clearly demonstrative of what was actually built. This diagram highlights the concern of Cottrell to avoid problems experienced by other universities that had developed on a more piecemeal basis on similar sites. He had found on visits to other universities that there were sometimes great distances to be travelled between residential, dining, teaching and recreation spaces – often resulting in either enormous inconvenience to students and staff, but even traffic problems as car use increased within the campus.

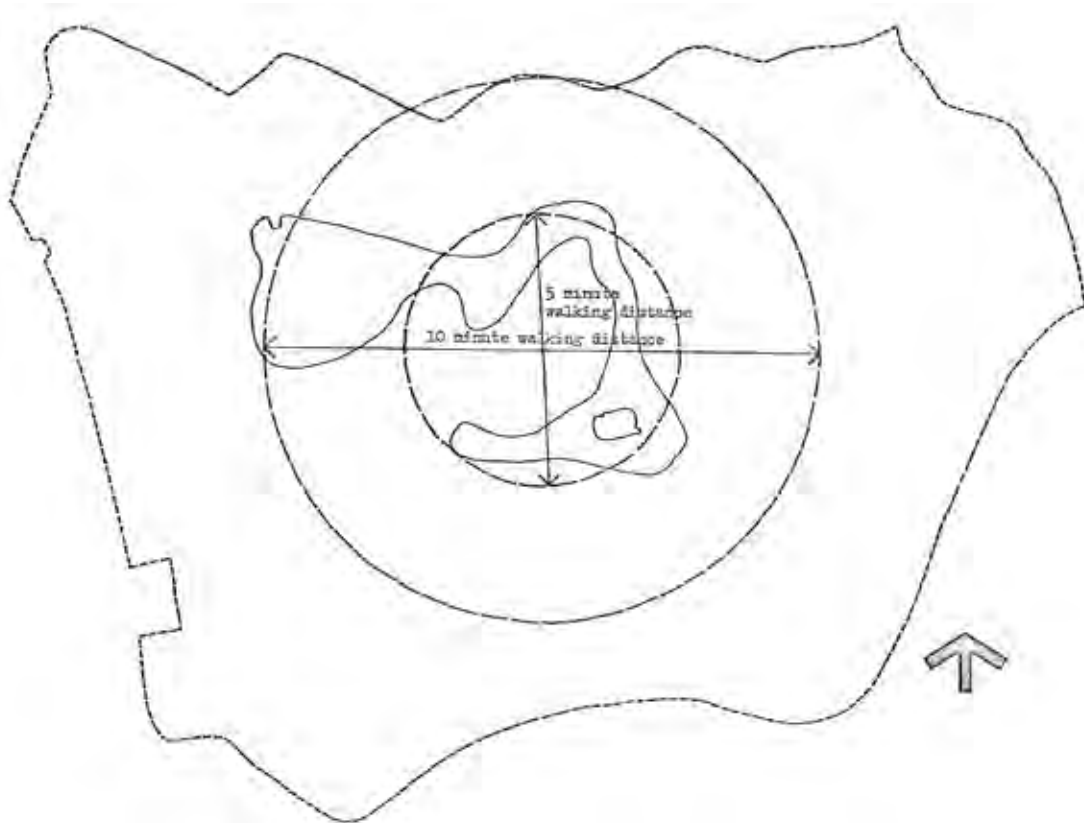
Figure 52 Diagram from 1966 discussion material showing walking distances. *UoS*

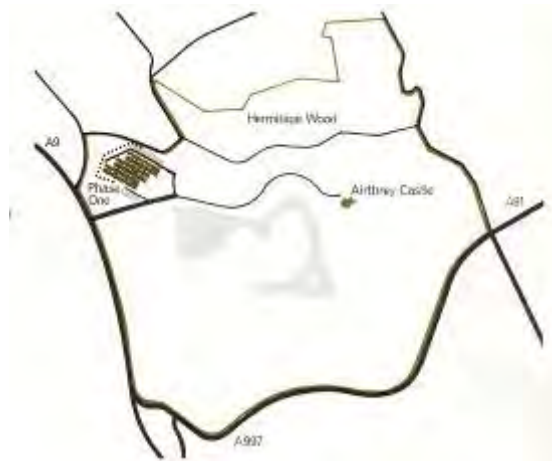
Figure 58 1968 development phase diagram showing buildings completed by September 1967. *UoS*

Of key interest from this report is the phase diagrams showing the development of the University campus. What is of particular note is the buildings that were not completed: primarily the residential area on the east shore of the loch and the student recreation buildings.

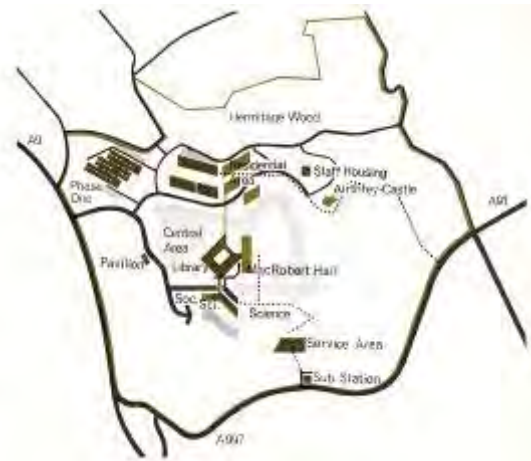
Figure 59 1968 development phase diagram showing buildings to be completed by September 1970. *UoS*

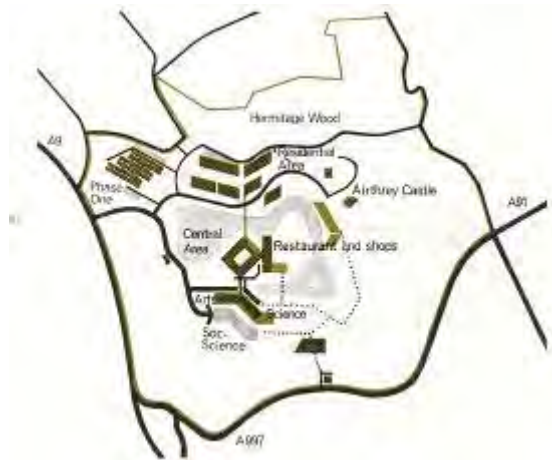
Figure 60 1968 development phase diagram showing buildings to be completed by September 1971. *UoS*

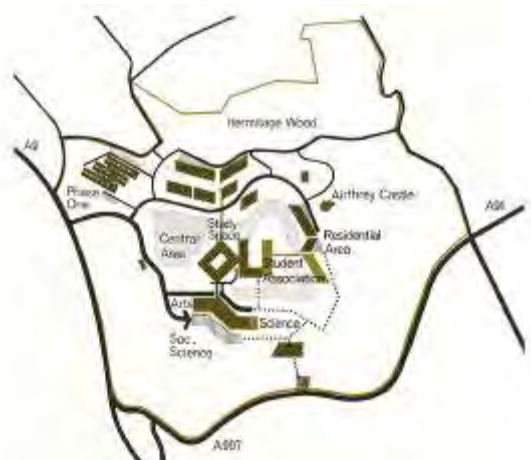
Figure 61 1968 development phase diagram showing buildings to be completed by September 1972. *UoS*

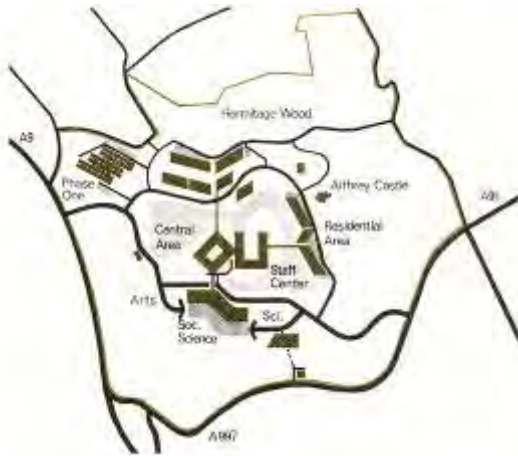
Figure 62 1968 development phase diagram showing buildings to be completed by September 1973. *UoS*

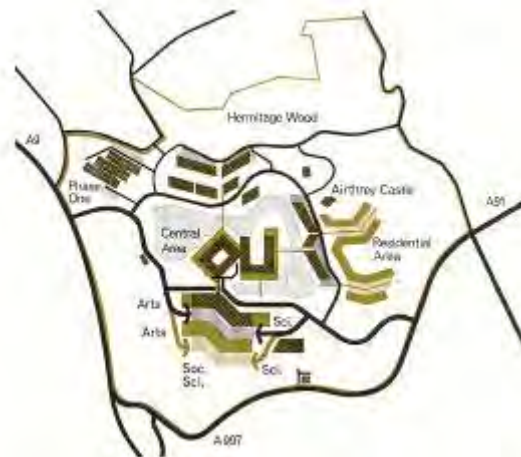
Figure 63 1968 development phase diagram showing Phase 3 buildings. *UoS*

1968 is when the first aspirations for post-Phase 2 development begin to appear. A revised population projection showed an intended doubling of undergraduate number by 1980. The final development phase diagram (figure 63), shows the early intentions for how this growth was to be accommodated – a repeat of the main teaching block on higher ground to the south, larger library and extensions to other central area buildings, and a massive expansion of student accommodation to the east. None of these developments were to be realised in the manner first proposed in this report.

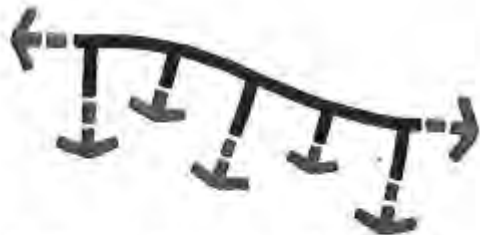
Figure 13.2 The Spine and Rib Growth Principle
'... simultaneous expansion of populations in the various fields of study should be reflected by the simultaneous growth of buildings to accommodate them ...'

The proposed growth of the teaching block (Cottrell) along the principle of the 'spine and rib' model was demonstrated in the 1968 report. More often identified as the ladder-plan layout once completed, the diagrams demonstrated not only the direction of intended growth (i.e. south, east, and west), but the way that this growth was related to the relationship between the different teaching subjects and the gradual movement from the Phase 1 building (Pathfoot).

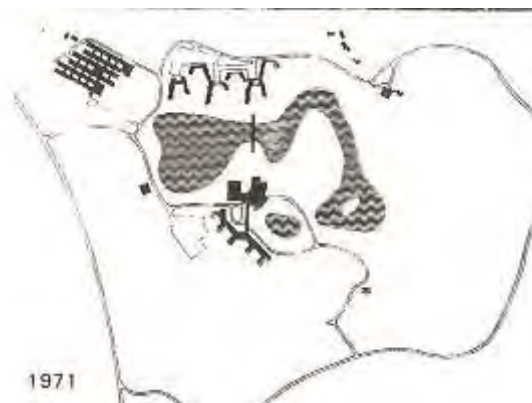
Figure 66 1973 development phase diagram showing buildings completed by 1971. *Architectural Design*

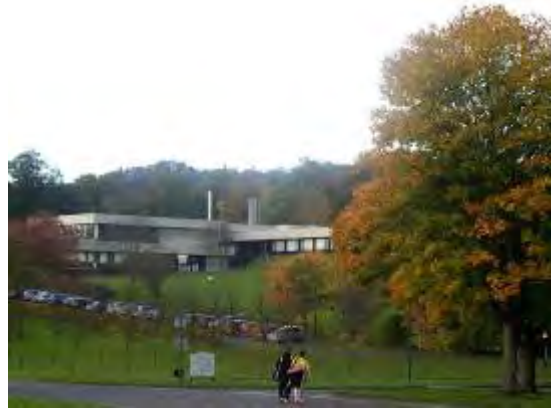
Figure 72 Plantation of lime trees to south east of Pathfoot 2008

An example of this approach being carried out today is the small plantation of lime trees to the south east of Pathfoot (figure 72). The end product of this plantation will be one lime tree. It is possible that during the Maternity Hospital period (1939 – 1969) this continuity of planting had been lost or partially lost. It was not however revived by Hilliard's scheme.

The regular plantation of lime trees to the south east of Pathfoot is one of the groups of trees which have been planted under the current management regime in order to ensure the succession of parkland trees which is a key part of the maintenance of the designed landscape. Over time these trees will be thinned, to leave a single tree.

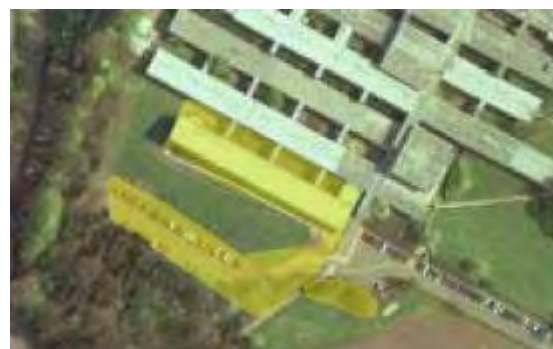
Figure 96 Aerial photograph with yellow colour indicating post 1980s alterations to landscape south of Pathfoot

This area has also been altered since 1984 by the building of an extension to the car park at the edge of woodland to the south (figure 96).

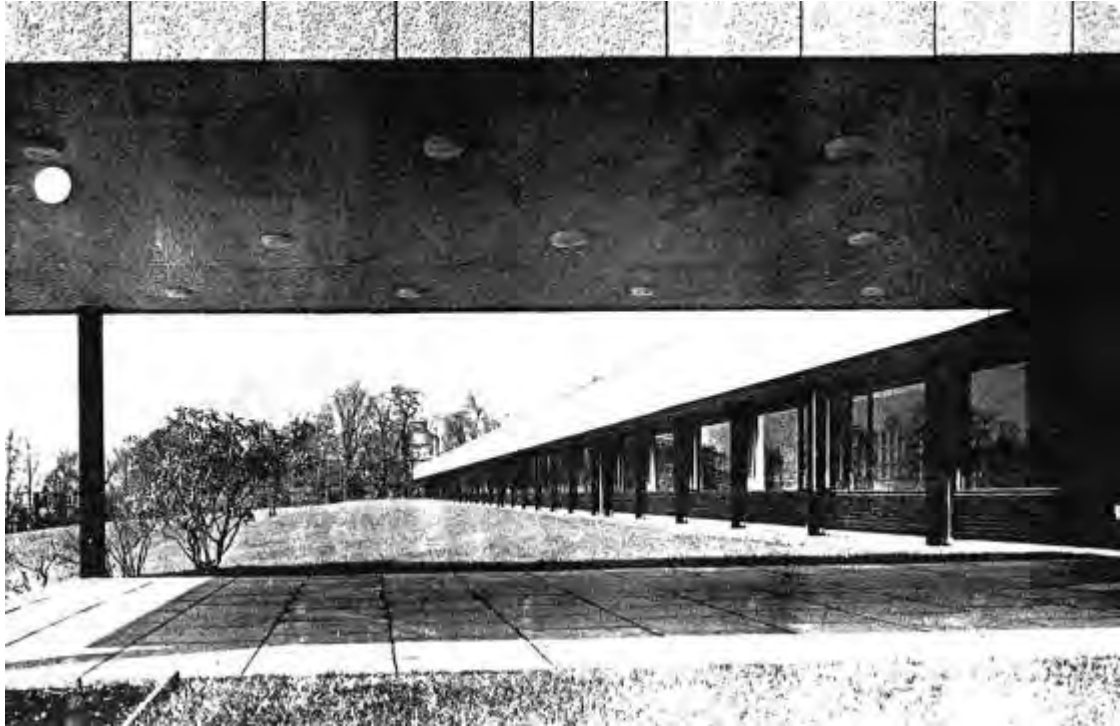
Figure 97 View to west from entrance to Pathfoot 1968 *Architects' Journal*

The construction of the main extension to the south has altered the relationship between Pathfoot and the landscape to the west, which is particularly apparent at the entrance. A photograph taken for the Architects Journal of 1968 shows how the entrance area was visually connected to the open landscape and tree belt to the west (figure 97). This view has been lost.

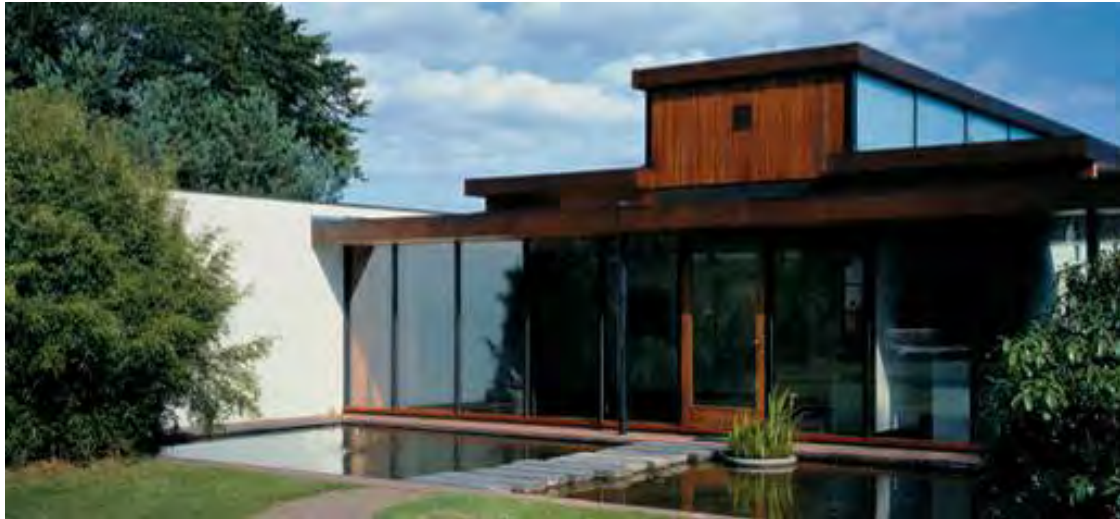
Figure 104 Exterior of the Louisiana Museum of Modern Art, showing similar arrangement of glazing, roof structure, and clerestory as found at Pathfoot. www.louisiana.dk

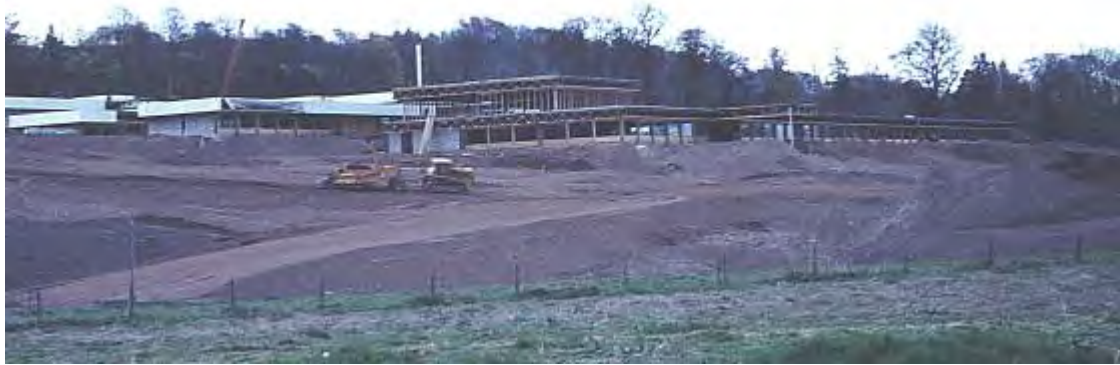
Figure 113 Pathfoot under construction, c1968. *UoSA*

In order to meet the construction deadline, RMJM conceived a custom-designed prefabrication system. Several other construction systems had been considered, including CLASP, but these were complicated by the fact they were designed to support several stories and so were unsuitable to the single-storey Pathfoot.

The construction process involved the erection of the steel framework first, followed by the roof, with walls following on, and the floor being finished last. As a result, the building was watertight at a very early stage. One subsequent drawback however was that the concrete floors did not have time to mature fully before the building was opened.

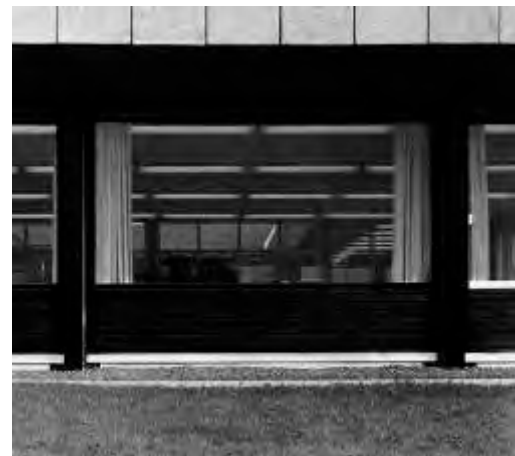
Figure 114 A typical prefabricated panel with full-width window. *UoSA*

The exterior walls consisted of pre-fabricated panels, of which there were a total of five types, set between structural I-beams supporting the overhanging roof. These standard panels were repeated throughout the whole building, with a result that 80% of the building was built to this generic standard. In order to maintain a generosity in the elevations, all the windows extended to the full width of each structural bay. Where a window opening was required, a single narrow casement was provided to one side. The remainder of the panel was horizontal black-stained redwood cladding. Some panels were solidly clad in timber, and a further generic type had full-width clerestory lights.

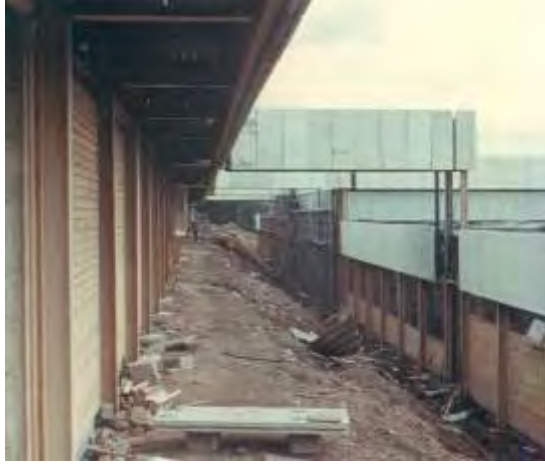
Figure 115 Pathfoot under construction, showing area between different terrace levels. UoS

The corridor walls to the external courtyards were all built with full-height windows, with red pine frames. At the changes in level between the terraces, the higher roof line continued over the stair, creating a clerestory above the lower level. Although this was criticised at the time, these windows provide dramatic views at the head of the stairs over the building towards the Wallace Monument⁹⁰.

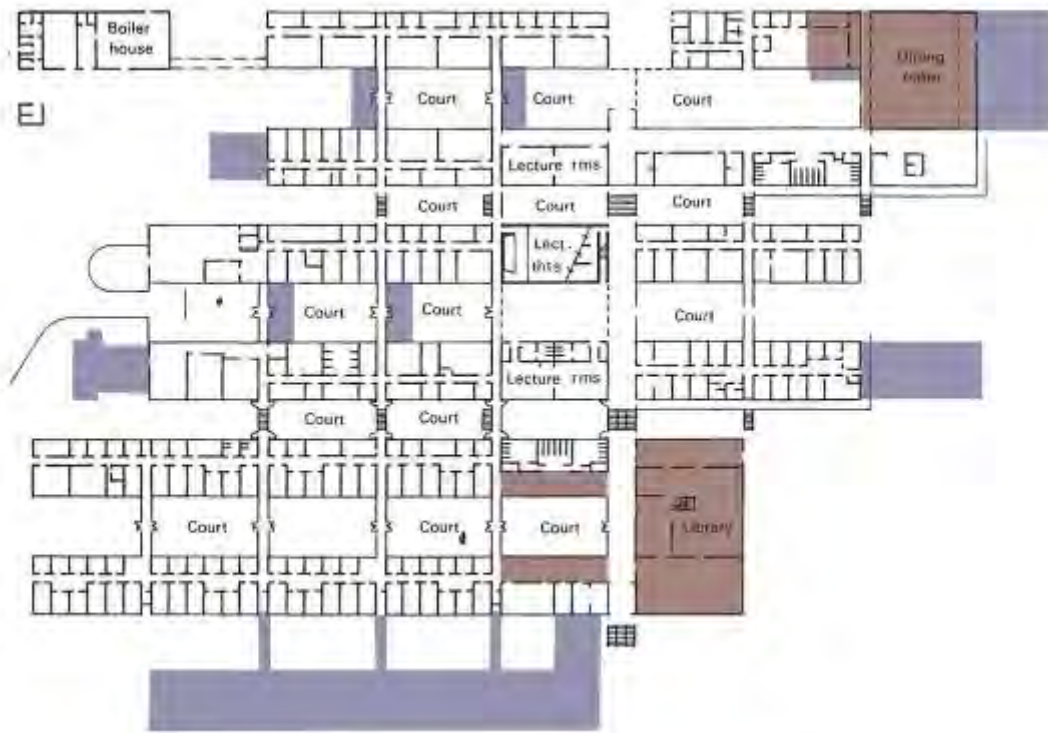
Figure 117 Plan showing additions (blue) and areas which have undergone major alteration (brown). *Architectural Review*, edited by S&B

The most major change that is clearly seen on both the approach to the building, and on the plan, is the addition of a seventh linear block to the south. In effect, this has added a third line to the lower terrace. The extension was added in 1993 and appears to fit well with the original building. The overall dimensions derived from the grid have been followed, and the generosity of the wide windows has been repeated. Although not appearing in the original building, the oriel windows to the new south elevation take the full width of the bay, so work well.

The use of materials on closer inspection begins to reveal the differences between the original building and the extension. The concrete panels with exposed aggregates have been copied but the original panels are much thicker, and appear more substantial, especially at the junction between old and new. The interior construction detail with full-height doorways comprising red pine door and panel above has also not been copied, either here, or in other altered parts of the building.

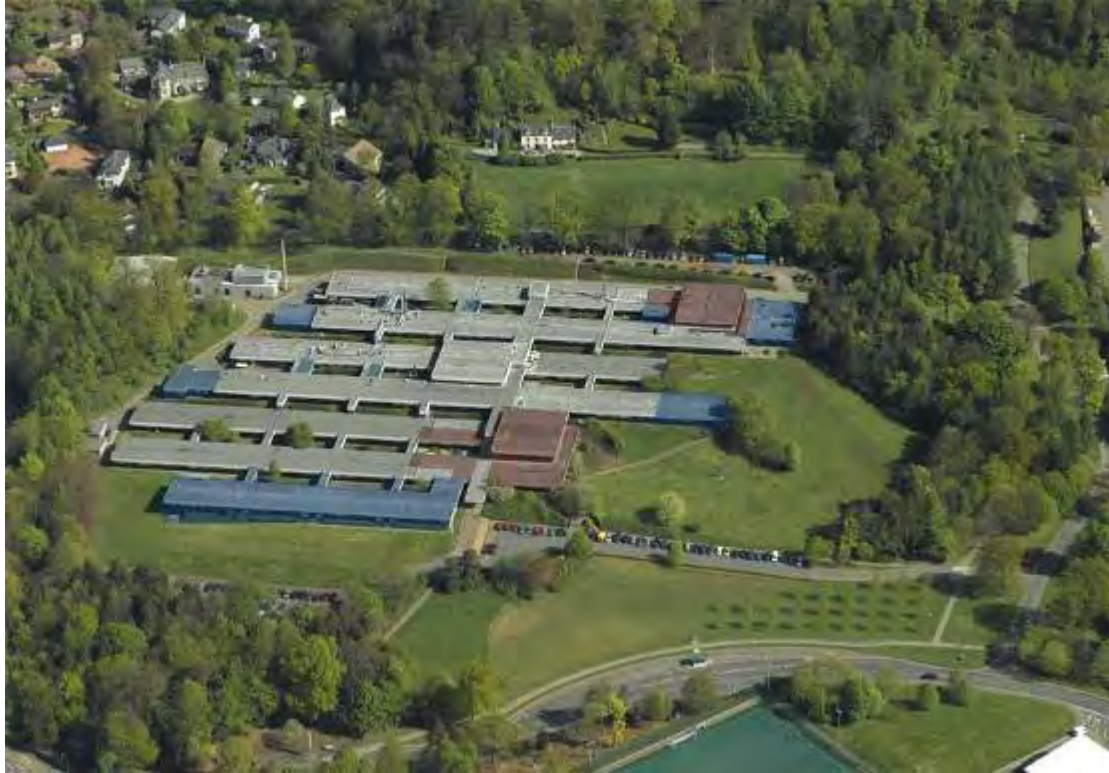
Figure 118 Aerial view showing additions (blue) and areas which have undergone major alteration (brown). *RCAHMS, edited by S&B*

Although the extension follows the expected footprint, by it being at the same level as the original lower terrace it has not followed the pattern of stepping down the site in paired blocks. If it were to follow the original design concept, it perhaps should have been conceived as the beginnings of a fourth terrace, one storey-lower than the existing entrance level. This would have had the added benefit of retaining the views from the windows on the original south elevation. The well-planned earthworks prior to the construction of the original building have also not been repeated, with the natural slope down to the west detracting from the horizontal emphasis.

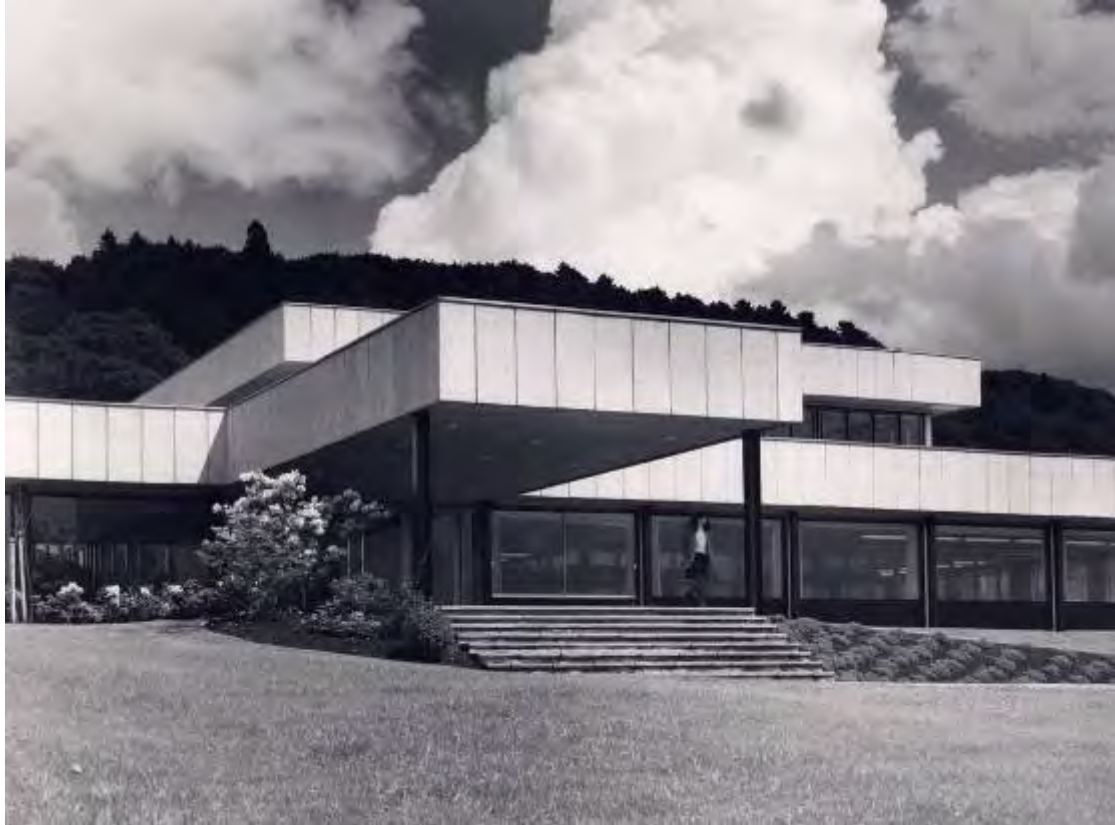
Figure 119 Pathfoot entrance canopy, projecting from the building as intended *UoSA*

This extension also forms “*an ad hoc corner*”⁹² at the entrance, with the notion of the projection of the canopy from the horizontal façade being lost (although this view of the original elevation would have been obscured by the mature trees anyway). Gerard Bakker points out that had a further block been envisaged in this position, the entrance would have been designed as a corner entrance, not with the arrangement that exists today.

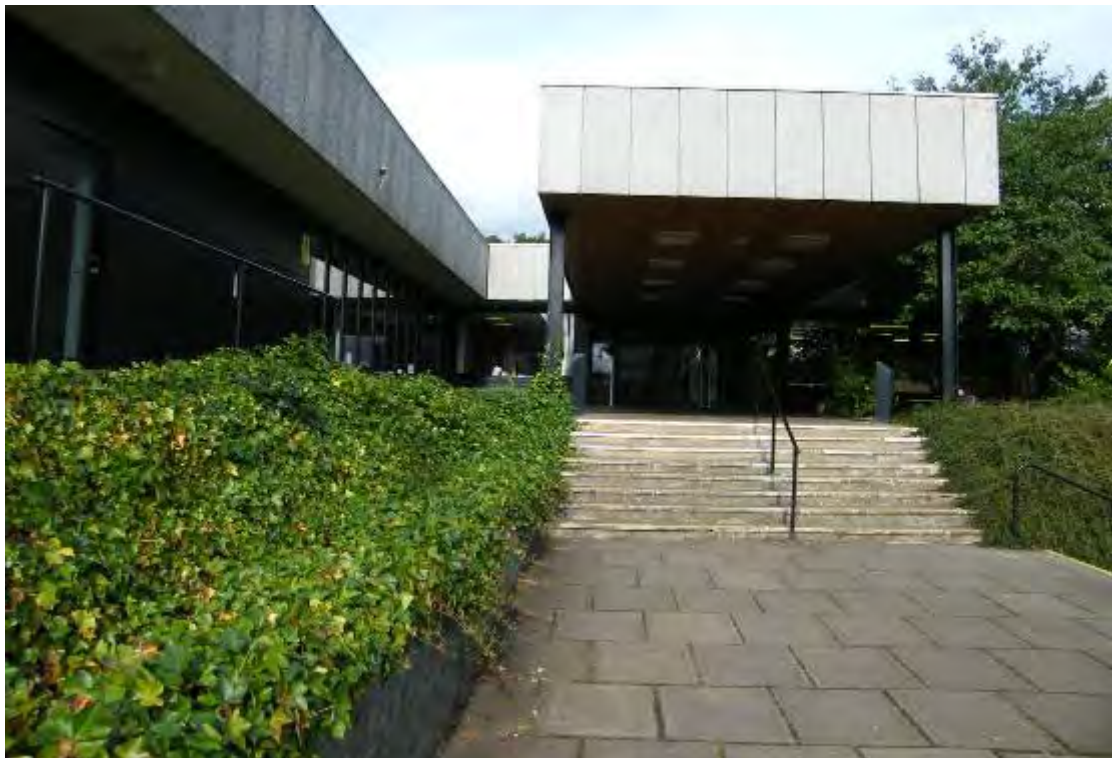
Figure 120 Pathfoot entrance canopy with 1993 extension to left 2008

Aside from the awkward nature of the original entrance canopy alongside the southern extension, the replacement entrance doors do not have the same presence as the original full-height doors. The reception desk has also been treated with a green tiled wall with section of rubble wall.

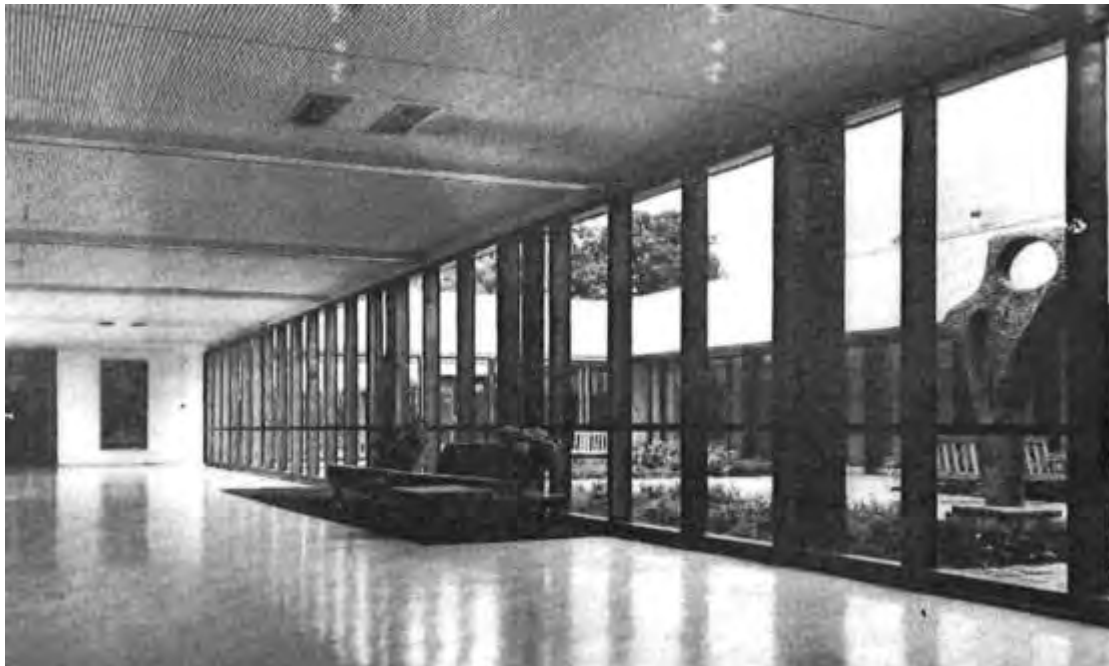
Figure 121 The entrance hall, a generous space repeated on the other side of the sculpture courtyard. Both spaces have now been filled with offices. *Construction Technology*

Also added at indeterminate dates were additions at the west ends of two blocks, both unfortunate in that they do not attempt to repeat the grid pattern. Several of the courtyards have also had small extensions added, most critically in the courtyards viewed westwards from the crush hall of the lecture theatre, thus blocking the through-view. Originally there was a generous circulation space around the sculpture courtyard near the entrance. The evolving use of the building put pressure on the university to infill this space to form office space. This has been achieved with relatively little visual intrusion due to the inherent flexibility of the design. The replacement of the full height glazing with panels of a similar nature to the original buildings has unfortunate vertical mullions breaking up the horizontal emphasis that should be apparent. Such subdivision of the windows means that the building “loses that generosity”⁹³.
