THE UNIVERSITY OF STIRLING CAMPUS

Conservation Plan

Simpson & Brown Architects

October 2009

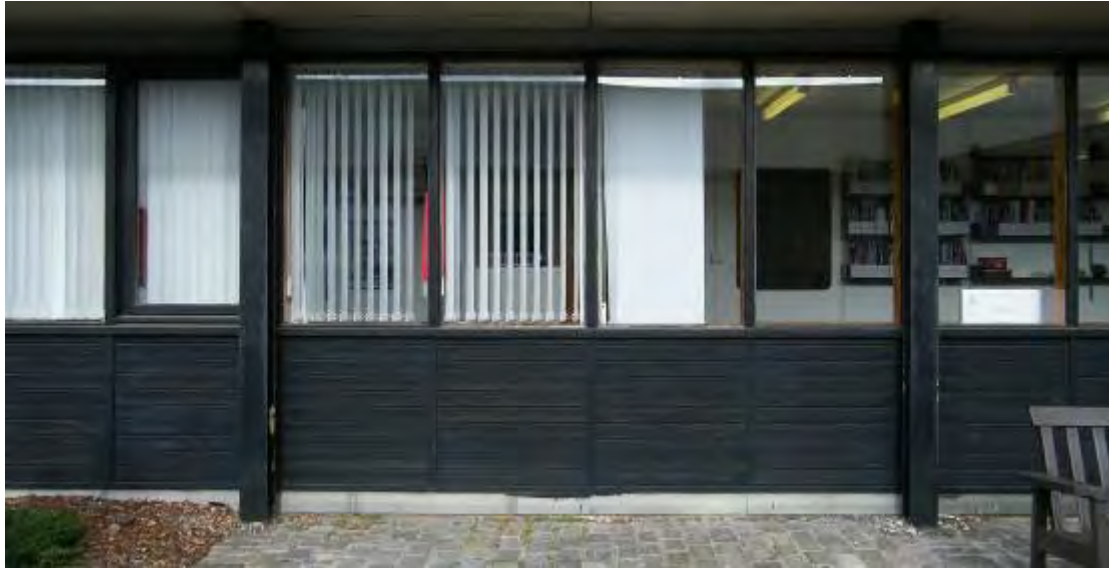
Figure 122 The same area as in Figure 51 above as viewed from the sculpture courtyard, showing the windows with vertical mullions.

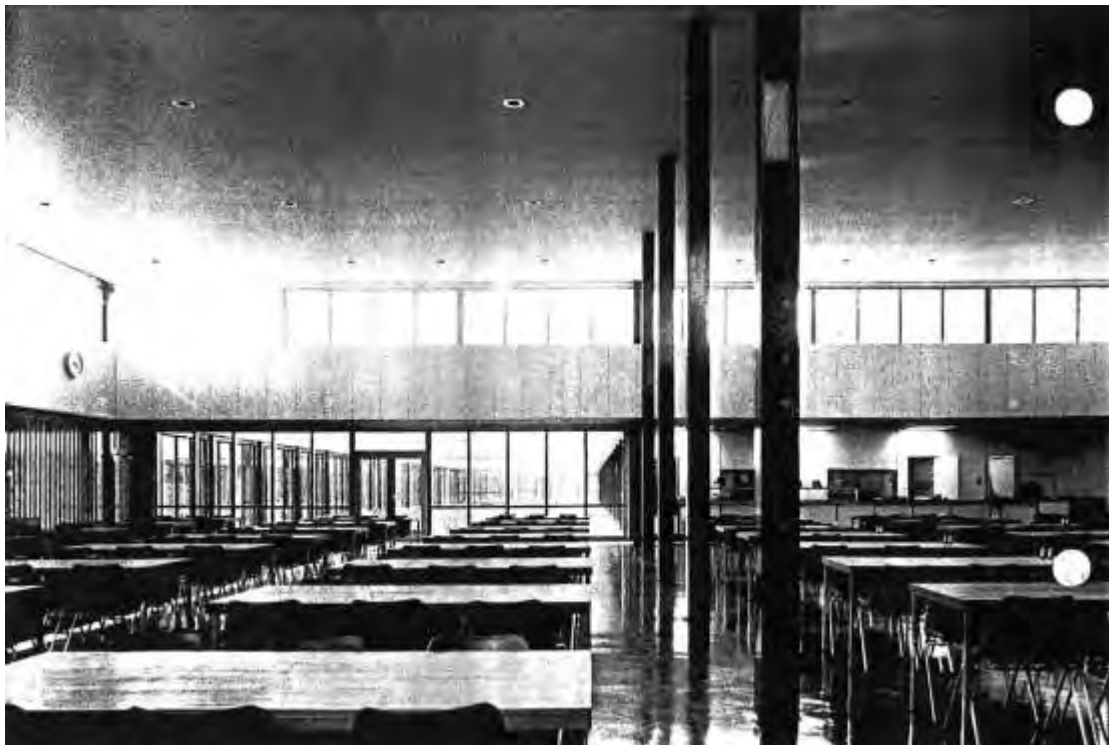
Figure 123 The restaurant in 1968. *Architects' Journal*

One of the most dramatic changes to the original building has been on the upper terrace around the cafeteria. An extension has been added to the east which has similar materials to the original building, yet does not follow the basic geometric design rules in terms of its massing or horizontal emphasis. An additional wall has been added between the cafeteria and the inner courtyard, and one of the clerestory elevations has been blocked, leading to a considerable change to the aesthetic that was originally intended.

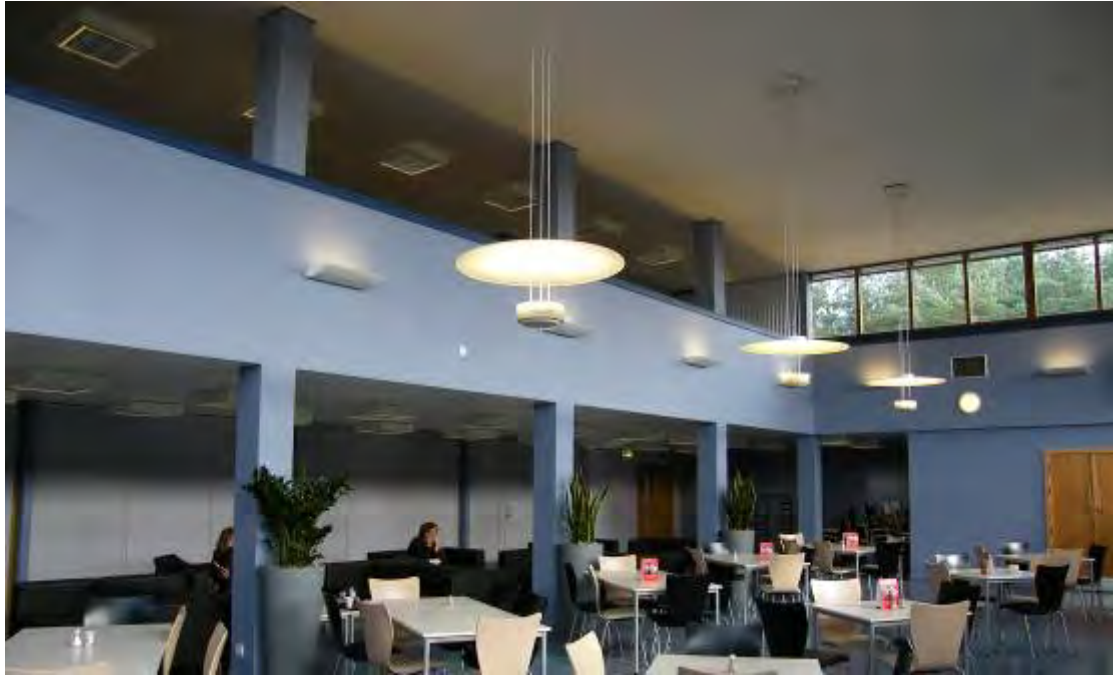
Figure 124 The restaurant in 2008.

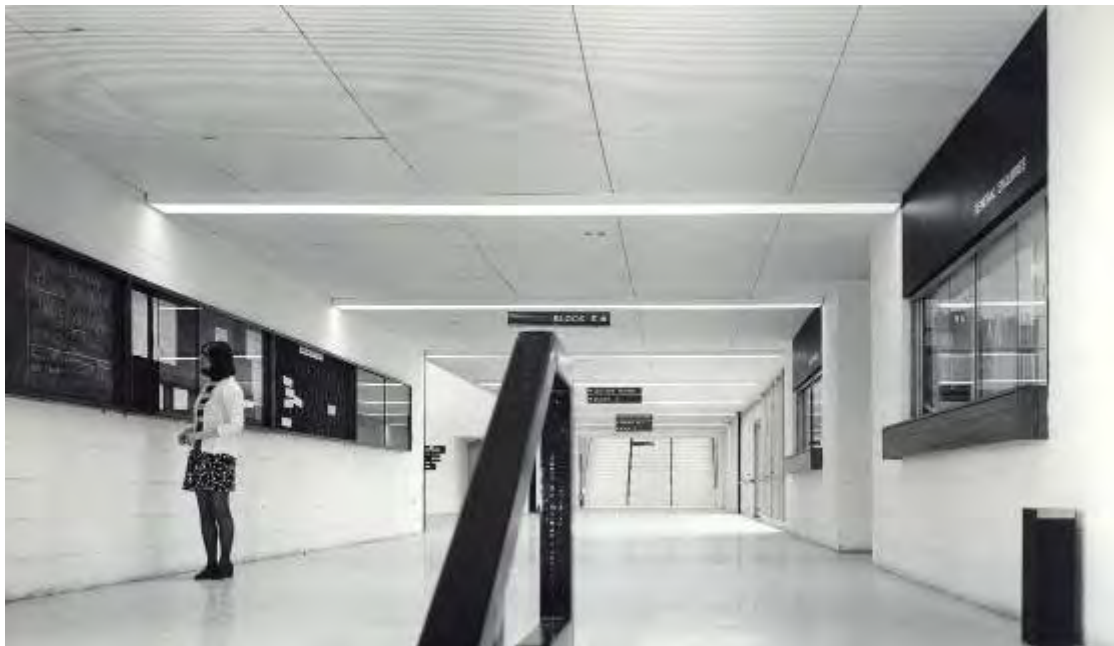
Figure 125 Main corridor of Pathfoot, showing original ceiling arrangement. UoSA

Throughout the building doors have been replaced, presumably to upgrade their fire rating, though they have been replaced using a less attractive pale wood, most commonly beech. Ceilings have also been lowered in many places, sometimes creating awkward junctions with door openings, and generally the use of generic grid pattern ceiling tiles is inappropriate in comparison to the carefully selected original ridged mineral-fibre tiles which are still visible in parts of the building. In the main concourse, the ceiling has also been lowered in order to accommodate recessed picture lighting, changing the nature of the corridor significantly. The *simple rules* of the building ensured that the ceilings in long corridors were visually shortened with the placing of the lights across the full width of the corridor.

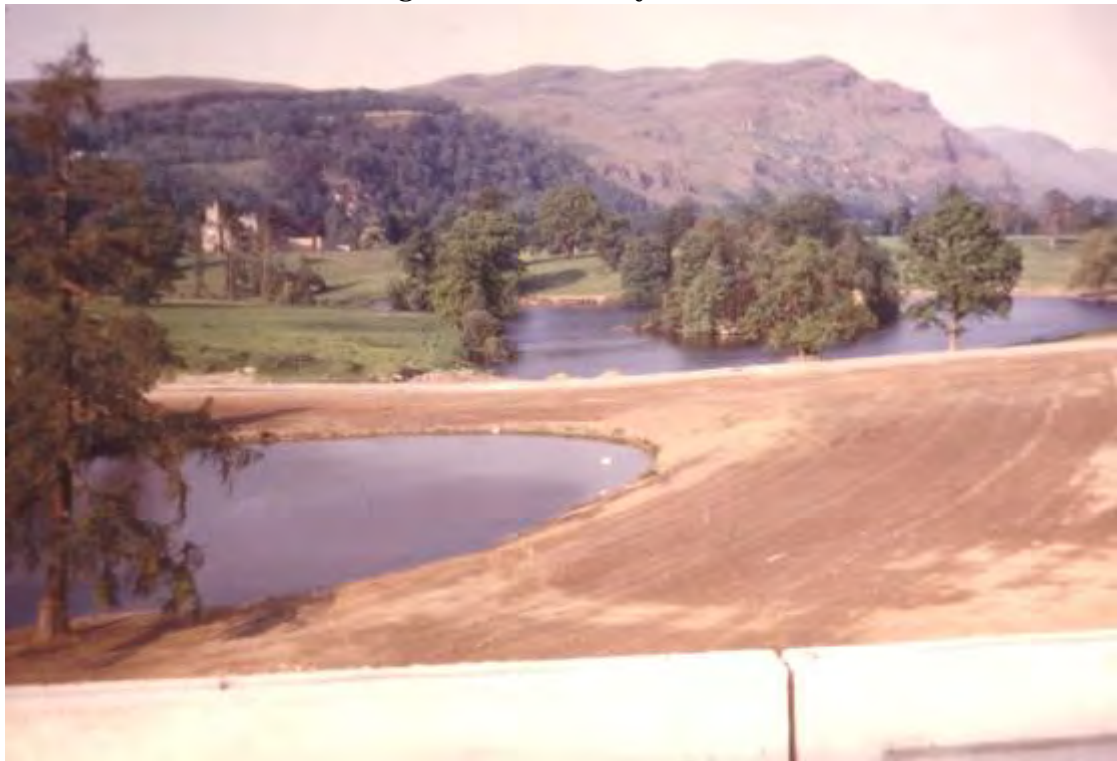
Figure 130 Construction of new road, dividing pond from loch c1968 *UoSA*

In 1968 the loch was divided at its south eastern extremity to form a pond, allowing road access to the new buildings of the University.

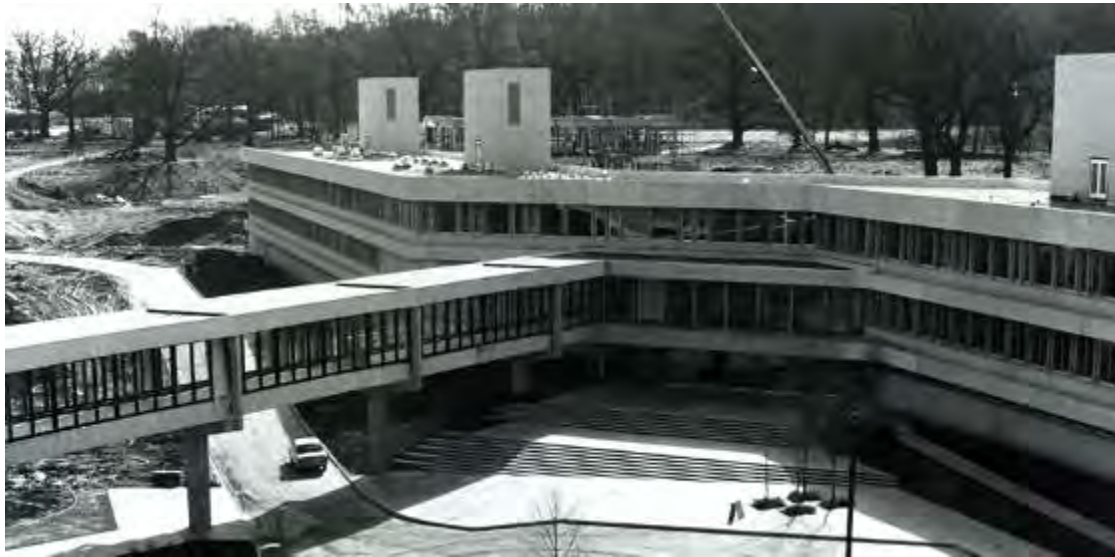
Figure 134 The north elevation of the first phase of the Cottrell Building nearing completion c1970. Note the start of construction of one of the 'rib' blocks in the background. *UoSA*

The form of the building roughly follows the contour of the site, with ladder-plan of long parallel blocks connected at regular intervals by distinct linking 'rib' blocks forming generous internal courtyards. The north block ('A') was built first, with the link buildings following on after and the south block ('B') finished in time for the University student population reaching 3,000.

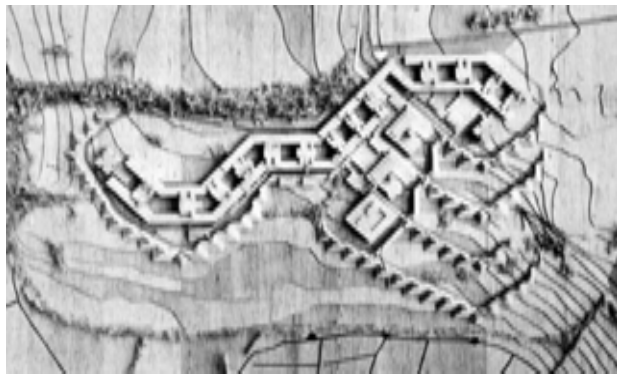
Figure 135 Model of Denys Lasdun's University of East Anglia. Note the ladder plan of the teaching blocks (not completed as shown).

The inspiration for the plan of the Cottrell block can be clearly seen in Denys Lasdun's iconic campus for the University of East Anglia (1962-8), where again the same model of expansion was suggested, though not executed as planned (the north range was not built). Nevertheless the concept of a continuous teaching block is one that rapidly gained momentum from the early 1960s and can be seen at East Anglia and Leeds, and concurrently in developments in North America⁵³.

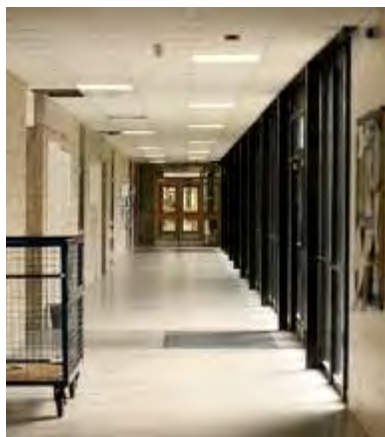
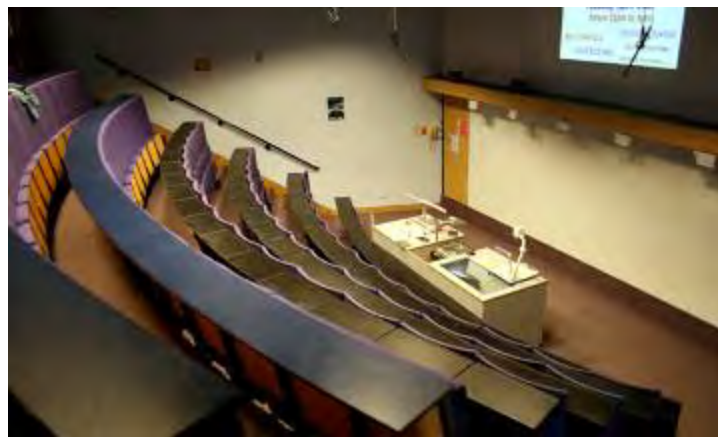
Figure 138 A typical corridor **Figure 139** Interior view of a typical lecture theatre.

The main ground floor corridors of the Cottrell block run the length of each block and face in towards the courtyards. Although not as wide as the main corridor of Pathfoot, they are similarly generously lit by the full-height windows to one side. The architects placed lecture rooms at the 45-degree angles in the plan: such rooms were ideally suited to the otherwise awkward splay of the triangular spaces. This also lends cohesiveness to the plan, and appropriate emphasis to these spaces.

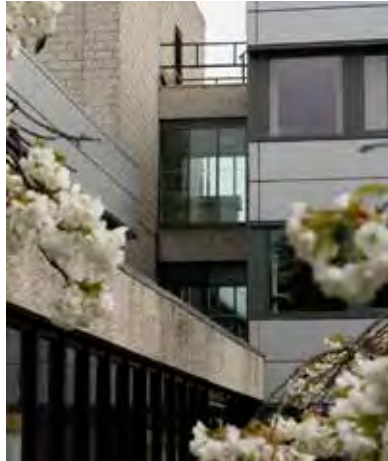
Figure 140 Original and replacement cladding and fenestration

Parts of the building were not included in the re-cladding project – namely the ground floor corridors and link corridors between the stair towers and ‘rib’ buildings between ‘A’ block and ‘B’ block (see figure 140).

The Flagreca cladding panels and around 2,000 windows were replaced in 2007-08 with a major project to overhaul the Cottrell Building. This had been prompted by the deterioration of the panel fixings at a number of different points, which was noted after a panel had fallen to the ground, and by a general desire to improve the environmental performance of the building. The clear black-and-white colour scheme that tied Cottrell to the whole University campus was deviated from and the re-cladding and re-fenestration were carried out with varying shades of grey aluminium, with colour highlights to some window frames. As a result of the requirement to avoid decanting the building during these works, the replacement fenestration was added outside the line of the existing fenestration which remained in-situ until the replacements were complete⁵⁵. Although this was beneficial for the functionality of the University, this further detracted from the original design intention that the fenestration was recessed behind the cladding. The cladding is

now effectively flush with the windows, particularly on the lower floors, though the windows are still distinguished by a darker grey (figure 141).

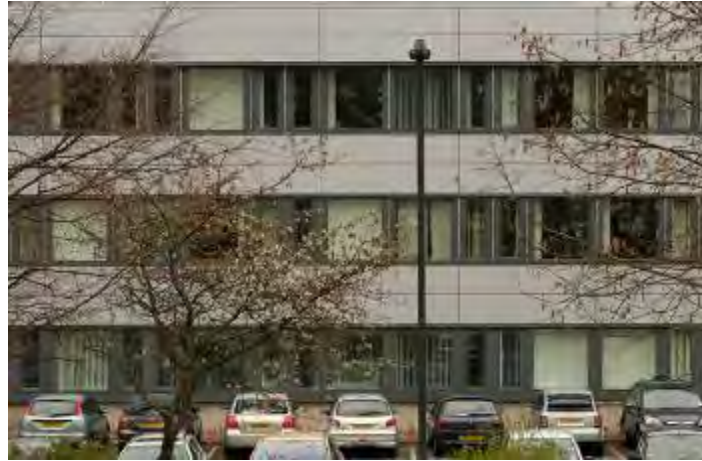
Figure 141 South elevation of Cottrell showing the replacement cladding and fenestration

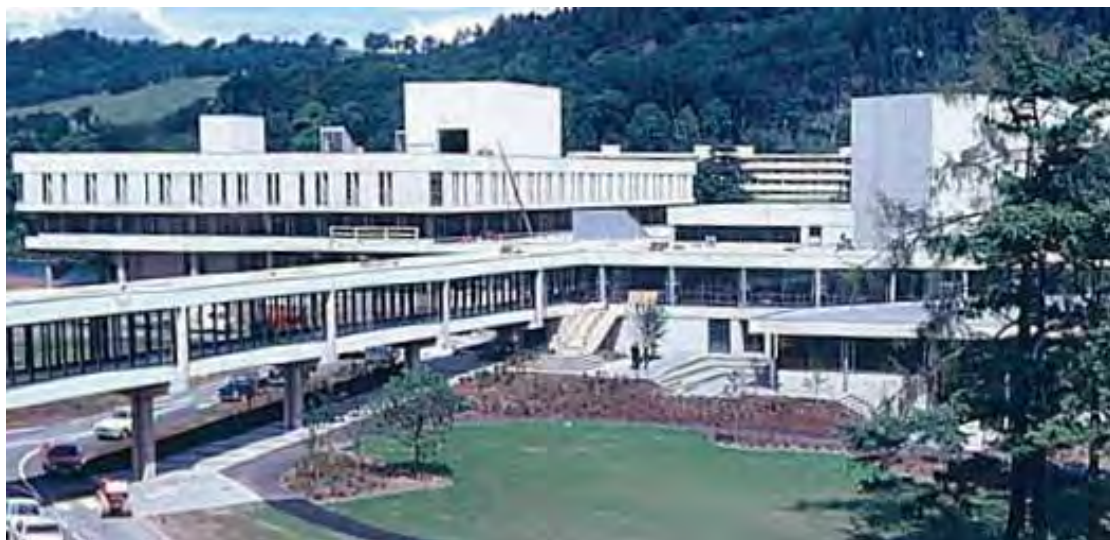
Figure 142 Central area buildings, renamed Andrew Miller building shortly after completion. The library and link bridge on the left, with the MacRobert Arts Centre on the right. *UoSA*

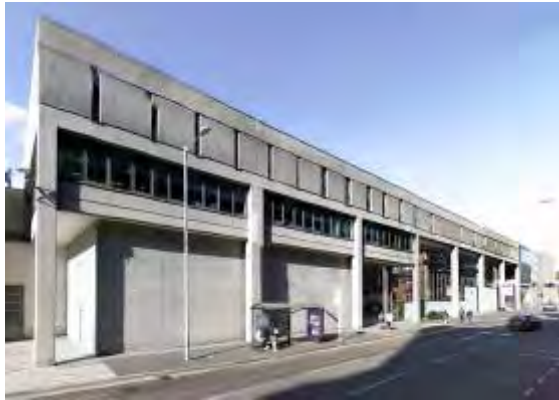
Figure 145 The 1968 Royal Northern College of Music by Bickerdike, Allen, Rich & Partners. *Google*

The library is arranged as an upside-down ziggurat over four storeys: the first floor projects out from the basement and ground levels and is supported by concrete columns equally spaced around the perimeter of the building. The second floor projects out further again. Gerrard Bakker, who worked on the Library recalled being influenced by the design for the Royal Northern College of Music in

Manchester that he had worked on (compare figures 145 and 146). Overall the plan of the building is arranged on a squared-grid of eight structural bays by five.

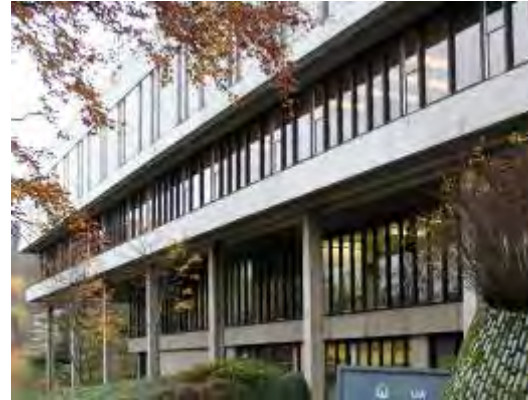
Figure 146 University of Stirling Library

The different uses of the building are clearly expressed on its exterior. The basement level has intermittent windows, with large areas of wall denoting the archival storage and administrative nature of this lower floor. Both the ground and first floors have continuous bands of black-stained timber windows with vertical glazing bars that light the large open plan reading rooms and book stacks on both these floors. On each of these floors, two aluminium vertically-sliding windows per structural bay create a welcome rhythm to the long facades. The second floor is treated quite differently from the other floors, and indeed any of the other buildings on campus: narrow strips of full-height glazing irregularly grouped in pairs or singly, with varying widths of Flagreca cladding comprising the bulk of the façade at this level. These narrow windows light individual study carrels.

concrete columns that rise from ground level. These columns are then hidden behind the façade on the first floor meaning the continuous band of windows gives the impression that the heavy top floor is floating – a lighter composition than the Royal Northern College of Music.

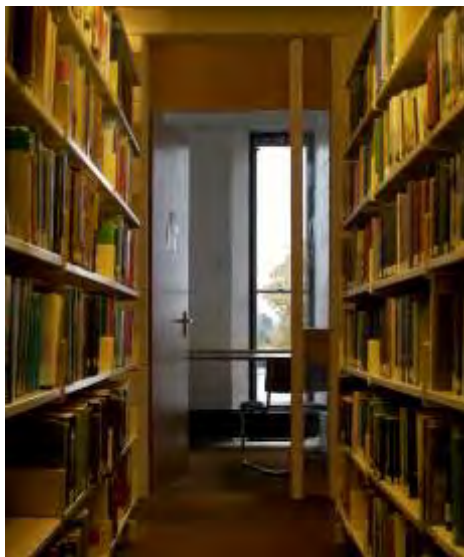
Figure 147 Individual study carrel on the second floor (level 4).of library

The library is currently undergoing a major redevelopment project by the architects Lewis and Hickey. The project will radically alter the interior of the building in particular with the insertion of a central lightwell occupying one square of the building's grid which will bring daylight into the centre of all the main floors. The main entrance will also be shifted north, to join with the north-west corner of the atrium, cutting across the remnants of the open courtyard. The individual study carrels on the second-floor will be removed.

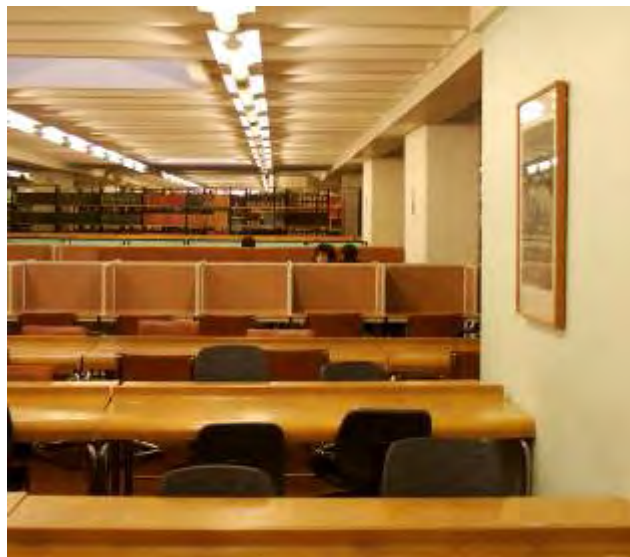
Figure 148 General view of second floor (level 4). Note original desks and replacement lighting on the underside of the coffered ceiling.

The entrance to the library is at concourse level – ie the first floor, or level 2. Interestingly, there was no link between the Library and the Study Centre when built – the plan of Level 2 of the Library stepped back underneath the upper levels. The ceilings on the interior were deliberately heavily engineered with deep coffering – this was designed to shade the lights and avoid glare. With the improved anti-glare designs of modern lighting, this is no longer required, and indeed some replacement lighting has been fixed to the surface of the ceiling (figure 148).

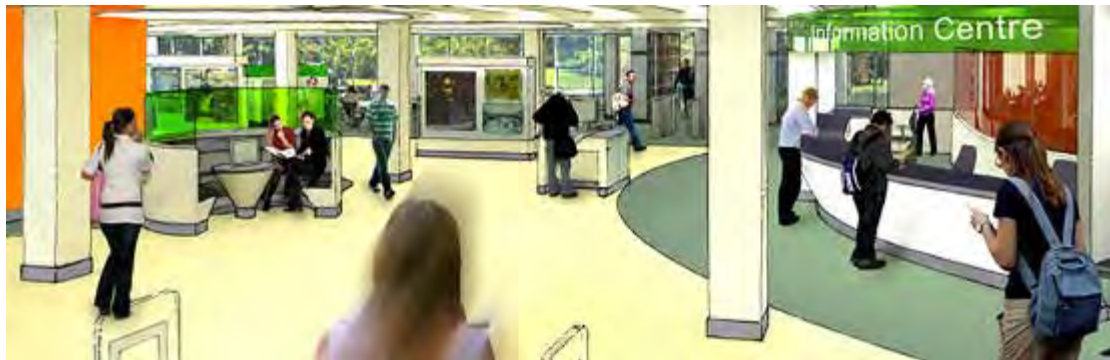
Figure 149 Sketch impression of new library entrance on Level 2. UoSA

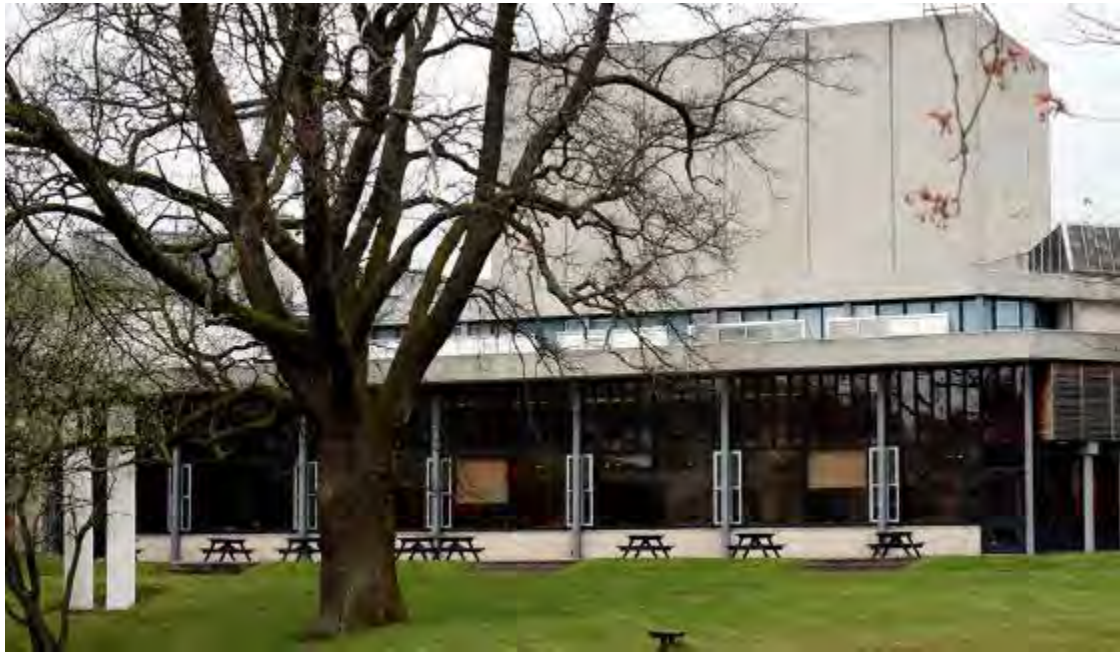
Figure 150 MacRobert Arts Centre with double-height dining space at the lower level and fly-tower behind.

The MacRobert Arts Centre was designed to be a prominent building at the heart of the university campus – the fly tower of the theatre rises above all of the buildings in the immediate surroundings, yet being without fenestration or other distinctive elements means that the Flagreca clad form of the fly tower is less distracting than its otherwise bold form would suggest. It also neatly mimics the stair towers of the library and Cottrell building. The oblique angle that the Centre sits at in provides adequate distinction from the other central area buildings. The positioning allows for the awkward shape of the auditorium to sit well in the overall composition – in the same way that the lecture rooms of Cottrell sit at the angles of that building – and allows the restaurant space to fully take advantage of the view over the MacRobert pond.

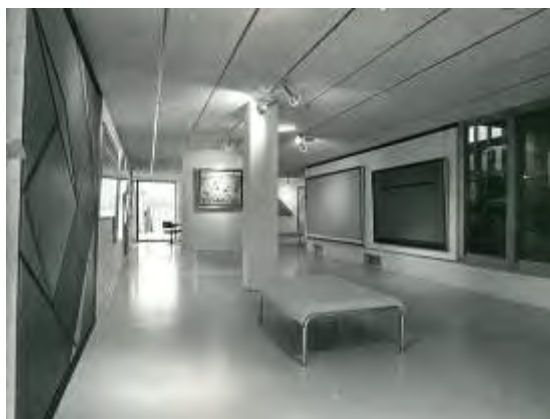
Figure 154 The art gallery, now converted into the main entrance and box office area. The stair leading up to the concourse is on the right. *UoSA*

The Art Gallery was situated underneath the concourse, wrapping around the large foyer space – this was later converted into the bar, and more recently, the main entrance and box office area.

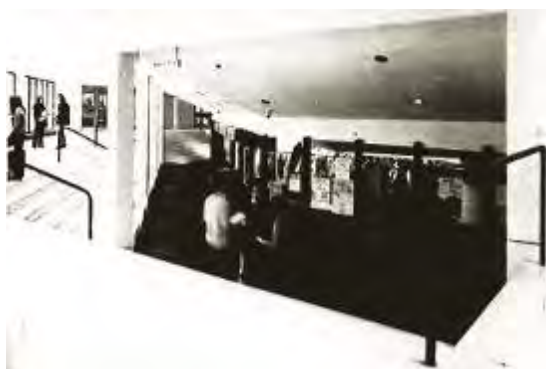
Figure 155 The foyer of the MacRobert, with the concourse level on the left (now the atrium). The ticket booths (centre) were under the rake of the theatre above. The columns mark the line of the wall shown on the right of **figure 156**. *Architectural Review*

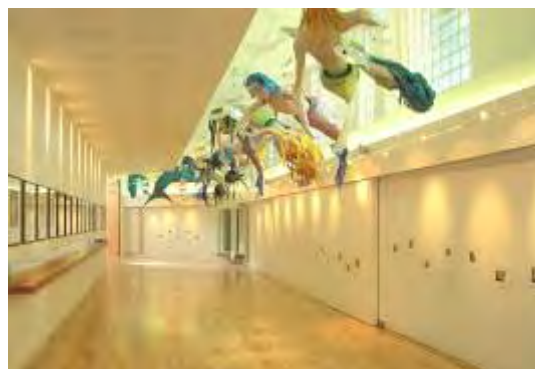
Figure 156 The same space after conversion (photograph taken from the other end at the lower level). The atrium is on the right, with borrowed light for the exhibition space coming from the glass bricks in the new wall. *Buro Happold*

The MacRobert underwent extensive refurbishment before its reopening in October 2002. This work, by the architects Appleton Partnership, included the refocusing of the MacRobert to its separate entrance adjacent to the Andrew Miller building entrance at the ground level of Queen’s Court. The ticket booths were moved to the bar area, just inside the Queen’s Court entrance. The original reception area was separated from the atrium space, a wall built up, steps removed and the floor lowered in order to create an exhibition space (‘arthouse’). This deliberately separated the university function and the more public function of the MacRobert – even though the integration of the two had been a key design aspiration of RMJM and Tom Cottrell. Nevertheless, the accessibility of the MacRobert was greatly improved. The main theatre (‘mainhouse’) and the studio theatre were also refurbished, with the smaller of the two was specifically redesigned for use as a children’s theatre (‘playhouse’).

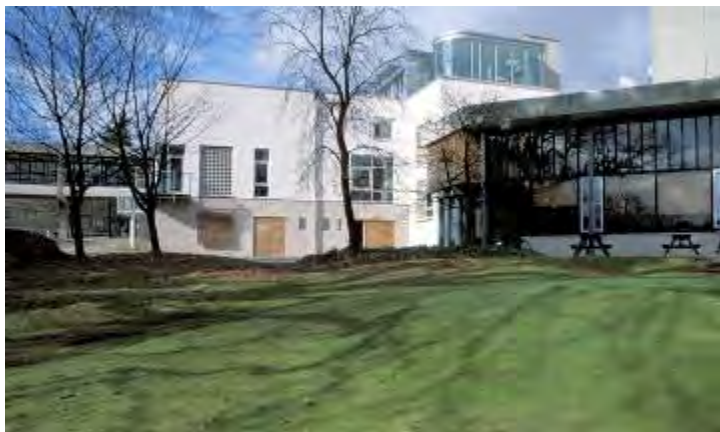
Figure 159 The MacRobert Extension. *Buro Happold*

As well as the internal alterations, a large extension was also built, providing a new workshop and rehearsal space (‘workhouse’) and cinema (‘filmhouse’). The new extension is a rather complex four-storey building (see figure 159) which despite being attractive in its own right detracts from the simplicity of the original design concept. The way that the extension abuts the link bridge was deliberately designed to maintain the original structural integrity of the bridge, but has in the process created an unattractive void along two bays of the bridge (see figure 160), and an awkward juxtaposition of materials.

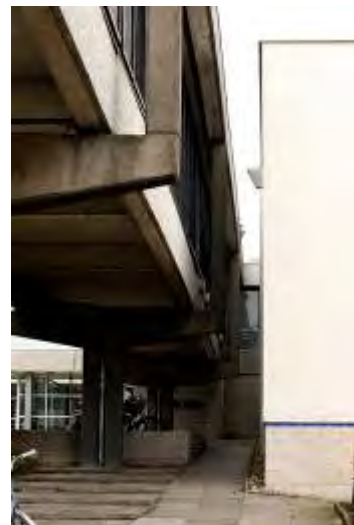
Figure 160 The MacRobert Extension adjacent to the link bridge

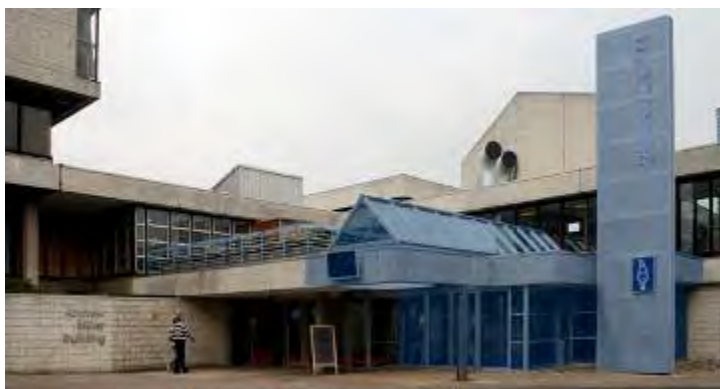
Figure 161 Architectural ‘clutter’ created with the refurbishment of the MacRobert Centre highlighted in blue.

The additions and alterations to the entrance from Queen’s Court also have drawbacks. Whilst enabling a higher profile for the MacRobert, it has achieved this only at the expense of the entrance to the Andrew Miller building.

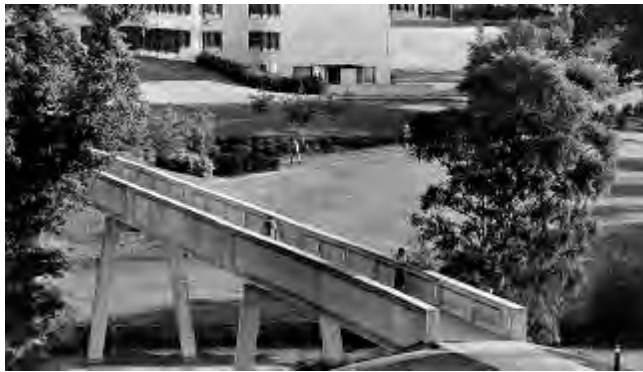
Figure 164 View showing the simplicity of the structure of the footbridge. *UoSA*

The footbridge over Airthrey Loch replaced an earlier bridge at the same narrow point of the loch. It was designed in order to facilitate the large volume of pedestrian traffic between the central area buildings and the students' residences on the north banks of Airthrey Loch. The height of the bridge above the water level of

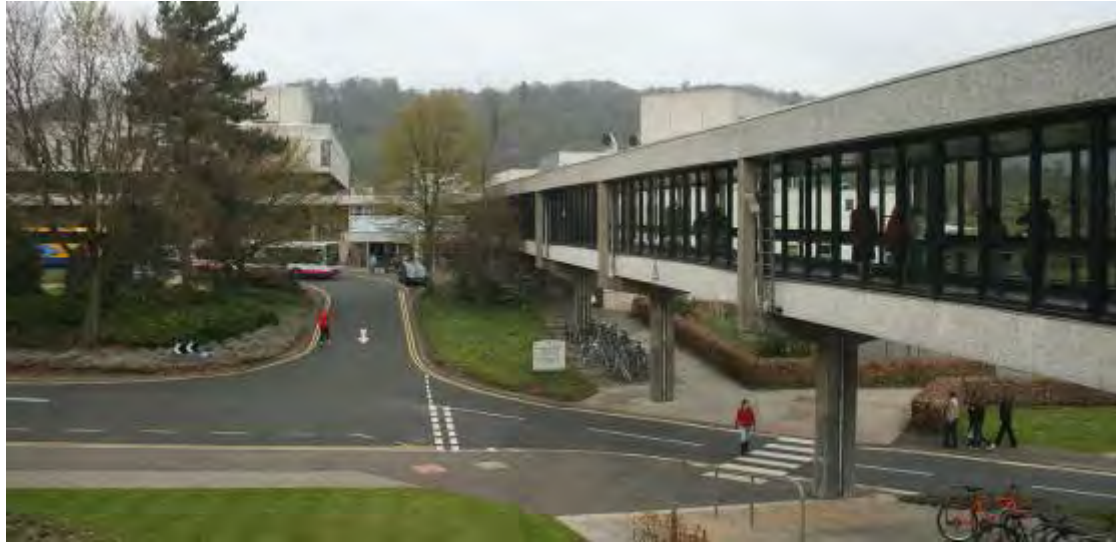
Figure 166 External view of the link bridge

Although the interior has the same simplicity as the corridors of Cottrell (and formerly of the concourse of the Andrew Miller building), the external structure of the bridge has an elegant structural form. The bridge stands on forked structural piers that split from a single column to wrap around the walkway to meet with the roof.

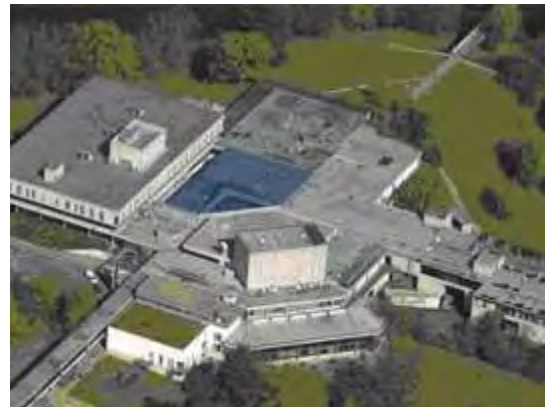
Figure 172 2007 Oblique aerial view from south-east with covered atrium highlighted in blue. *RCAHMS edited by S&B*

What is now referred to as the atrium was created in 1998 by Ian Burke Associates⁶⁰, and involved the covering over of what was originally designed as an open courtyard, with the concourse running around the perimeter. A large glazed tetrahedron roof provides light to this space which is used for a variety of social purposes. A slim courtyard between the atrium and the library building was retained, with access to the open area adjacent to the loch maintained.

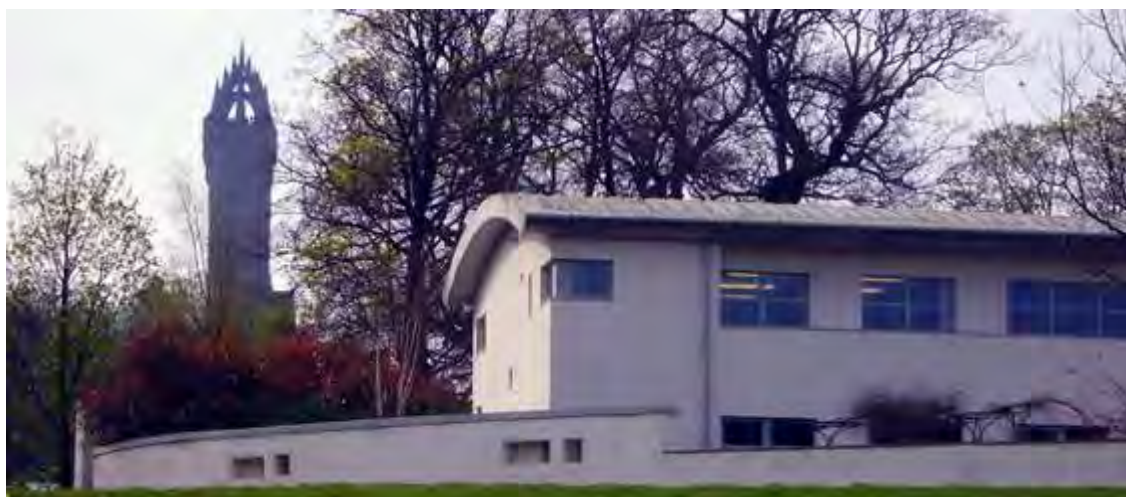
Figure 177 Iris Murdoch building 2009

This building, designed by Burnett Pollock Associates, houses the Dementia Services Development Centre. The plan of the building was deliberately set out to demonstrate good practice in accommodating users with dementia in a public building by maximising clarity in order to aide orientation and avoid confusion. Presentations demonstrating these aspects are regularly given at the centre.

As well as a mix of open-plan and cellular office space, seminar and meeting rooms, the building includes residential accommodation for visiting academics. The garden, also designed to cater for people with dementia, was by the landscape architect Annie Pollock.

Built at a cost of £1.5m it was completed in March 2002.

This end suggests the limit of development in this direction. There are some mature trees further east. The buildings are in good condition although the garden walls of the Iris Murdoch building are disfigured by staining and some cracking under the copes. There is also some staining on the circular entrance tower of the Iris Murdoch building.

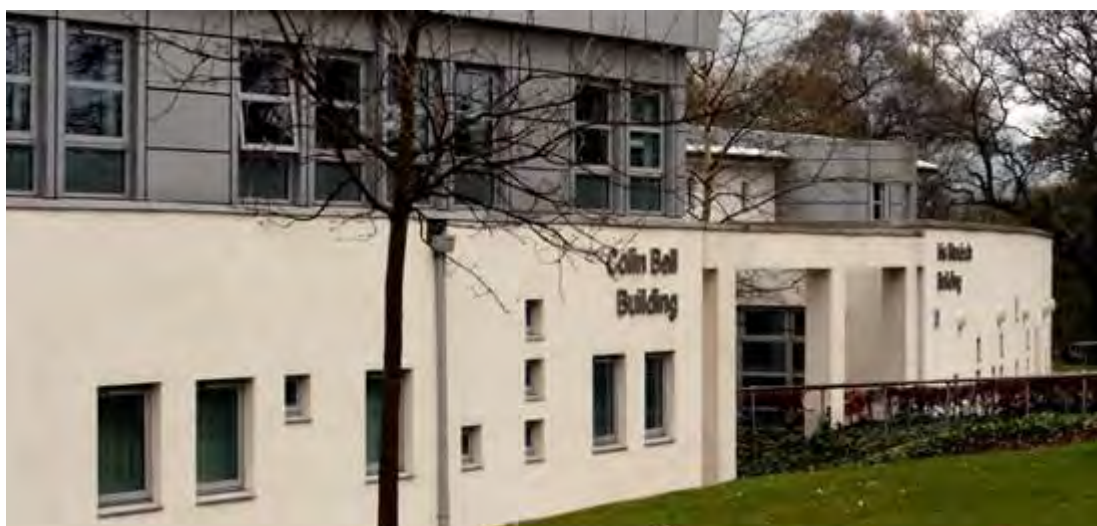
Figure 178 The Colin Bell and Iris Murdoch buildings.2009

Designed by Burnett Pollock Architects the Colin Bell building was built to house the Department of Applied Social Science. Being masterplanned at the same time as the adjacent Iris Murdoch building, the architectural treatment is very similar with white render ground storey, aluminium-clad upper storey, and a variety of sizing and placing of fenestration. The two buildings are, in plan, completely separate yet are tied together visually by a simple screen across the entrance porch which leads to a porch for both buildings.

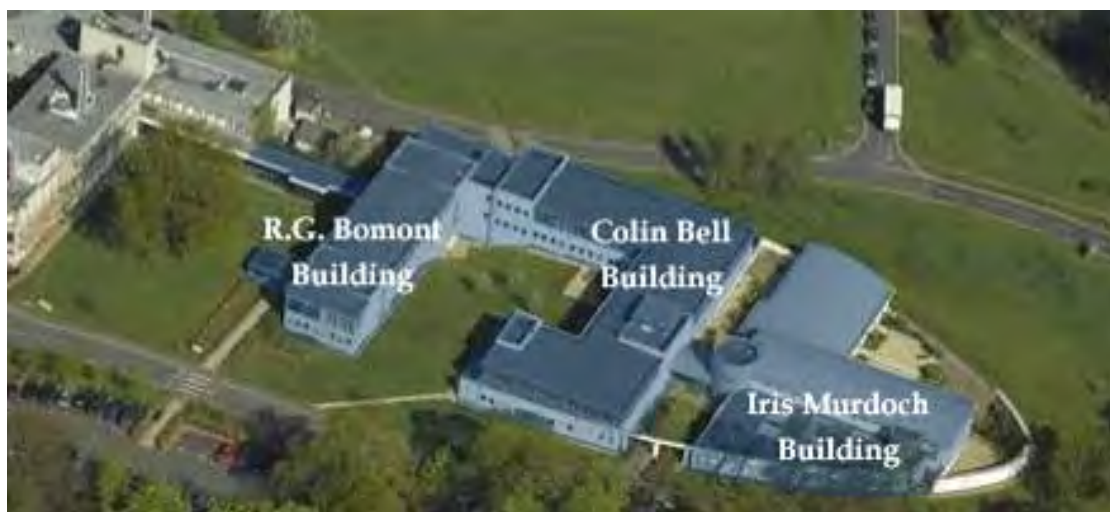
Figure 179 The post-1997 extensions to Cottrell

This group of post-1997 buildings demonstrate an interesting academic and architectural move away from flexible teaching space and a return to custom buildings for stand-alone departments. As a group they act as an effective ‘full-stop’ to Cottrell, providing the satisfying conclusion that was always intended but not built for more than two decades. Whilst taking on a completely different format in both layout and materiality, they remain closely connected to Cottrell in terms of their massing, footprint and building line. The Colin Bell and Iris Murdoch buildings are particularly well liked – even being referred to as ‘Pathfoot Mark II’ by staff who work in them⁶³.

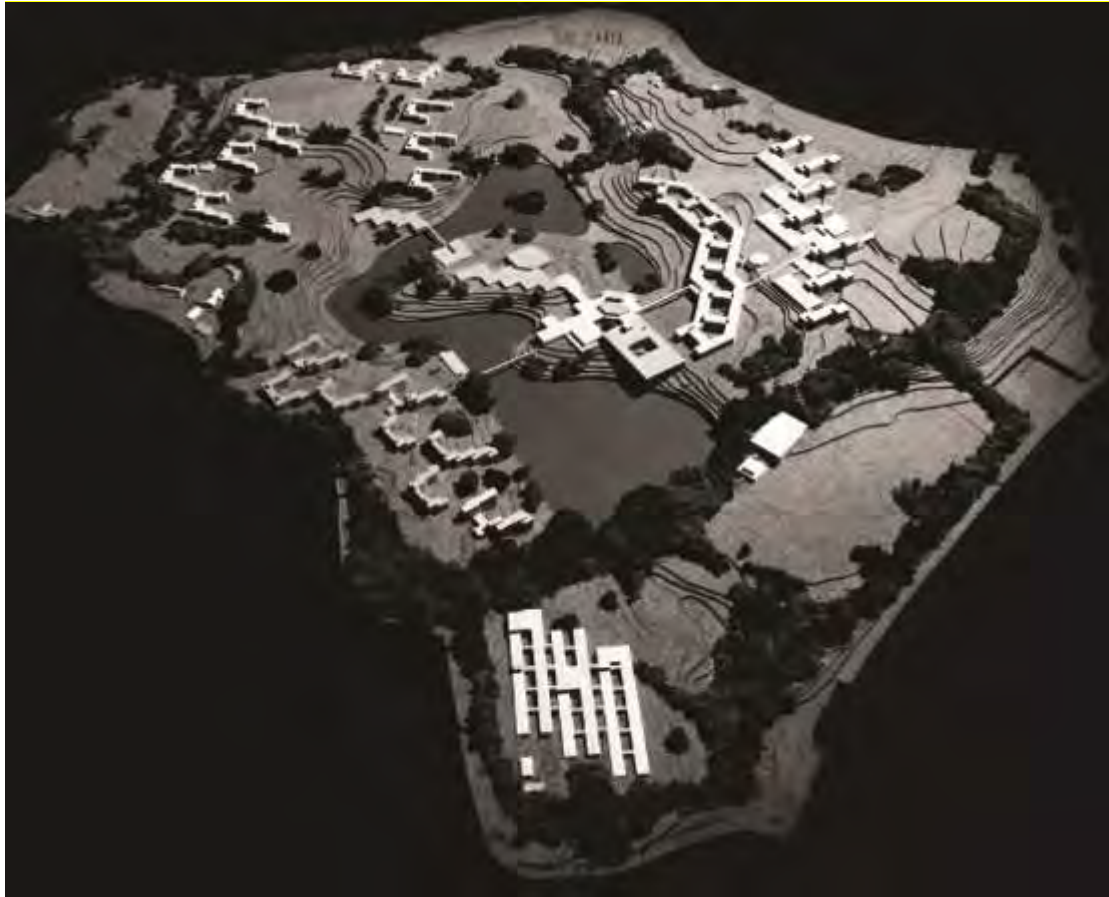
Figure 180 The Phase 3 model prepared by RMJM. Note the extended library projecting over the edge of the loch, the distinct nature of the Phase 3 teaching block south of Cottrell, and the residences to the east of Airthrey Loch, accessed via the extended social buildings and second bridge over the loch. *RMJM*

The Phase 3 growth was also intended to include an expansion of the library – the photograph of the model shows the suggested doubling of the building with an additional five-by-eight bay block connected with two-bay wide links with a large open courtyard. The north-west corner of the additional block would have been cantilevered over the edge of the loch.

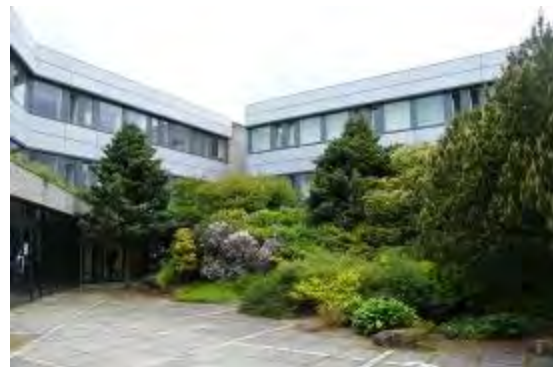
Figure 181 Courtyard within Cottrell 2009

The most attractive quality about the Cottrell Building are the inward facing courtyards. In each case they have a mix of formal and informal planting. The central courtyard has a paving design which reflects the 45 degree diagonals of the

Cottrell building in a design of concrete paving and bands of sets. The garden between blocks X and Y is less formal. The courtyard between Y and Z is a service courtyard with parking. The courtyard between blocks X and W and between U and V is also informal with tree planting but less intense and with a greater area of gravel. The latter courtyard has some beautiful trees.

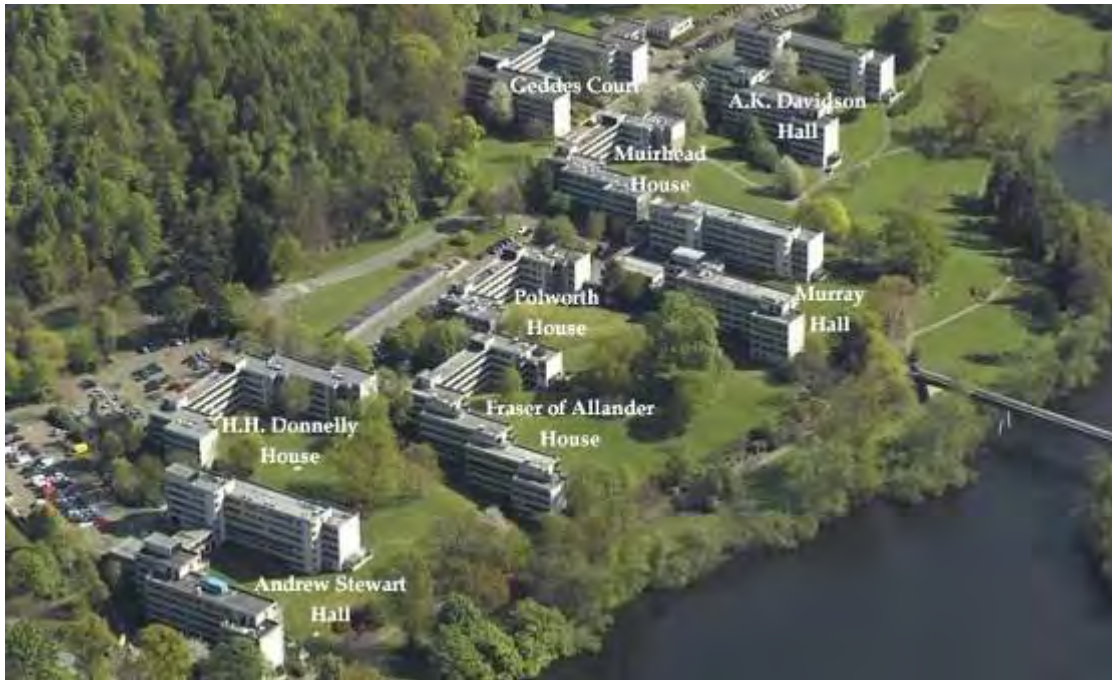
Figure 193 Oblique aerial view from 2007 of the Students' Residences, annotated with the building names. RCAHMS edited by S&B

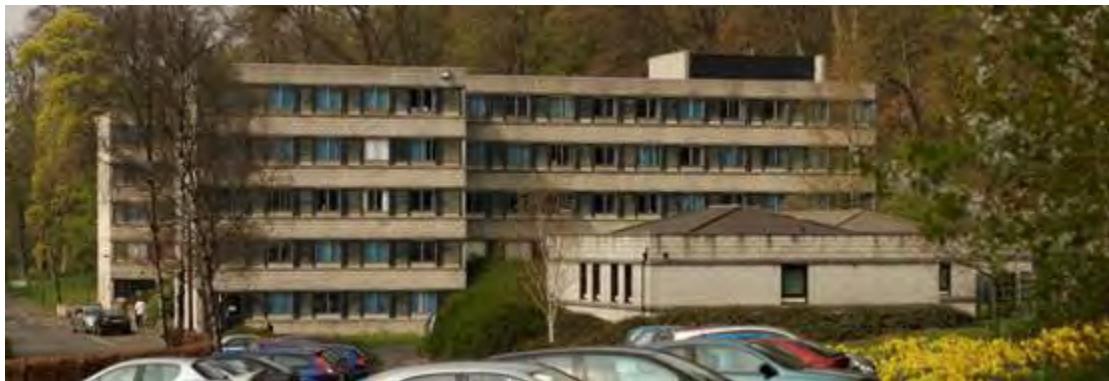
Figure 197 General view of Geddes Court.

Although conceived as individual buildings, covered walkways allow for sheltered communication between most. These walkways start as arcades beneath the blocks, stretching out to connect at corner points where paths leading to other parts of the campus lead off.

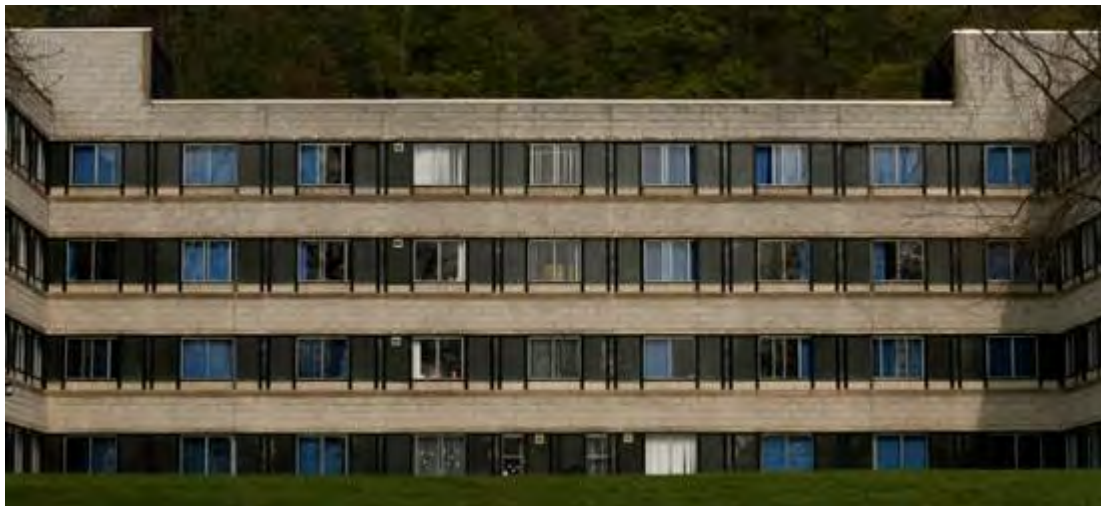
Figure 198 General view of Muirhead House, with the original fenestration.

Ongoing refurbishment of the Students Residences has had two main effects on the fabric of the buildings – the replacement of the original single-glazed fenestration and the insertion of en-suite facilities to cater for increased expectations of current students and vacation letting. The insertion of en-suite facilities in general involves the conversion of alternate bedrooms into two bathrooms – resulting in the loss of approximately one-third of the total number of bedrooms. Even the less ambitious refurbishment projects have resulted in the loss of bedrooms as improved communal facilities require more space.

The replacement of the windows has had a surprising effect on the elevations. The replacement double-glazed top-hung windows in dark black-stained timber create a bolder colour scheme than the original aluminium frames – something that is rather successful. Although efforts were made by the university to source sliding windows, it was not possible to do so, and the new top-hung windows have introduced a measure of ‘movement’ to the elevations when compared to the sliding mechanism of the original fenestration.

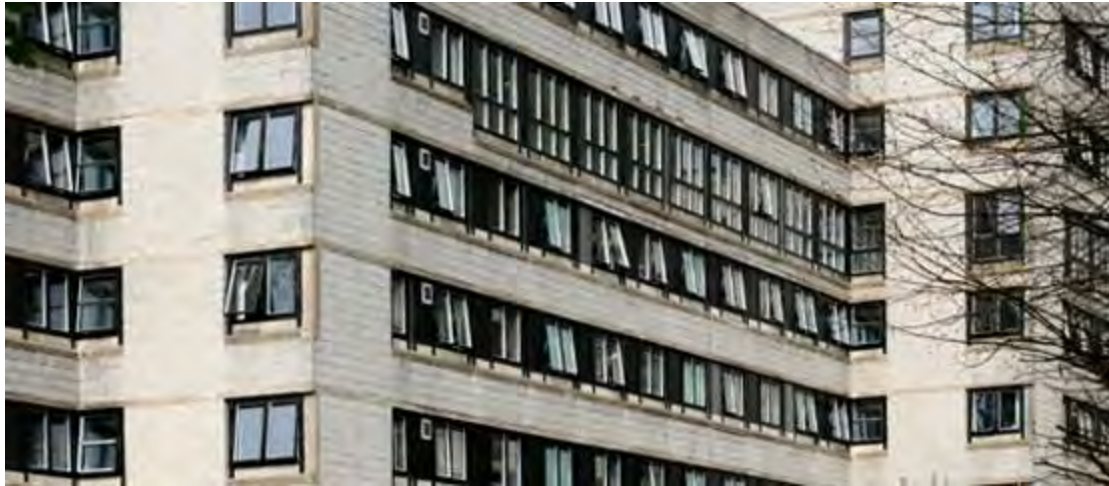
Figure 200 General view of replacement fenestration – note the bold black frames and the top-hung hinged opening.

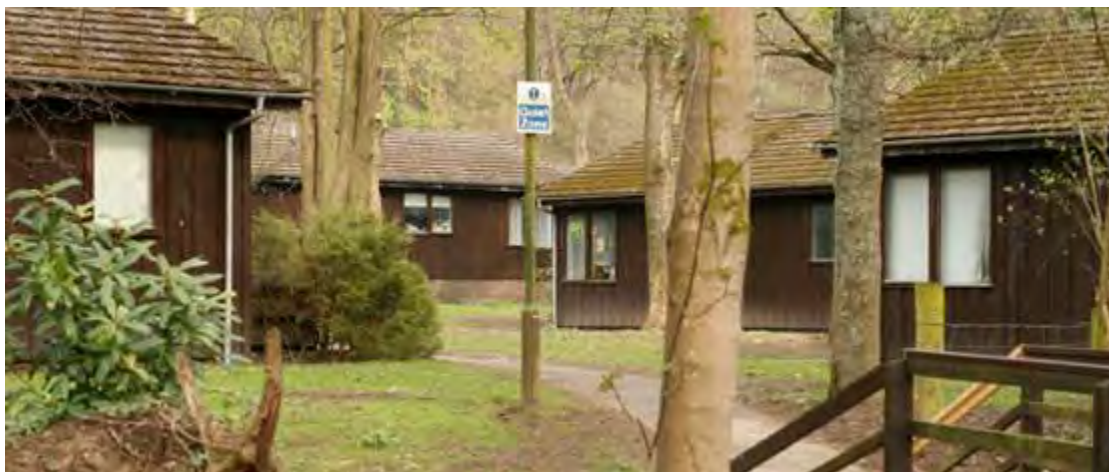
Figure 201 General view of chalets at Pendriech Way 2009

In 1981, additional student accommodation was supplied in the form of ten chalets at Pendriech Way. The chalets are all single storey Scandinavian-style timber constructions of the type more normally found in holiday parks, but are ideally suited to the woodland setting east of Pathfoot. They are popular with the returning undergraduates who live in them and as holiday accommodation in vacation periods. Each chalet accommodates five students, or up to six as a holiday-let.

To the north west is an area of chalets. These are more closely spaced than the chalets in Character Area 8 and they make a better use of their woodland setting. The buildings are in fair condition. There is a heavy build up of moss on the roofs but this is not unattractive and, since the gutters are all UPVC, there is no problem about acidic run off from these surfaces.
