THE UNIVERSITY OF STIRLING CAMPUS

Conservation Plan

Simpson & Brown Architects

October 2009

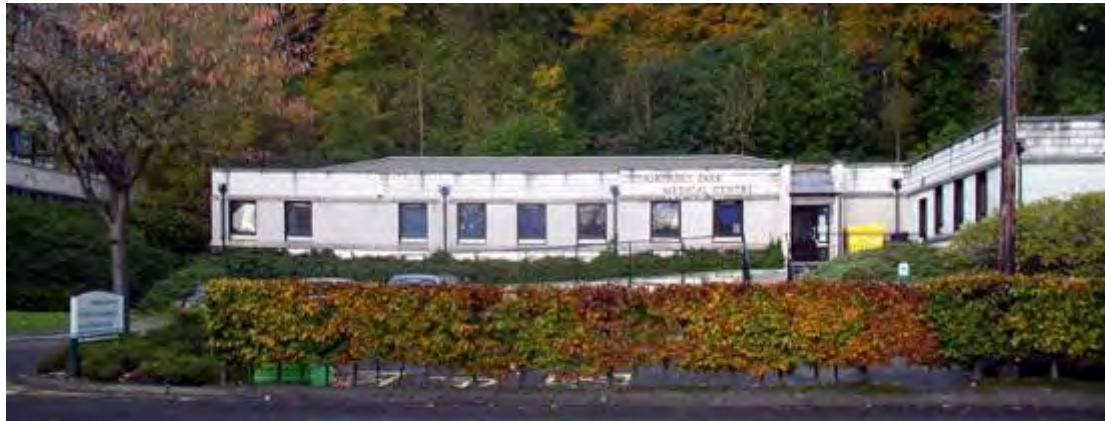
Figure 202 Airthrey Park Medical Centre 2008

A small area of land immediately east of the students' residences is leased to the Airthrey Park Medical Centre. The building is a fairly nondescript single-storey L-shape with matching later extension that ties in with the colouring and materiality of the students' residences. This practice is aimed primarily at staff and students at the University but is also open to patients from the local area.

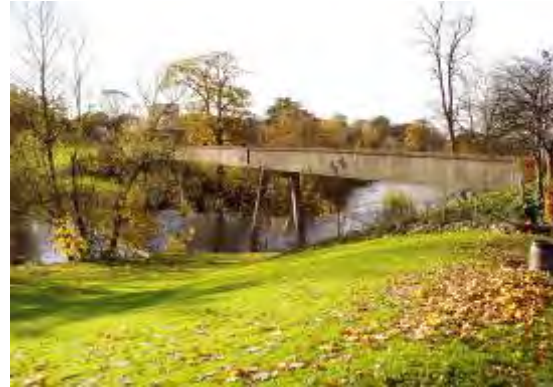
Figure 205 Footbridge from east 2008

This bridge is an audacious piece of architecture and engineering. The elevated and level line running through a natural landscape has been important to the designers, as has the intention to bring the two pairs of supporting pillars directly into the loch. As exposed and unprotected concrete, the bridge is now much more stained and covered with moss than originally intended. It would have looked very white and fresh when it was first built. The inner faces of the parapets have been painted white.

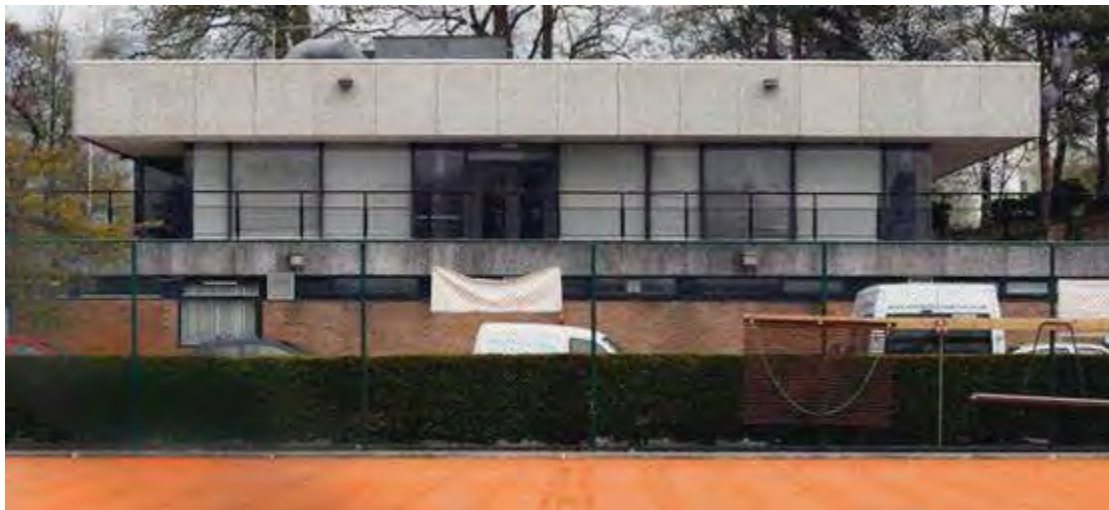
Figure 217 East elevation of Gannochy Trust Pavilion. Note the closed blinds on the upper level, the car parking and the fenced off tennis courts in front.

The materials used on the building include Flagreca cladding panels on the overhanging roof slab and black-stained timber windows, neatly tying the building into the rest of the campus. A red brick was used for the lower level which highlighted the prominence of the elegant upper level. The changing rooms at the lower level were lit by a narrow band of clerestory windows, with larger windows at either end which provided a pleasing balance to the composition of the façade. The pavilion was an exceptionally well designed and well thought through building.

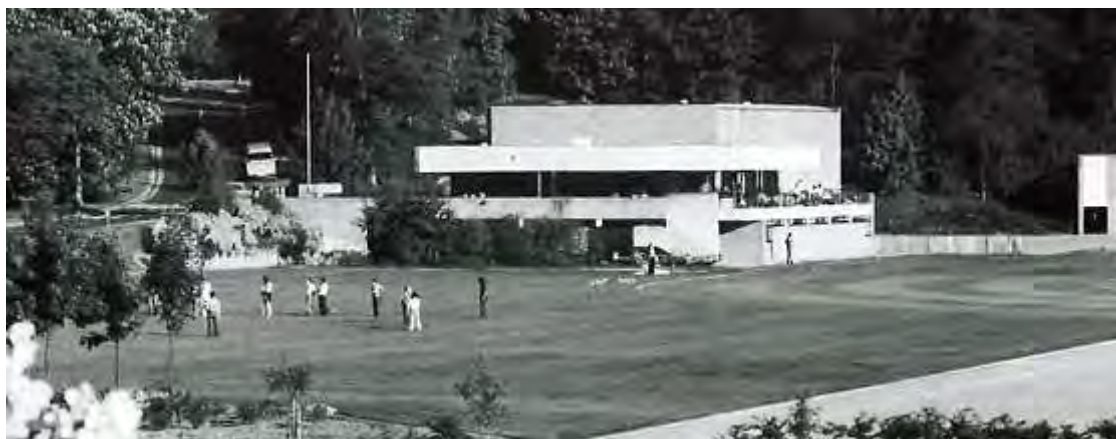
Figure 219 Gannochy Trust Pavilion with phase 2 swimming pool behind, and separate squash courts block on the right. Note the busy terrace of the pavilion. UoSA

These more detailed drawings clearly delineate the phasing of the proposed centre – the phase 1 Pavilion was by then complete, phase 2 comprised the administrative offices, reception and a weights room on the lower (ground) level, with changing rooms, small studio and the swimming pool on the upper level. The 1st floor walkway connecting to the Pavilion was included in this phase. Also included was the squash courts block containing three courts. This phase was completed in 1973.

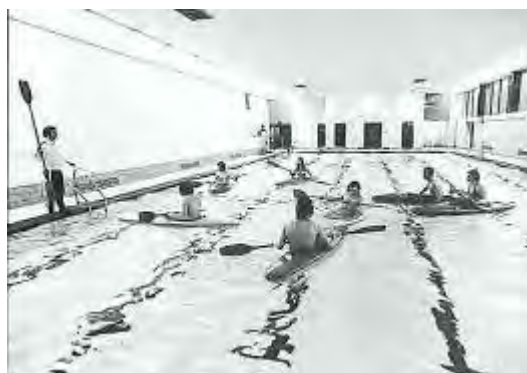
Figure 221 Gannochy Sports Centre swimming pool, since converted for use as a fitness suite. *UoSA*

In 2002 the University opened the new £6.4m six-lane 50 metre Robertson Trust Swimming Pool, housed in a new building immediately north of the Gannochy Trust Pavilion. The 1973 swimming pool was subsequently floored and converted into a fitness centre. The building, which houses the Scottish National Swimming Academy, was designed by Faulkner Browns Architects in 2000⁸⁷. Faulkner Browns have designed a number of similar buildings including the Aquatics Centre for the Manchester Commonwealth Games in 2002, and the refurbishment and extension of the University of Edinburgh's sports buildings at St Leonards Land⁸⁸. The form of the building is dominated by the roof that sweeps up over the building in a single pitch before curving round on the rear elevation.

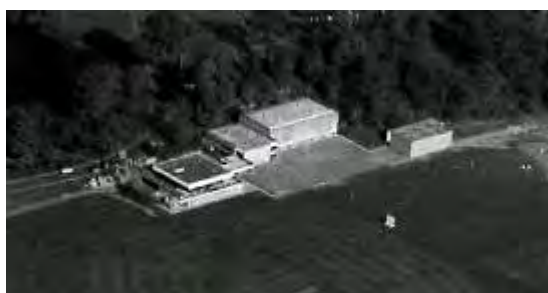
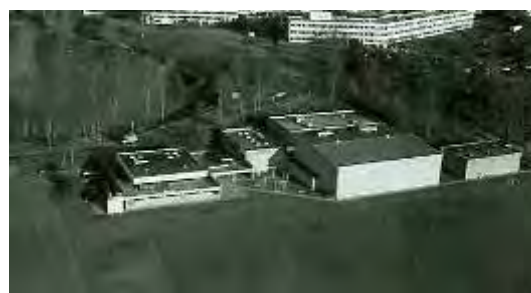
Figure 222 Oblique aerial views showing the development of the Gannochy Sports Centre. The image on the left is post-1973 showing the swimming pool and squash courts building. The image on the right, post-1980, shows the addition of the games hall. *UoSA*

The subsequent phase with the large and small halls in front of the phase 2 buildings was not completed until 1980. The planned incorporation of the squash courts into the main body of the building by adding a further five courts and a connecting corridor at first floor level was not built, and the three phase 2 squash courts remained separate.

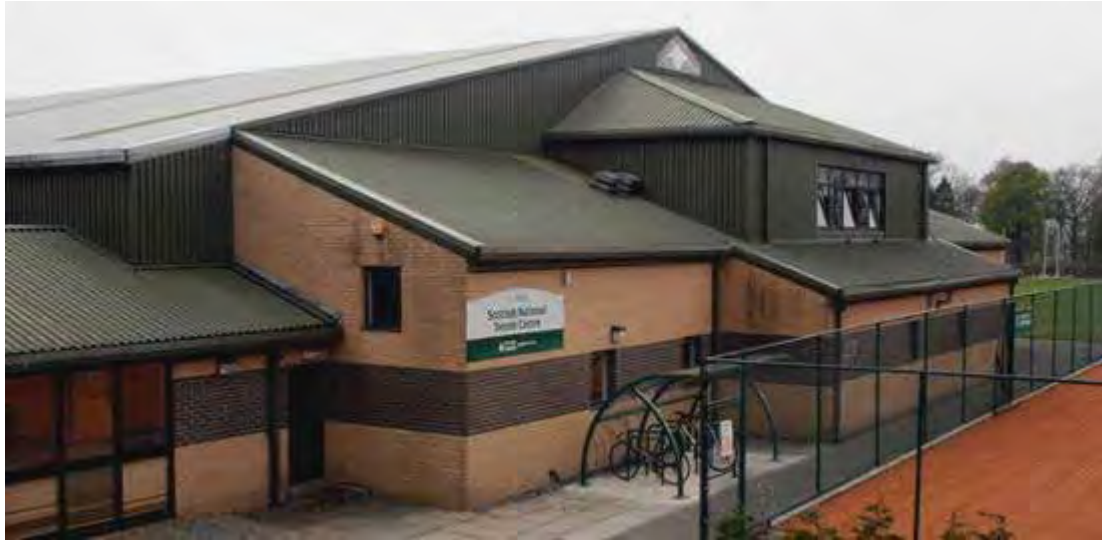
Figure 223 Gannochy Tennis Centre 2009

The Gannochy Tennis Centre was opened in 1991 by HRH, Princess of Wales. The building is a straight-forward industrial-style building in two-tone brick with metal cladding and roof in dark green. It houses four indoor tennis courts.

The Scottish National Tennis Centre at the north of this western run of buildings is the least attractive and least architecturally distinguished of any of the buildings in this character area. It presents a blank face to the pitches with the token patterning in the brickwork and a sheeted band near the roof which has a number of dents and bashes in it. Water is overflowing from the northern end of the western gutter.

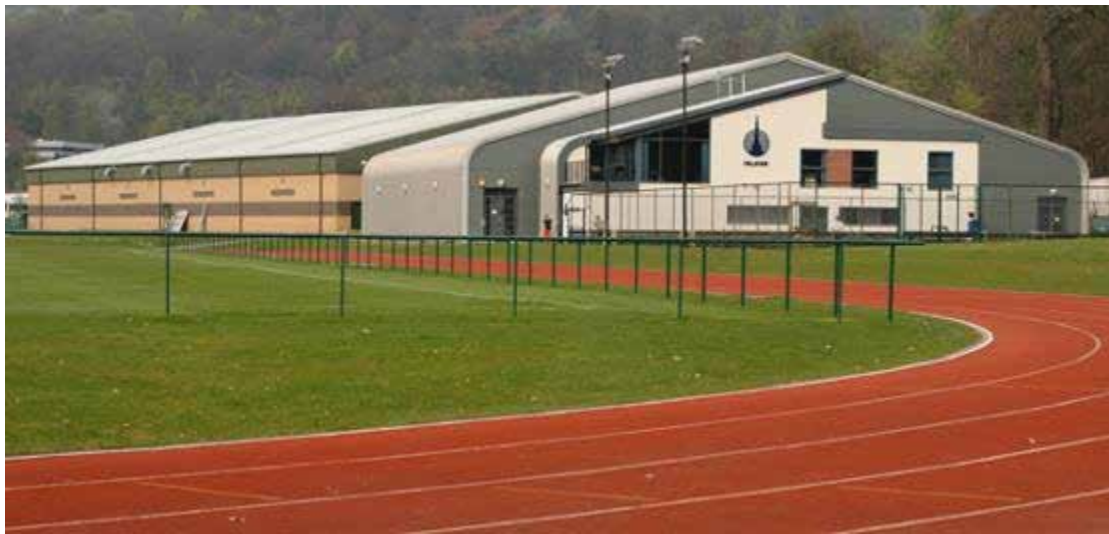
Figure 225 Craig Gowans Football Centre with both Tennis Centre buildings behind 2009

Built on the site of the former outdoor tennis courts, the football centre is the training facility for Falkirk Football Club. The £900,000 building was designed by McEachern and MacDuff as a two-storey asymmetrical block immediately to the south of the indoor tennis centre extension of 2006. This south block, white-rendered with a grey metal roof that matches that of the tennis centre and houses offices, changing rooms, physiotherapy space and a players' lounge.

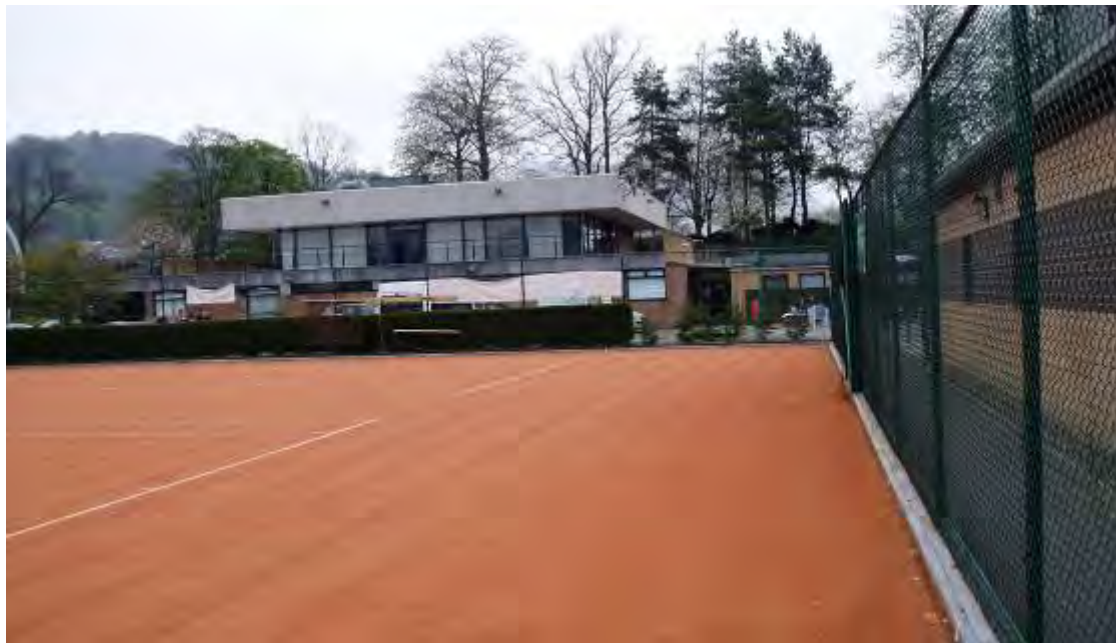
Figure 227 Gannochy Pavilion and tennis courts 2009

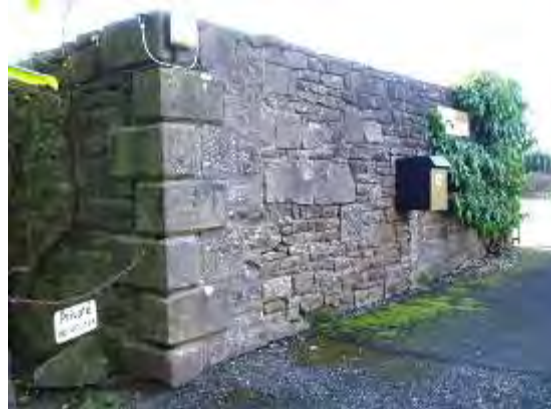
Figure 234 Quoins on former wall of steading

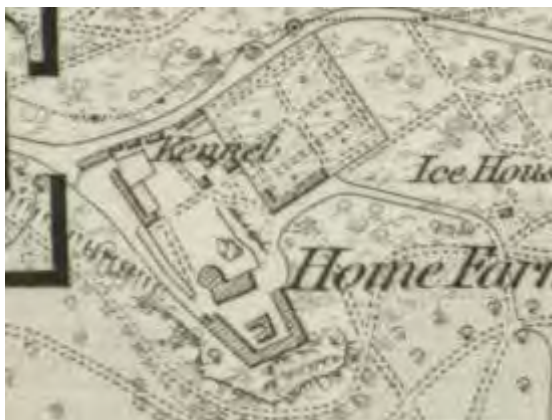
Figure 237 1st Edition OS 1865 BLA

The earliest map showing the buildings in detail is the 1st Edition OS 1865 (figure 237). The 'Home Farm' area, together with the walled garden to the north east, covered a fairly large, approximately L-shaped area. It was bounded to the south and west by a steep fall in the ground, and to the north by the boundary wall, forming the north wall of the walled garden, leaning against which were various small buildings, possibly kennels. At the north west the wall was a gated entrance.

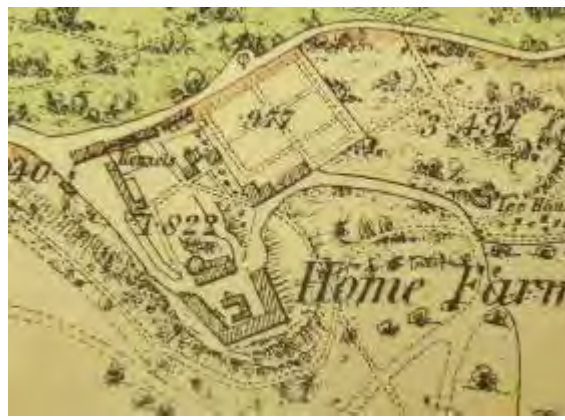
Figure 238 Estate Plan 1885 UoSA

The stables and offices were described in the 1885 Sales Particulars as ‘commodious and suitable. There are 4 Coach-houses, 2 Harness-rooms, 24 Stalls and 2 Loose-boxes, and ample accommodation for Coachmen and Grooms.’ Kennels are also shown on the 1865 OS and the 1885 estate plan (figure 238). Little alteration to the footprint of the buildings is shown on later OS maps (figure 239-240).

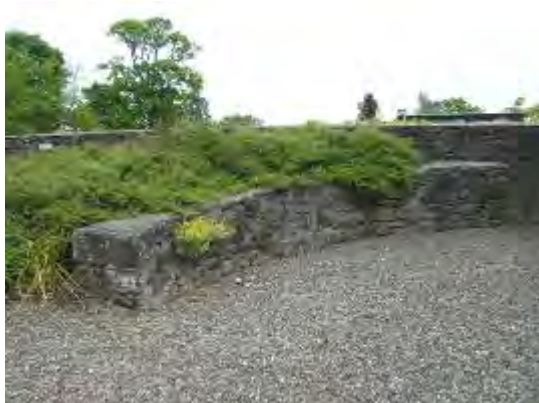
The buildings were in a poor condition by the 1960s and the walls were carefully demolished down to levels that related to the design of the new Principal's House. Stone from the demolitions was re-used to build bases for two of the Nuffield Houses closest to the Principal's House on the west side (figure 244). The walls of the central farm building were taken down to a level relating to the new houses and retained. A part of the curved wall from the demolished horse gin was also retained (figure 243).

Figure 243 Curved wall of former horse gin, with walls of former farm building and roof of Principal's House beyond 2009

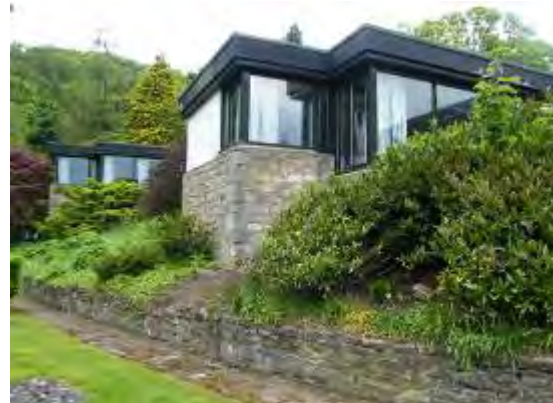
Figure 244 Re-used stone forming bases for Nuffield Houses 2009

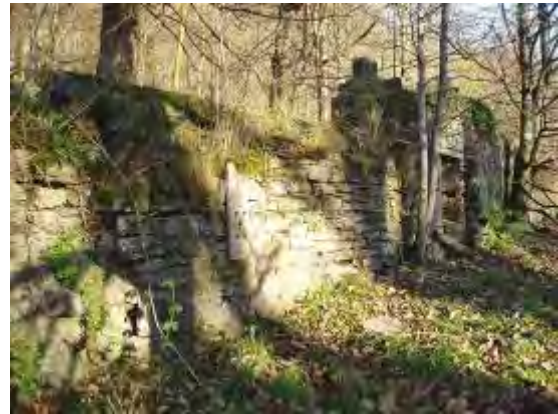
Figure 246 North wall of former walled garden with indications of former lean-to buildings 2008

At the northern limits of the yard area are stone walls enclosing a walled kitchen garden set at the base of woodland. These walls are in poorer condition than the walls close to the Principal's House. Significant pointing and repair is required, together with removal of vegetation and the resetting of copes. In the part of the wall to the east there are no copes. There are a number of places where young trees are growing out of the wall. These should be removed urgently before their roots cause more damage. To the north east corner are bee hives. On the east wall there is a heavy build up of ivy which should be cut back. A tree has fallen onto the wall and this should be cut away so that it cannot damage the wall any further.

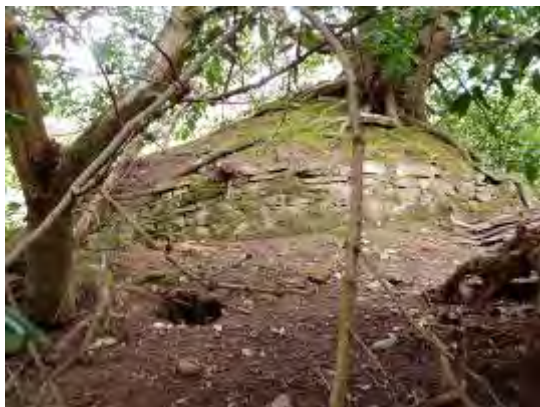
The Icehouse is a late 18th century structure, part of the complement of estate buildings of an improved estate. It is likely to have been added to the estate after the digging of the loch, which would have provided a good supply of ice. The laurel tree on its roof was probably deliberately planted there in the 19th century to create a romantic character.

Figure 247 Icehouse, with laurel on roof 2009

At the icehouse, some maintenance in the form of repointing is needed. It would be better to break out the door and have a metal gate in place which would allow ventilation of the interior. The retaining wall against the bund to the south of the cutting appears in poor condition and is beginning to collapse. It should be thoroughly raked out, the moss removed and repointed, possibly with a tie back into the bund behind.

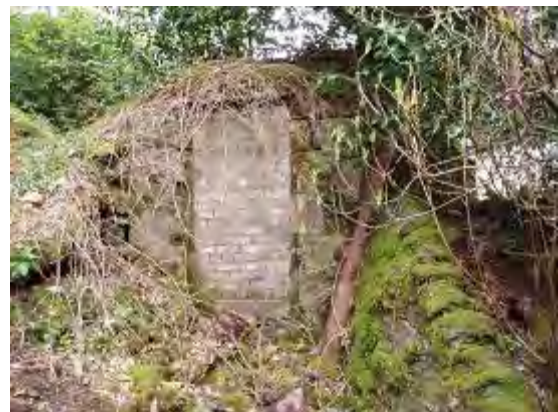
Figure 248 Icehouse, blocked door 2009

At the foot of the route up to Airthrey Castle yard is a circular icehouse building with a rubble stone roof. It is built of rubble walls and has an earth bund around it. The entrance was from the west with a rock cutting to one side and a stone wall built to a batter to the south. The entrance has been blocked with engineering bricks. It is in fair condition although it has a substantial laurel tree growing on its roof. The laurel

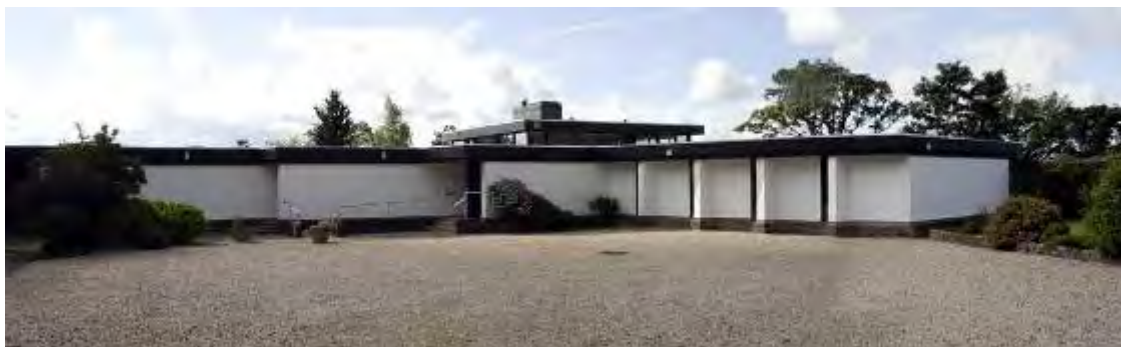
Figure 254 Entrance elevation of the Principal's House. RCAHMS edited by S&B

Although the modernist design is striking, perhaps even more so than any other building on the campus, it sits on the same floor plate of the building it replaced, and the south and west elevations incorporate remains of the stone walls into the design.

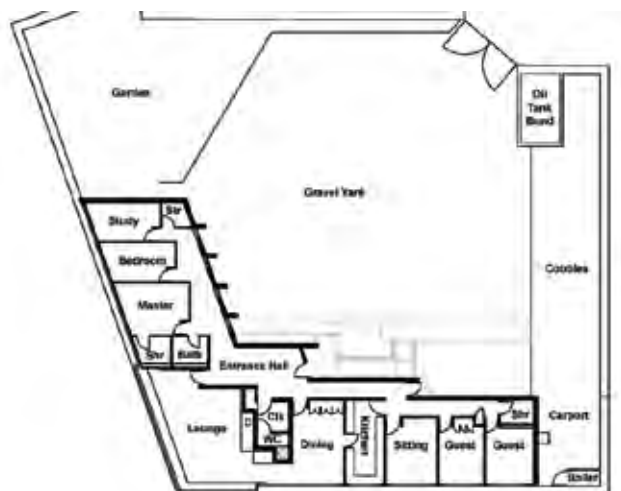
Figure 255 Plan of the Principal's House as existing 2009 UoSA

Not only does this clever piece of contextual design ensure a degree of harmony *with* the site, and a link to its immediate past, the non-orthogonal layout of the building and its dimensions are derived *from* the site, as shown in figure 255.

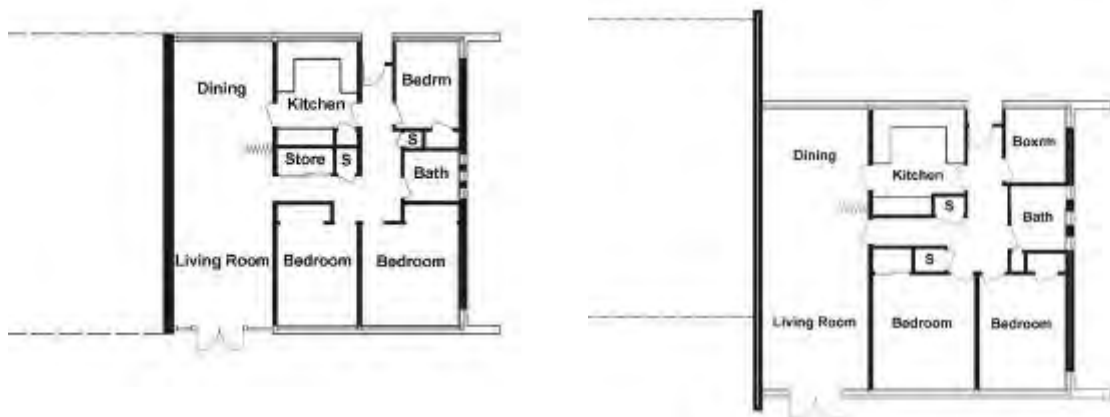
Figure 267 Plan of No 4, with part of No 5 in dotted lines. *UoSA*

Figure 268 Plan of No 6, with part of No 7 in dotted lines. Note the slightly shallower plan, with the reduction of storage space, and box room instead of bedroom *UoSA*

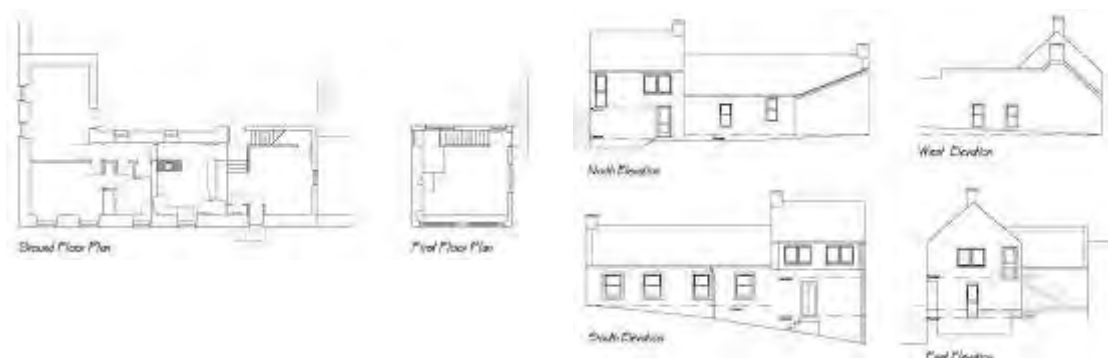
At some point after the 1970s, a single storey extension was added at the eastern end of this building.

Figure 269 Plan of Airthrey Cottage 2009
UoS

Figure 270 Elevations of Airthrey Cottage
2009 UoS

Airthrey Cottage, the cottage and office on the route up to the castle yards, could look better. Its stained modern windows are not entirely appropriate in appearance and would look better if replaced with painted windows which are more in keeping with the architecture of the cottage. Some cables disfigure the elevations and plastic rhones and pipes are bent out of shape and full of moss and grass.

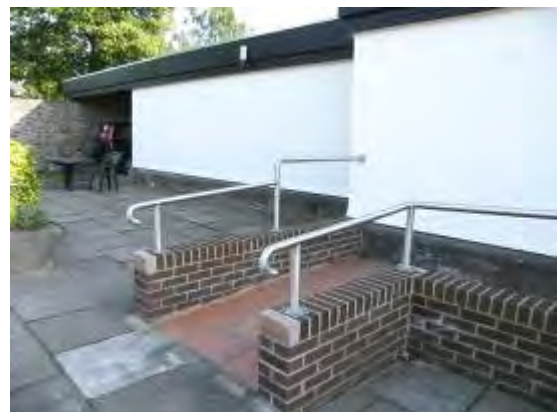
The building is in good condition having been repaired fairly recently. A ramp and steps have been fitted (figure 273), unfortunately using materials which do not respond to the original materials on the building. Rubble walls and stone paving, although more expensive, could have been made to be much more in keeping with the architecture of the building. The handrails are also of inappropriate appearance.

Figure 273 Ramp and steps 2008

Whilst it would be desirable to move the access ramp to the side door, using materials that are sympathetic to the original design such as rubble walling and/or white-rendered surfaces, it is recognised that it would be more practical if the existing ramp could be altered, with the replacement of the red tiles and rendering of the brickwork.

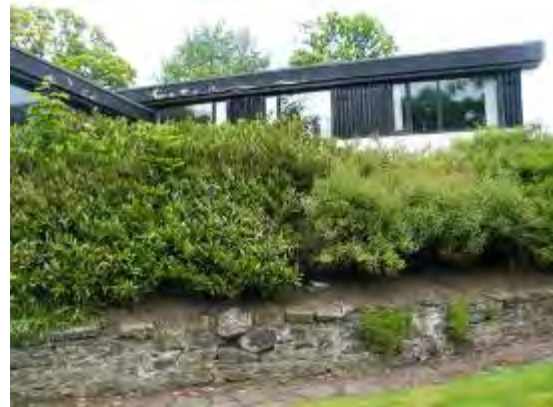
The main windows face south west towards Stirling Castle and the hills beyond. There are bands of windows with louvered panels. The same fascia and flat roof detail has been used. The walls are a mixture of rubble and render. The rubble appears to have been reused from demolished buildings around the yards. The condition of these buildings is not as good as the Principal's House and there are many signs of decay and rot in the joinery and sills around windows, and in the fascia.

Figure 274 Flaking paint on fascia 2009

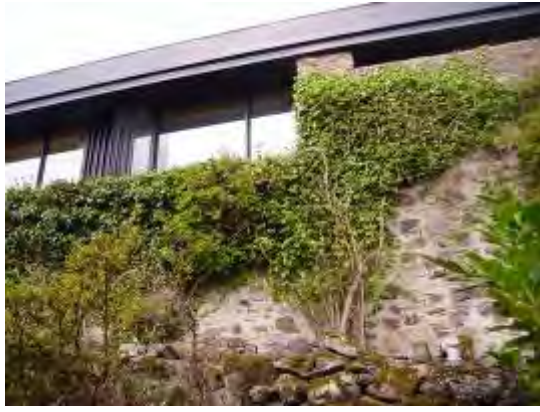
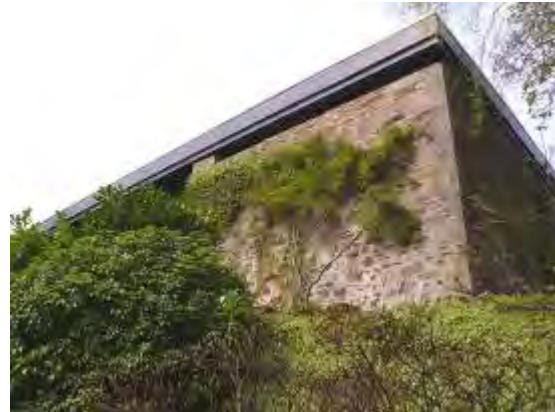
Generally the rubble walls around the courtyard are in fair condition. There is a considerable amount of open joints and vegetation growing from them but this can continue for some years without significant deterioration. All of the walls have been capped with cement. This sheer wall profile without copes is part of the aesthetic of the new house.

Figure 275 Vegetation on rubble walls, Principal's House 2009

A large part of the character of this area is in the contrast between the very pure modern architecture and the informal character of the existing walls and landscape. The character of this area would not be as good if all of the original walls were pointed and had vegetation removed or if the paths around the buildings were absolutely pristine. However, walls can not remain forever with vegetation, damaged capping and open joints. Considerable care is needed to carry out repairs without damaging the character of the area. This might be done by carrying out small scale repairs as they are needed according to regular inspection and marking up a set of drawings of the original walls. Another way in which this work can retain the character is to ensure that good quality and original materials are used, for instance lime mortar in the walls brought flush according to the precedent of Airthrey Cottage.

At some point in the future it will be necessary to overhaul the cement cappings to the wall surrounding the Principal's House by raking out vegetation and packing up joints and cracks. In some places, such as adjacent to the path to house no.2, the capping has failed and should be remade fairly soon. Some parts of this wall need to be rebuilt because the stones have fallen out exposing the clay core.

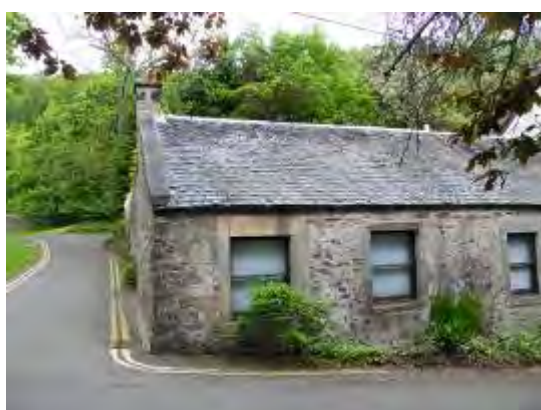
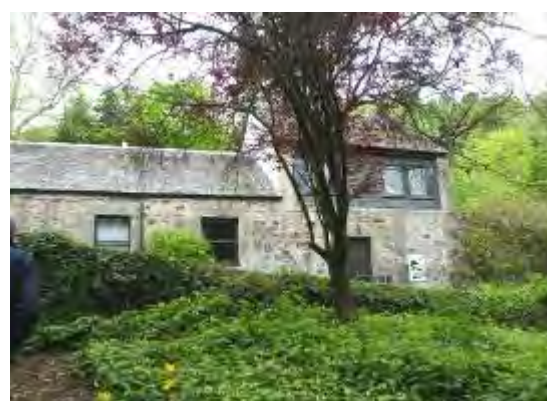
Figure 284 Airthrey Cottage, west block 2009

Figure 285 Airthrey Cottage, east block 2009

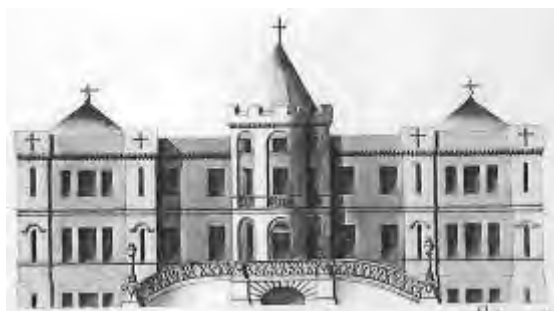
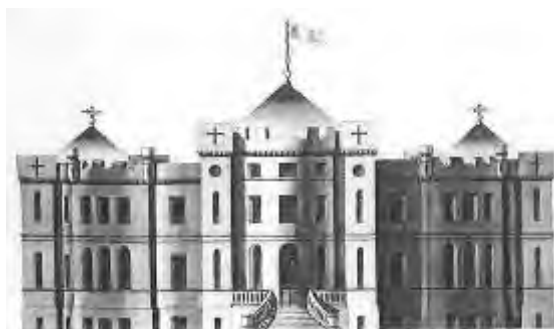
Figure 302 North elevation, Robert Adam 1791 *SJSM*

Figure 304 South elevation, Robert Adam 1791 *SJSM*

have been Adam's intention for the chimneys of the castle itself, which are not shown on the elevations drawings (figure 302), although they do cast a shadow on the plans of the roof.

19th century images of Airthrey as it was presumably originally built show two significant differences from the Adam elevations of 1790. As built, the chimneys project above the parapet line, lessening the castle's monumental quality and emphasising instead its domesticity. Secondly, the ground slopes up to the raised drive, so that Adam's arched opening below the front door was not needed, again making the house seem more approachable, and less imposing. Both the entrance tower and the south tower were built higher than Adam's designs.

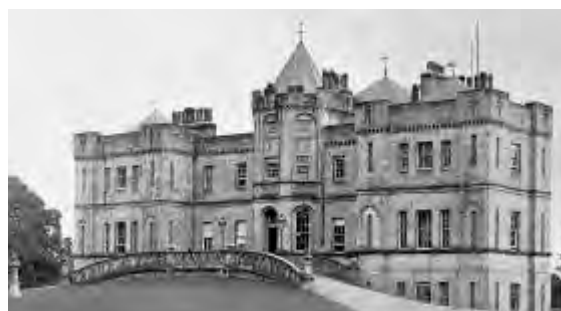
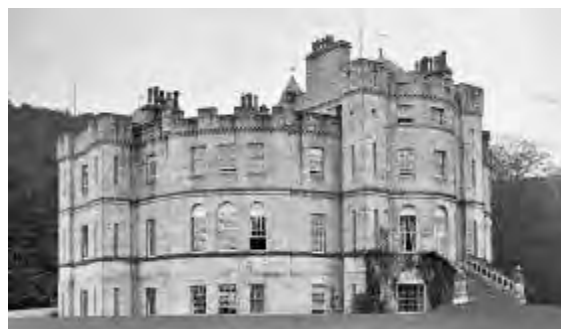
Figure 303 North elevation 1880 *StAU*

Figure 305 South elevation 1880 *StAU*

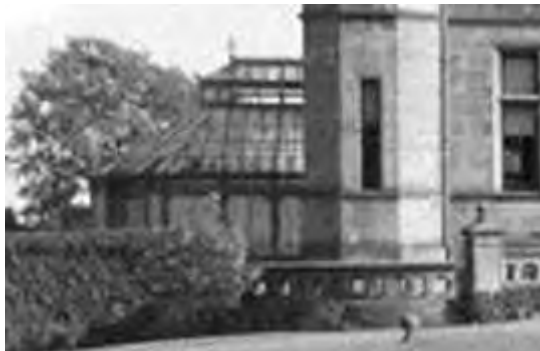
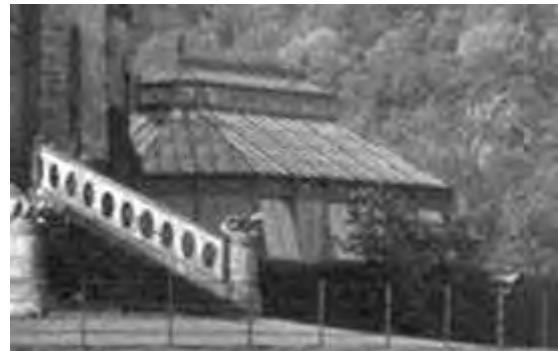
Figure 329 Conservatory from north 1937 *StAU*

Figure 330 Conservatory from south 1937 *StAU*

A conservatory was added to the east (figures 329, 330), which is shown indistinctly on the 1904 photograph and more clearly on the 1937 photographs.

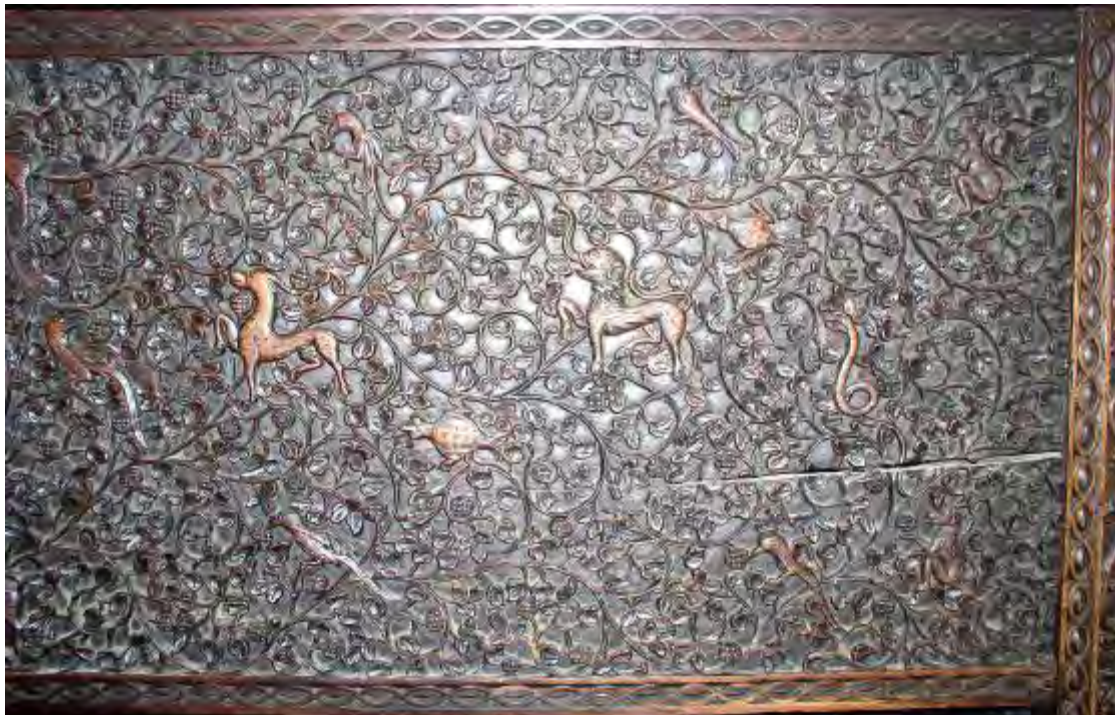
Figure 331 Antique panelling reused to form chimneypiece in Billiard Room. Probably Persian, of outstanding quality.

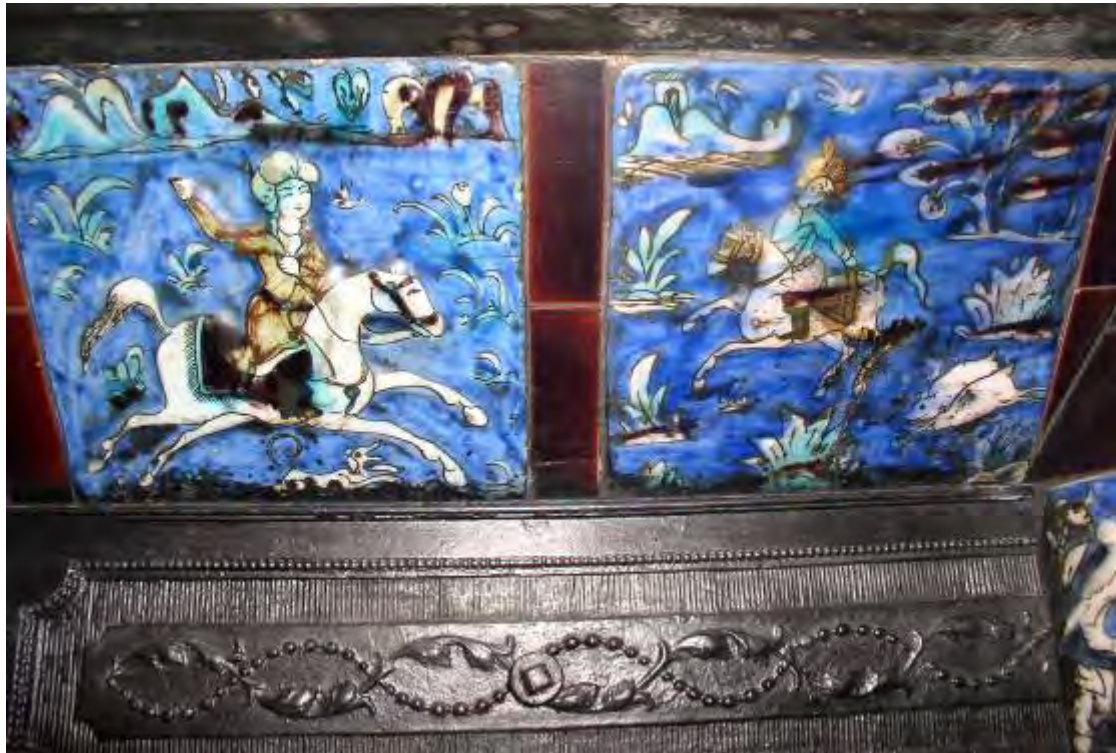
Figure 332 Persian tiles from Billiard Room fireplace, probably from Kashan, 17th or 18th century, with 18th century cast iron firegrate below.

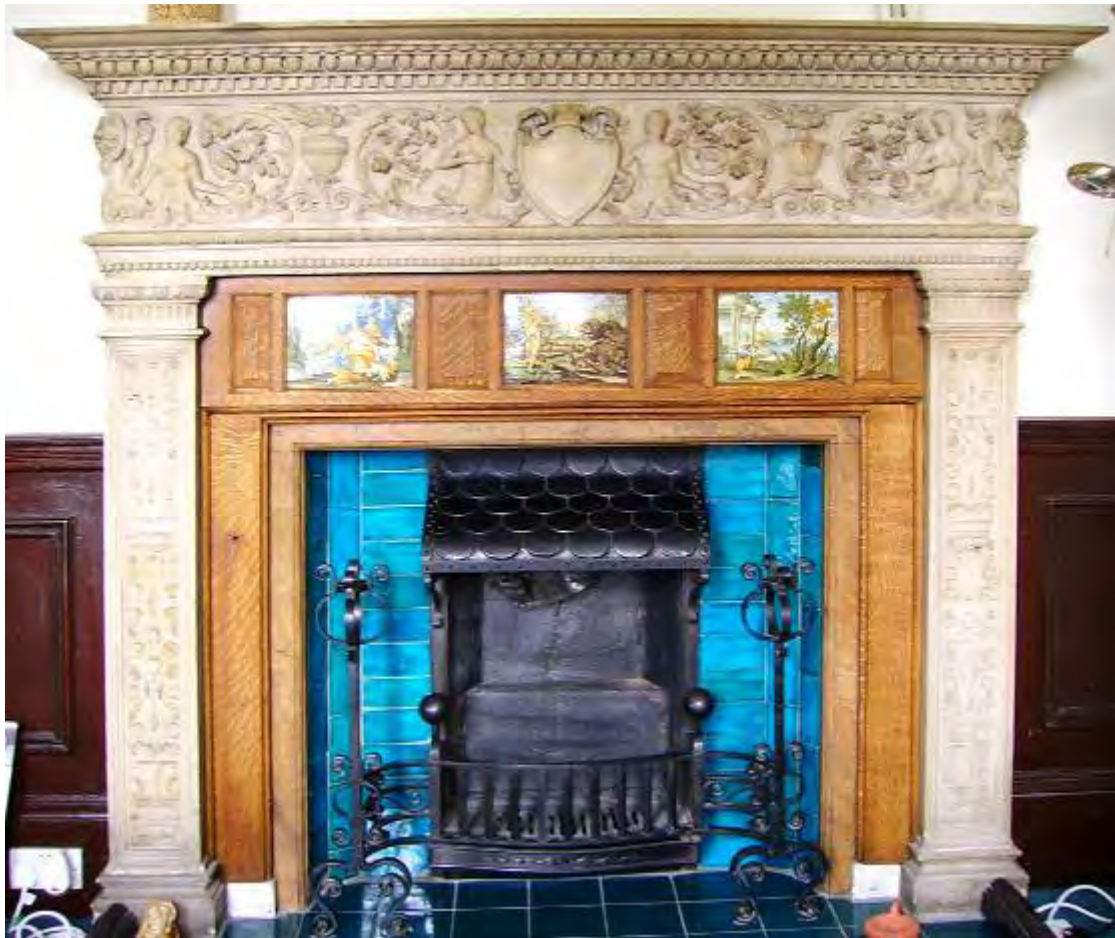
Figure 337 Former Dining Room, Italian Renaissance carved limestone chimneypiece, with inset pictorial Majolica tiles, and late 19th century oak setting and wrought iron chimney grate

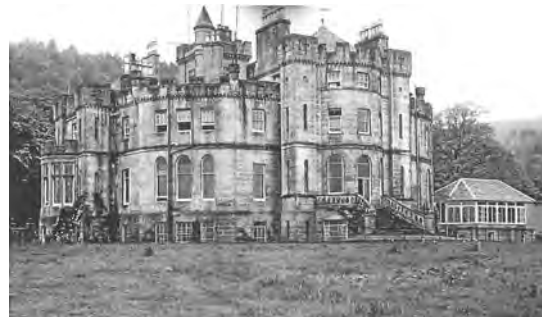
Figure 339 View from south west, with new conservatory and edge of nurses block just visible to right 1954 NMRS

The exterior was more significantly altered with plate glass replacing the original windows, and a large number of drainpipes disfiguring the south elevation in particular (figure 339-342). A carved decorative stone over the main entrance, shown on a photograph of 1937 (figure 327) was removed in the late 1940s at the request of one of the sons of Donald Graham, who had settled at Logie Cottage. It was replaced with a plain stone. According to Health Board archives, Mr Graham later removed

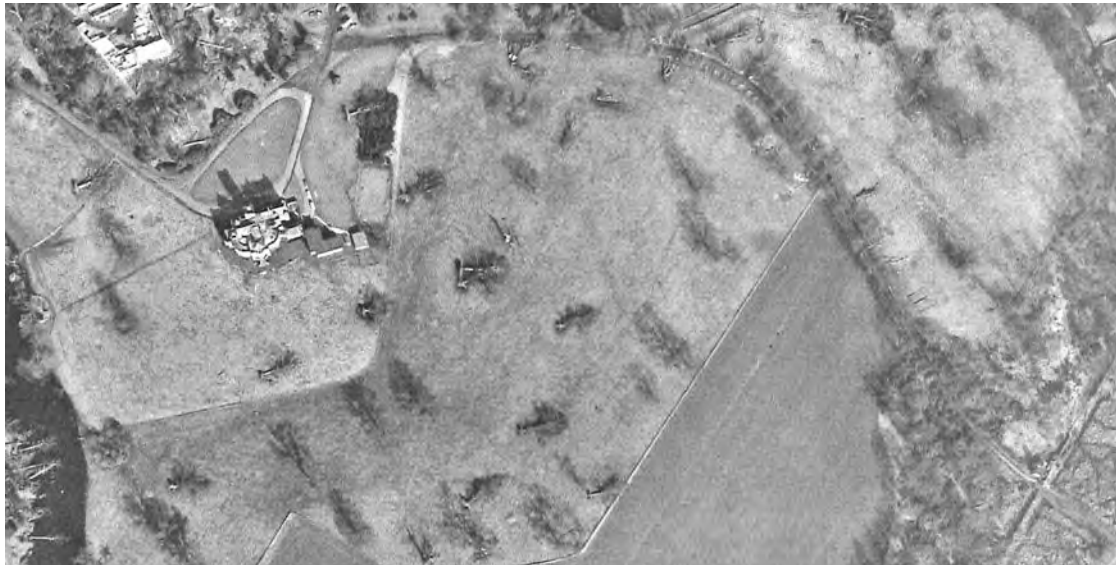
Figure 343 Aerial view of parkland showing fallen trees. March 1968 NMRS

The parkland suffered like the rest of the landscape from devastating winds in January 1968, which destroyed a number of the mature trees (figure 343).

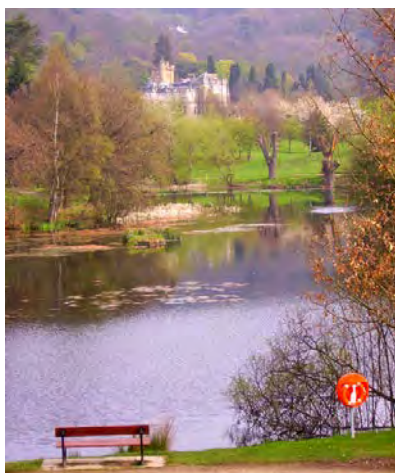
Figure 346 View of Airthrey Castle blocked by small trees

Dense hedges of coniferous species were added as part of the golf course, which interrupt views of the castle.

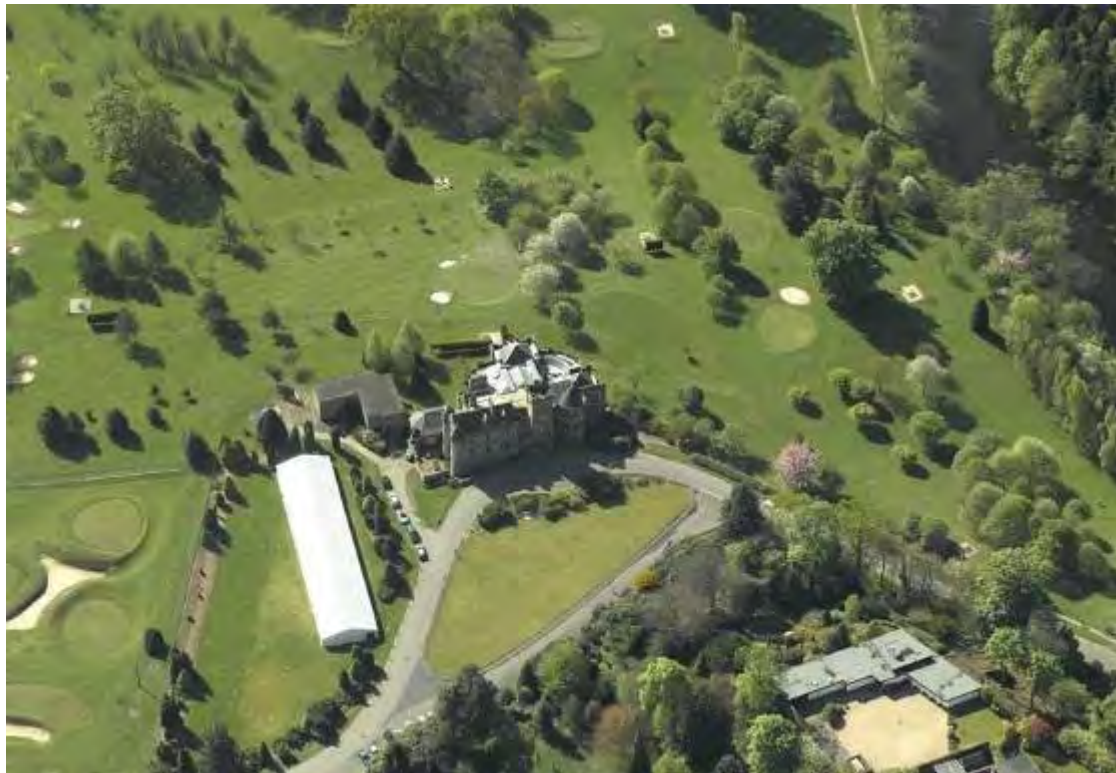
Figure 348 Aerial view of Airthrey Castle and recent planting to south 2007. The large white building is a temporary marquee. *NMRS*

Since the 1980s, the area to the south, south west, and south east of the castle has been planted with smaller trees, in groups or singly. Species include rowan and birch, which are short-life trees and will not reach the size appropriate to a parkland setting. Other trees are spruces and firs, which would be appropriate in other parts of the estate (such as the Arboretum), but bear no relation to the historic character of this area. The cherry trees, maples and others which have been planted as commemorative trees to the west of the golf course are also inappropriate in this location.

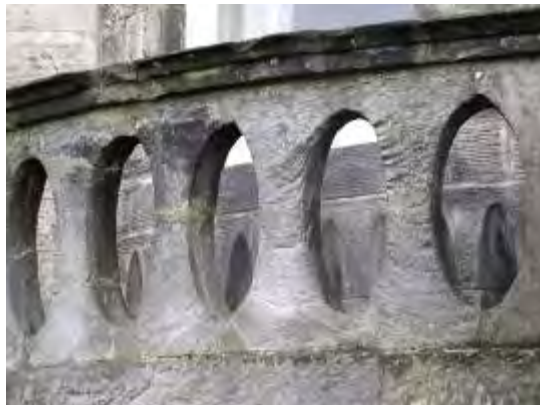
Figure 350 Detail of balustrade 2009

This is the earlier part of the building built according to Robert Adam's design. The central pavilion is typical Adam castle style design with battlements and corner turrets with blind windows. The central section is bowed outwards. There are three storeys above a balustraded balcony and a further basement floor below. The windows apparently had astragals originally but most have been removed and replaced with plate glass, particularly at the first floor level. The condition is fair although there are some points of open joints requiring pointing and a structural easing in the eastern bay of the south bow which has involved slipped keystone at first floor level and splits through sills and dentils above. There is further missing pointing at ground floor level. The central staircase is in fair condition but requires repointing throughout. Tiles and bitumen have been placed on the face of the balcony. There is a further split lintel on central bow at basement level facing south west.

On the outside of the balustrade is a rather intriguing motif where the ovals cut into the balustrade are repeated by cutting into the face of the bow wall. Due to the curvature the ovals in the wall at the bow are narrower. They do not appear to line up.

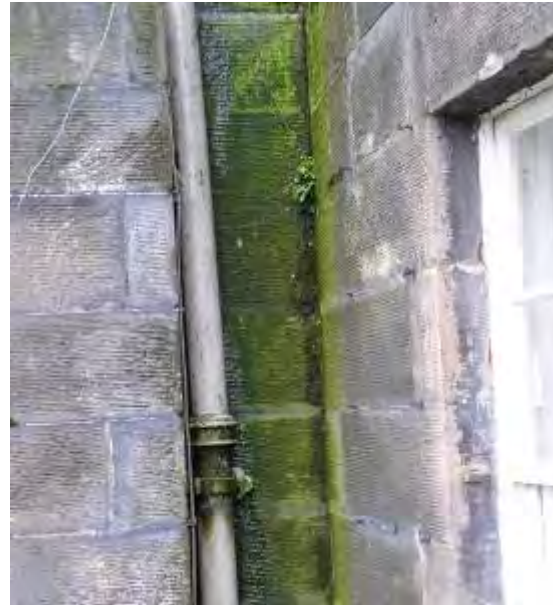
Figure 352 Leaking pipe 2009

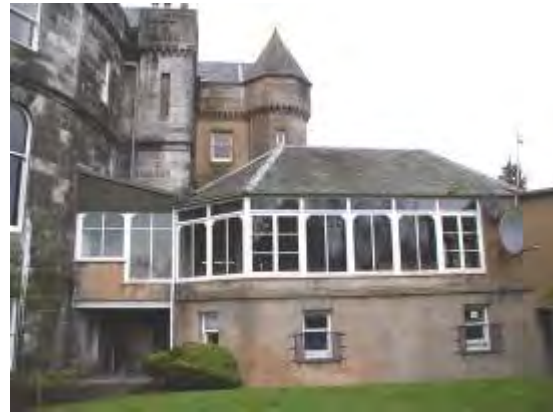
Figure 353 South elevation of conservatory 2009

To the east is the link block for the conservatory. This is a stone base which dates from the 19th century conservatory. The 19th century conservatory has been replaced by a conservatory dating from the mid 20th century. This building has a slated roof. The slates are heavily covered with lichen, some slates have slipped and are missing. The general condition of this roof is poor.

The ridges and hips are covered with zinc which is a relatively short life material and has been nailed through from above. The link block to the original building is covered with felt. The base is ashlar stone, it is in fair condition. About 50% repointing is required to open joints. Iron fixings, especially around metal mesh guards should be removed or replaced with stainless steel or non-ferrous fixings. Iron fixings for climbing plants should be removed and the joints repointed.

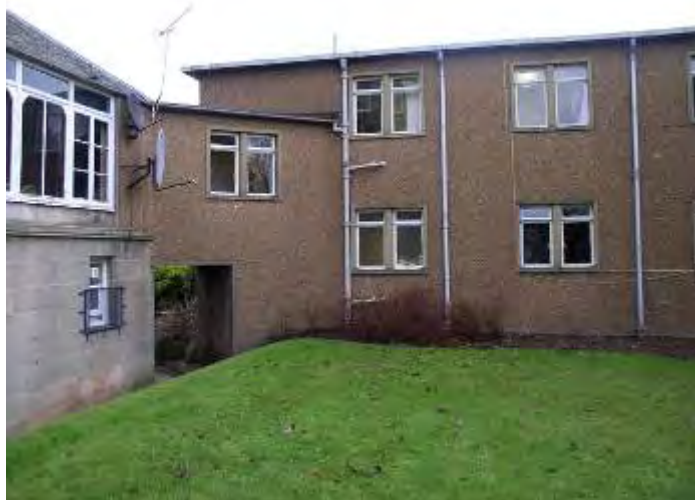
Figure 354 Conservatory and former nurses block 2009

Joined to the south east of the conservatory is the 1950s nurses accommodation block. This is in fair condition although there are some splits in the cast stone mullions and some damage to the render. This building, however, is of poor appearance generally and blocks appreciation of the original country house in the round. Although the nurses building does reflect the period of the hospital occupancy of the castle of 30 years, it should be considered to have negative significance within the overall ensemble.

The north side of the conservatory has a nicely detailed stone circular stair rising to a door in its north east corner. The stone plinth passes across the north side and includes three garage openings. The original doors have been removed and replaced with shutters or with walls covered in cement. There is a lot of cabling on this wall, most of which looks redundant. The north side of the conservatory has boards with applied surface fillers.

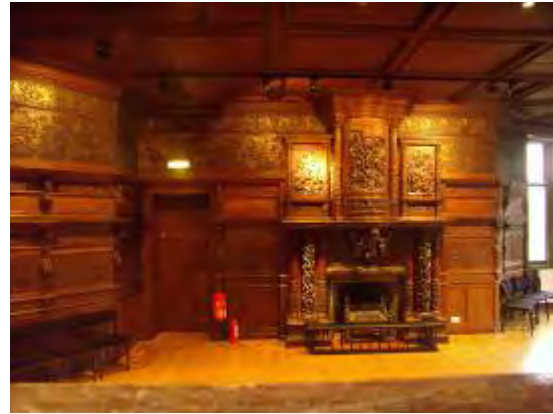
Figure 358 Hall fireplace 2009

There is particularly robust joinery above the fireplace, parts of which are salvaged early 17th Flemish pieces. The frieze is embossed and coloured leather. There are tiles in the fireplace and also oriental ceramic tiles set into the surrounds to borrowed lights. The ceiling is panelled. The north west corner bay has been brought to a full circle.

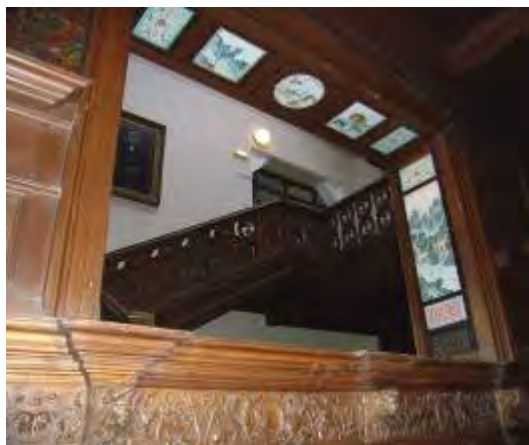
Figure 359 Panelling with inset Oriental tiles and salvaged antique stair balustrade beyond

The stair balustrade also has the character of a reused salvaged material. The panel across the gallery of the stair landing looks to have been a gallery front from a Baroque church. At the lobby at the foot of the stair on the south wall is a salvaged Baroque panel made of leather and painted in a naïve character. To either side there are slits and damage in the finish of the leather with some of the substrate timber showing through. This will require careful conservation. There are further splits in the leather to the west of this above a door to Room 17 and also above the door to the office of the Head of Department of the School of Law (Room 18). The condition of the leather work has further splits, particularly along the mid-horizontal line of the larger and lower of the two frieze panels. There are further splits in leather above the door to the lobby.

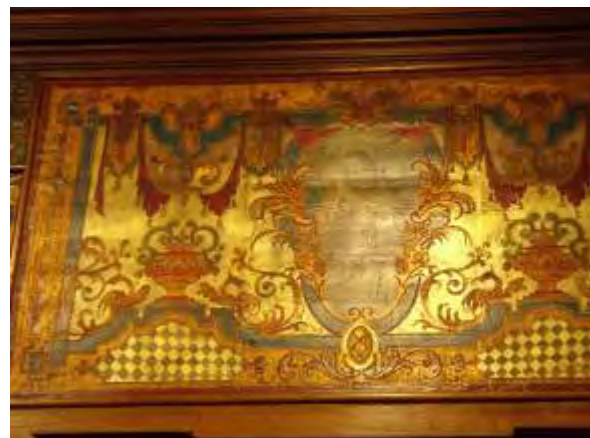
Figure 360 Painted and gilded panel in frieze above panelling.

In the panelling there are numerous minor defects and missing mouldings. Few of these affect the overall character of significance of the room although missing mouldings, for instance at the eastern corner of the north west bay, should be repaired. The use of chairs at the base of the wall has caused some surface damage to

joinery which should be repaired by French polishing. There is some staining under the windows, probably from condensation. The windows retain their curved glass. The carved dog at the foot of the stair balustrade mentioned in the 1941 condition report is now missing.
