THE UNIVERSITY OF STIRLING CAMPUS

Conservation Plan

Simpson & Brown Architects

October 2009

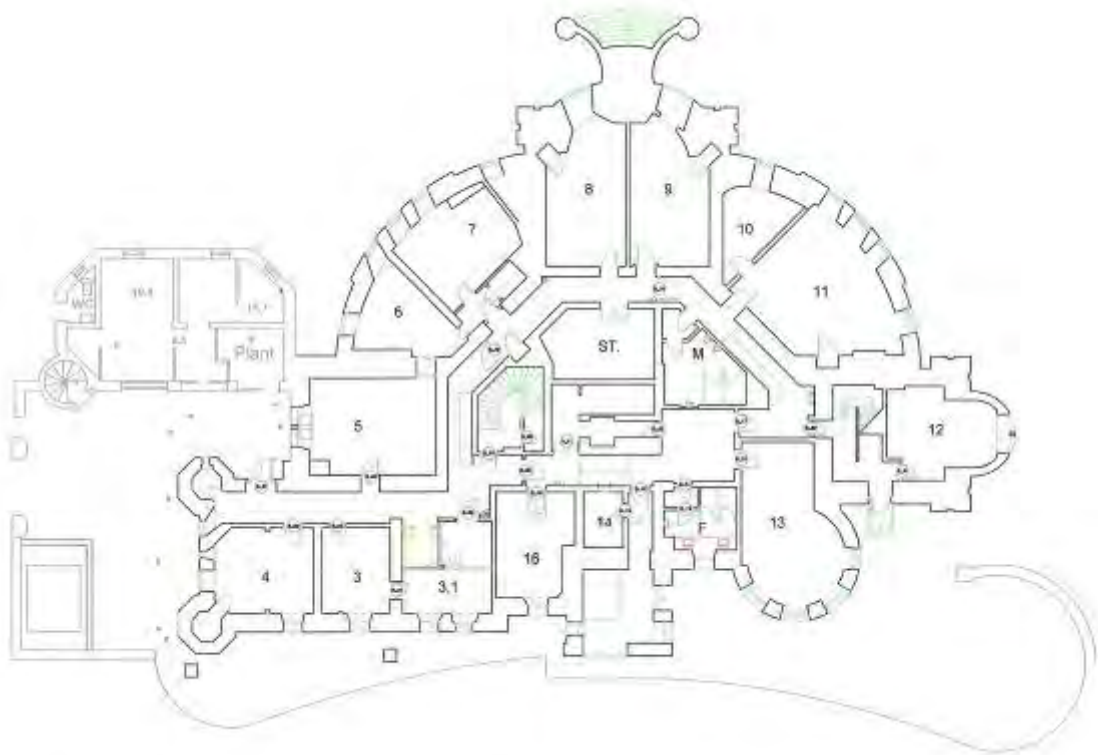
Figure 364a Basement floor plan 2009 UoS

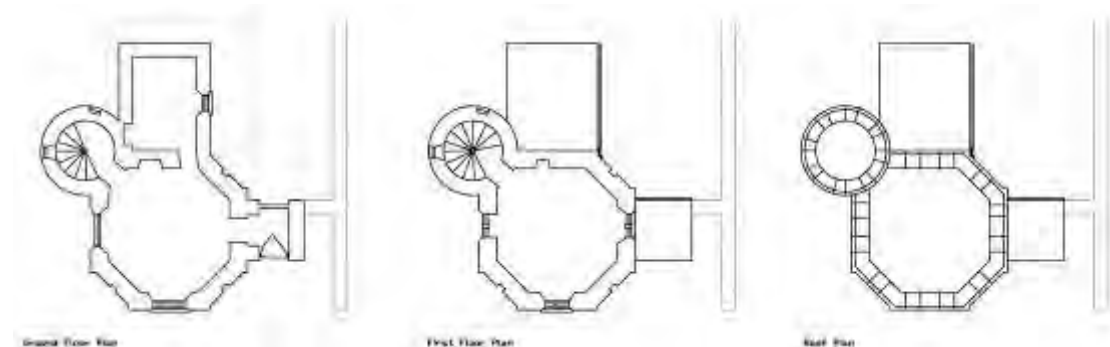
Figure 372 Plan of East Lodge UoS

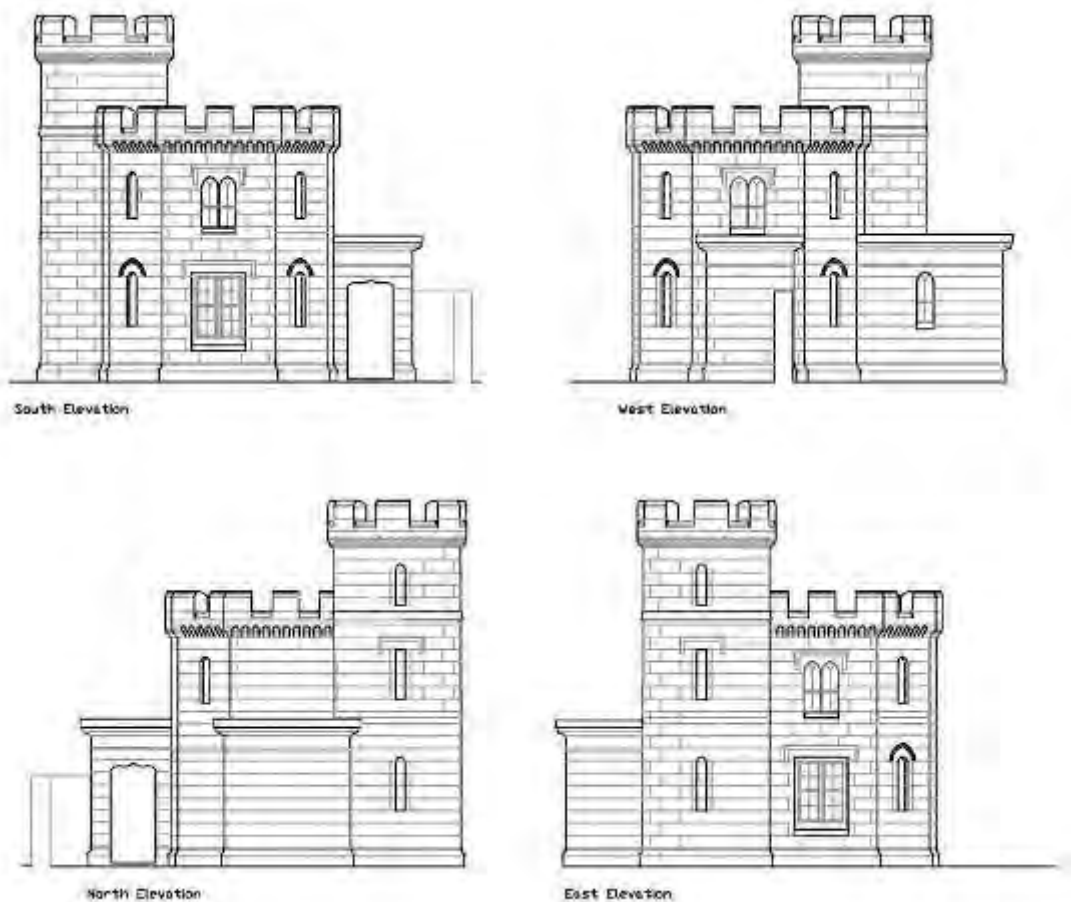
Figure 373 Elevations of East Lodge 2009 *UoS*

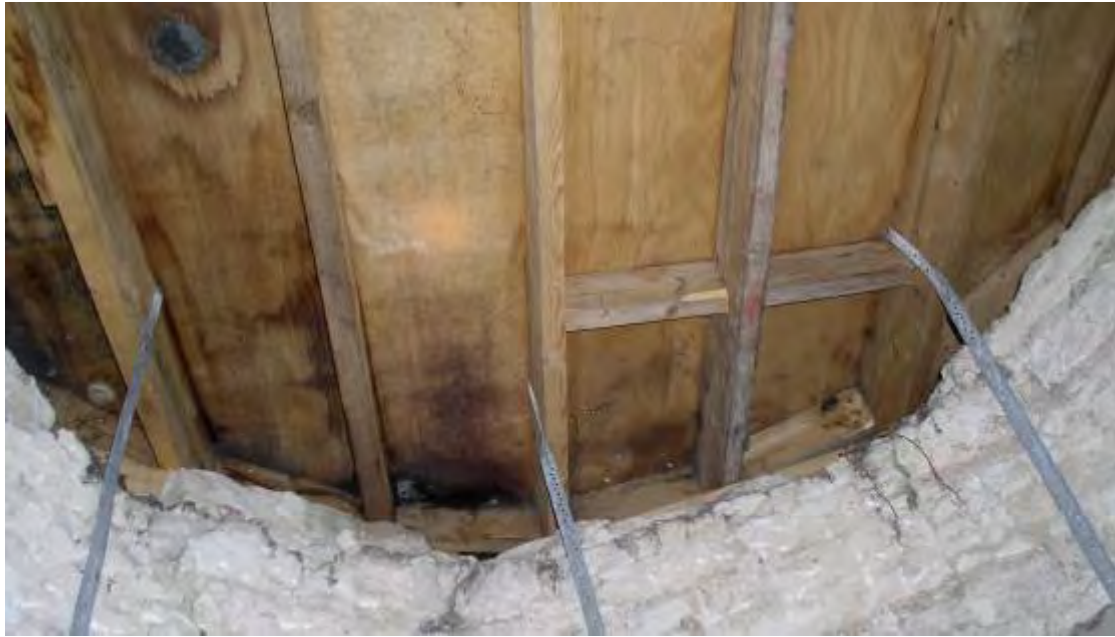
Figure 374 Staining on ceiling of East Lodge 2009

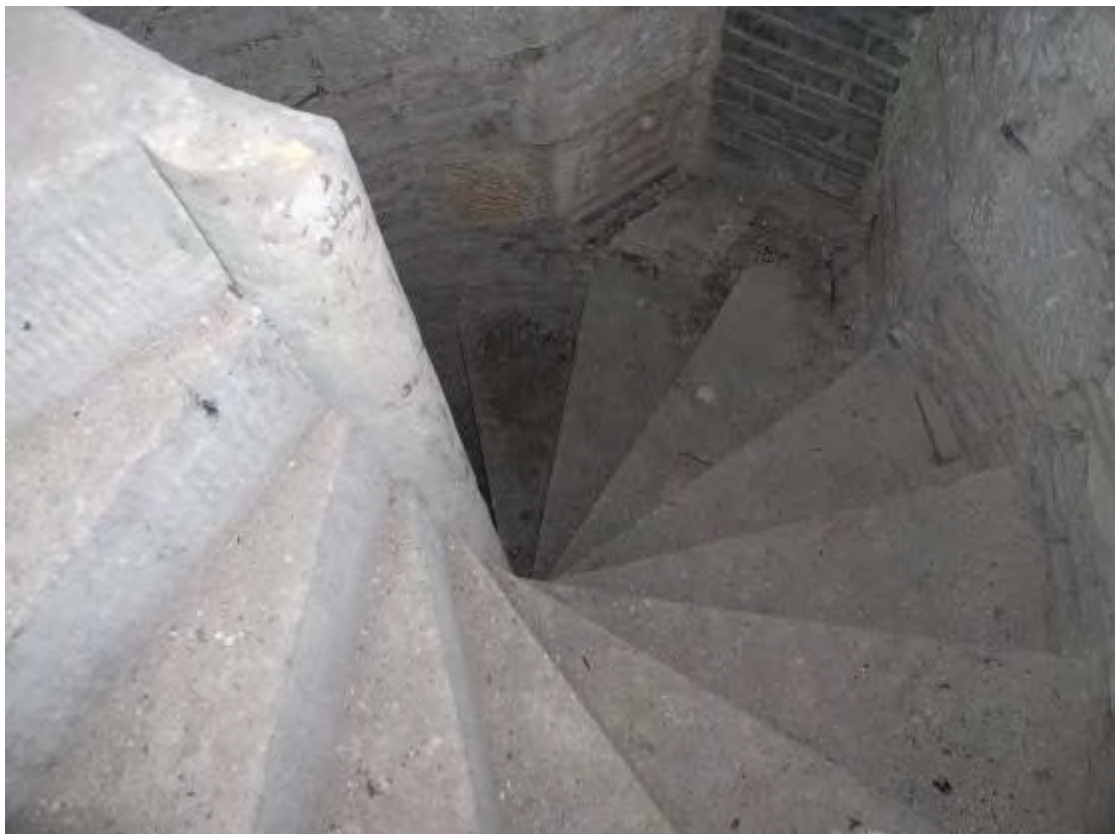
Figure 375 Spiral staircase in East Lodge 2009

The stairs are in good condition with only some wear in the treads. This is a generously proportioned stair.

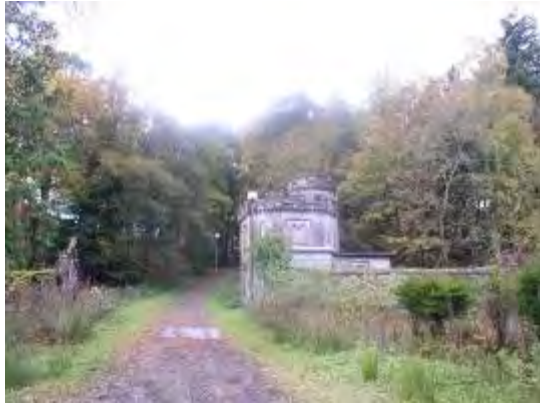
Figure 383 Lodge and gatepier from south **Figure 384** Estate wall to west of lodge 2008
2008

The gate pillars are in poor condition and have lost their finials. It would be of considerable advantage to the appearance and conservation of the East Lodge if these gate piers were restored. Ivy should be removed from the north gate pier. The tarmac on the roadway is in poor condition and badly drained. The appropriate context for the lodge would be a country house driveway of packed stones and rolled gravel with soft edges where the grass and mosses encroach. It might be possible to provide the appropriate character using a bitumen bound gravel. This is admittedly expensive and would only really be effective in views from the east in the same treatment continued up the curving driveway and out of site.

The original arrangement of the gate piers should be investigated. Some metalwork is missing and it is possible that the piers have been relocated to allow wider vehicle access.

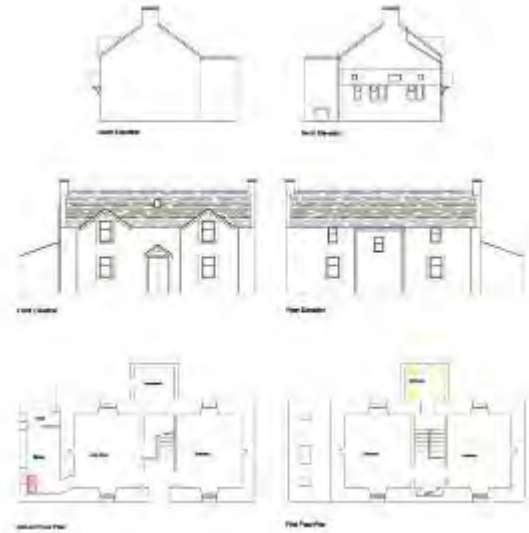
The cottage was altered in the later 19th century with the addition of half-dormers on the front elevation and a wooden porch. The proportions of the rear elevation were left unaltered, although a bathroom extension was added. A lean-to building was added to the north.

At some point in the late 20th century the building was boarded up and has since suffered from vandalism.

Figure 398 Elevations and plan of Ivy Cottage 2009 UoS

Ivy Cottage could be restored to its original appearance, and would form an attractive building which could be used as holiday letting or as accommodation for the university. Similar properties have been successfully managed by the Landmark Trust and the Vivat Trust. Basic repairs to the roof should be carried out to prevent further decay and the building should be ventilated to allow the fabric to dry out.

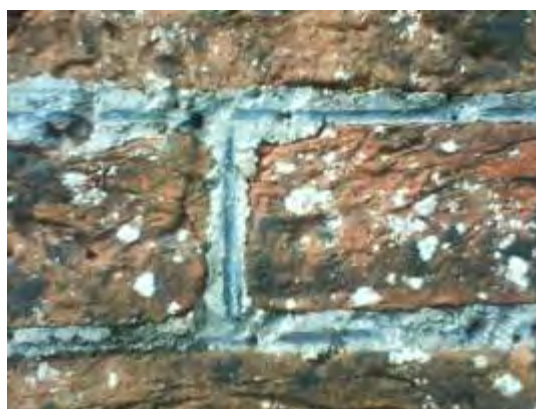
The wall itself is brick faced towards the garden. The outer face is rubble sandstone but with significant areas patched or rebuilt with brick. The wall occupies two sides of the former walled area – to the west and the north. Some 19th century estate fencing survives close to the south west corner. The west wall is generally in fair condition although some raking out of trees and weeds is needed.

Copes need to be rebeked, particularly at the south end where trees have been established under them. On the west side a tree has started growing in the

Figure 404 Lime pointing in walled garden wall 2009

wall itself and should be removed urgently. Facing the garden, there are some other places where trees should be removed and where copes need to be rebeked, particularly near to the portacabin which has been placed about midlength along this wall. The wall has been pointed with lime but then with lines struck into it and colour in each joint line (figure 404). Near the north west corner is a door with stone lintel and stone quoins. It appears to have been designed for a steeper wall since the lintel appears to overcompensate for the slope of the ground.

At the north west corner of the walled garden, on the outside face of the west wall, is a structural crack running up diagonally. This crack should be repointed. At the southern end of the west of the west wall is a buttress which might be a reaction to previous structural movement in this very tall garden wall. To the north of the gateway on the south wall is a structural crack in the wall running full height which should be packed and pointed.

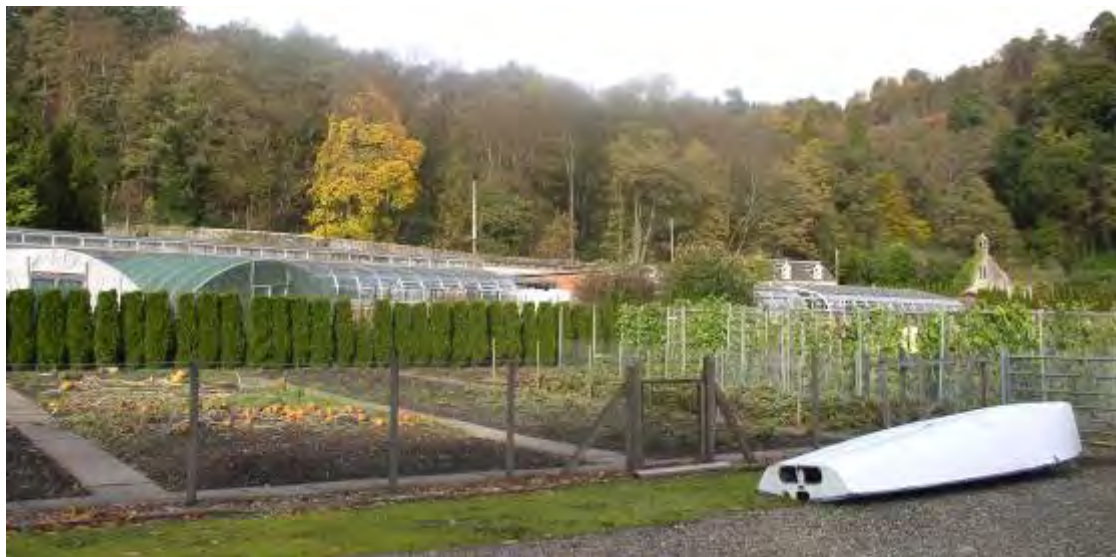
The greenhouse structures themselves have been built during the period of ownership of the university. They are attractive as useful garden buildings but they have no particular aesthetic or historical significance. Their main benefit, in addition to their function, is that they provide an appropriate context for area within the Walled Garden.

Figure 405 View north within walled garden from right: Old Logie Kirk, Garden Cottage, polytunnels, with north wall of garden above. 2008

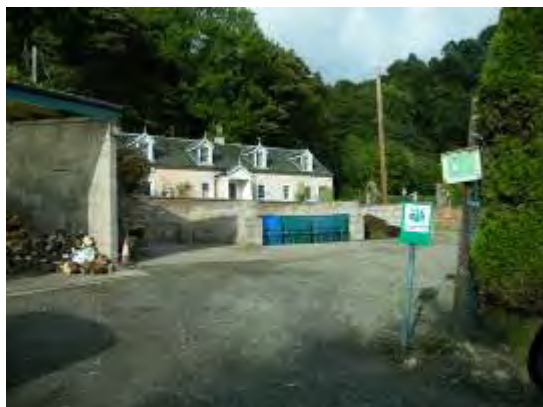
Further west is the lobby which passes into the bothy area. There is a further 19th century stair rising in the north east corner of the bothy. At the lower level is a shower room with toilet cubicle beyond. The windows to these spaces look 20th century. There is a further toilet and wash room in the north part of the ground floor of the bothy. All of the finishes in the ground floor of the bothy are 20th century and have no significance. There is one area of very advanced wet rot below the partition wall to the west of the bothy stairs. Some staining above this suggests that there are leaks through the roof.

The first floor of the bothy has no particular finishes of interest. Generally 19th century but with a mid 20th century window frame. Some of the plaster to the east of the dormer is decaying with advanced staining from mould and leaks. This suggests that there are slates missing to the east of the dormer or a defective flashing. The first floor of the remainder of the building is connected together even though there are two stair cases. The central stair is the steeper of the two and rises in a straight flight. At the head of the stair is a small 6 over 6 pane sash window, apparently 18th century with much of its original glass and early shutters which have lost their knobs.

To the west of the stair a coomed bedroom with 18th century fire surround and overmantle with a 19th century cast iron inset. Most of the joinery looks to be 19th century with all the window sashes. The dormer is possibly early 20th century. There is considerable damp staining in the west wall of this bedroom with part of the ceiling collapsing and staining in the gable wall.

Figure 407 Garden Cottage with walled garden in foreground

Garden Cottage should be repaired, particularly to prevent further roof decay, and this attractive building should be brought back into use as a matter of urgency. The surviving historic fittings including fireplaces and joinery should be preserved, however adaptations to provide accommodation or for office use would be possible. A front garden could be formed to the south of this building.

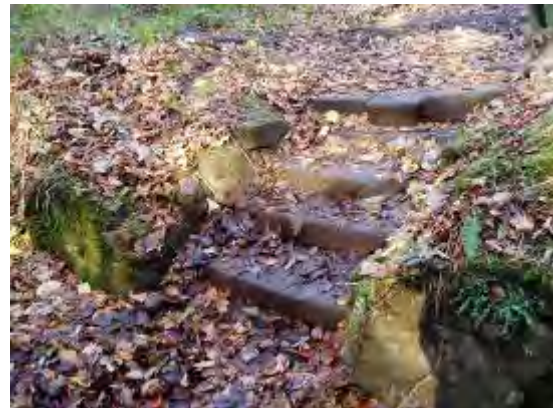
Figure 451 Entrance steps to Hermitage Wood at southern edge, behind Airthrey Yards

Along its southern edge is a wall and a track, once the main public road to Logie. This wall requires some general maintenance. It has collapsed in places, particularly next to the footpath route running north-south from the castle.

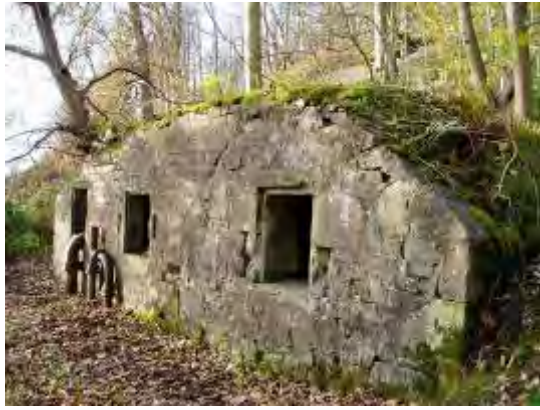
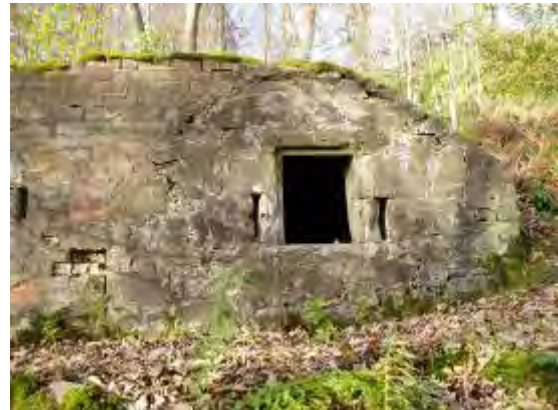
Figure 452 Cistern, with 19th century extension to left 2008

The path passes a brick vaulted cistern building. This is faced with stone and brick, and built into the ground to the hillside at the north west. This building is not maintained and the masonry and vaults are under threat from the roots of trees which have grown up from under the moss-covered roof.

The cistern building has moderate historic significance as part of the late 18th and 19th century service buildings for Airthrey Castle.

The cistern building is not of high significance and could be allowed to decay naturally into the woodland. It should be recorded photographically and in drawings before it decays much further. The removal of the large tree growing on the western end of the roof would lessen the speed of decay.

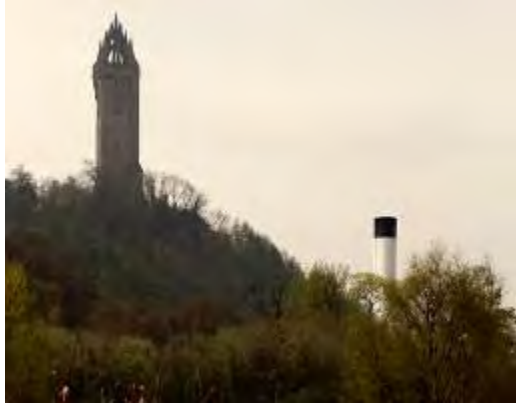
Figure 463 Wallace Monument with boiler house chimney below

The buildings are contemporary with the main central area buildings, being opened in time for the Phase 2 expansion in 1970. When viewed from the central area of the campus, the chimney is a rather pleasing contrast to the Wallace Monument that otherwise dominates the skyline – the black cap to the chimney suggests that this was deliberate. It could be said that the relationship between these two vertical structures reflects that of the relationship between the University and the Airthrey Estate.

To the north east is the boiler house. The boiler house is a sheeted building. Its paint finish is not in particularly good condition and the colour of the building - white - is rather more prominent than it needs to be. At the south of the boiler house is a concrete chimney.

The dominant features in this part of the campus are the views towards the Wallace Monument and Abbey Craig – the chimney of the boiler house mimics this in an attractive manner, and is a well designed part of the RMJM-designed campus. As a piece of the original 70s campus, this is of moderate significance.

It is recommended that consideration be made to retaining the boiler house and chimney in any future redevelopment of this area.

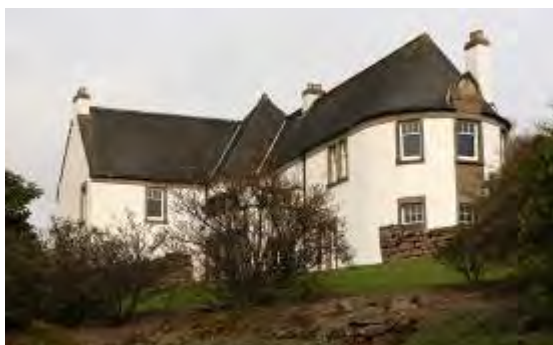
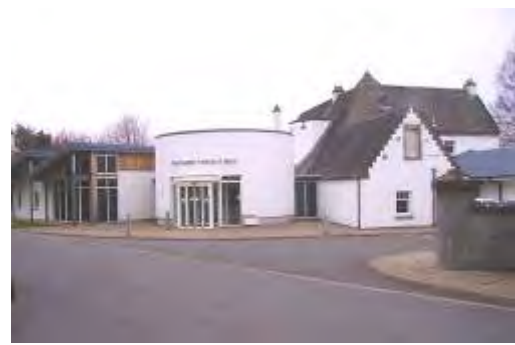
Figure 472 Villa from south with front garden

Figure 473 Villa and extension from north east

The original villa seems in fair condition although quite a few slates are missing from the upper part of the main pitch and on the bowed end facing south. There is a network of lightning conductor tapes on the building which look to be far in excess of what is needed, although it might comply with the current, British Standard. Some weeds should be cleared out from gutters.

The garden is now rather untended. This type of villa was intended to be seen in a much more intense garden surroundings than now exist. At the bank above the road there is a rubble wall which divides the garden in two. This rubble requires some repair. The southern pier of the rubble wall at the opening within this wall is at the point of collapse and should be repaired urgently.

The Scottish Institute of Sport building, including the extension, is generally well maintained. Some missing slates on the roof of the villa should be replaced, and gutters should be cleaned out.

Repairs are required to one of the piers in the garden wall, which is in danger of collapse

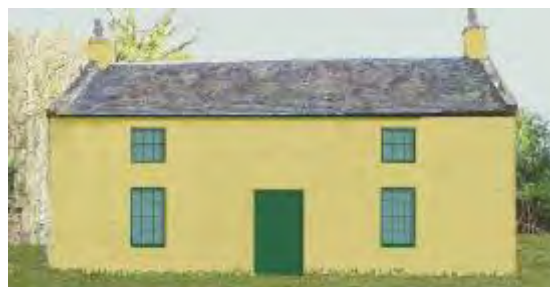
Figure 476 Conjectural appearance of restored Ivy Cottage *S&B*

Ivy Cottage is the building in the poorest condition on the estate. Its significance is as a characteristic and pleasant stone built 18th century cottage. It is not exceptional and contains no remaining interior features of significance. However, it would be a pity, in conservation terms as well as in terms of the potential asset of a habitable building, to let this building decay further.

The part of the building to the east, which is an extension, is in poorer condition than the original three bay block facing towards the bowling green to the west. This part of the building is not worth retaining and should be demolished. The single storey lean-to to the north is also in poor condition and is unlikely to be economically viable for repair. This part could also be demolished.

The original core of the building will need a careful conservation led strategy for its protection, drying and eventual repair and conversion. If the extensions are removed then further openings should be protected. The method of protecting these openings should allow air movement through the building. If there is no ventilation then the existing timber decay will continue unchecked. The rotten timber within the original core of the building should be stripped out. This probably amounts to stripping out all of the finishing timber and plaster, with the possible exception of structural floor joists. Floor joists should be left in place, even if they are rotten, since they have some tying function between the front and back walls. As part of the same campaign the roof should be fully repaired to stop water ingress and the valleys, slates and gutters kept maintained. It might be sensible to monitor drying at three or six month intervals for a period of years until the building walls are no longer saturated and interior finishes can be reinstated without risk of fungal decay.

In the longer term Ivy Cottage could be restored to its original appearance with lime harled walls, sash and case windows, and a traditional vertically boarded door (figure 476).

The character of reinstatement of the interior is not a conservation issue. The building is capable of sensitive extension to the east and north. Such extensions might be necessary to provide a

sufficiently large house to make repair financially feasible. An extension on the east side of the building could be larger than the footprint of the existing extension without compromising the character of this building or area.

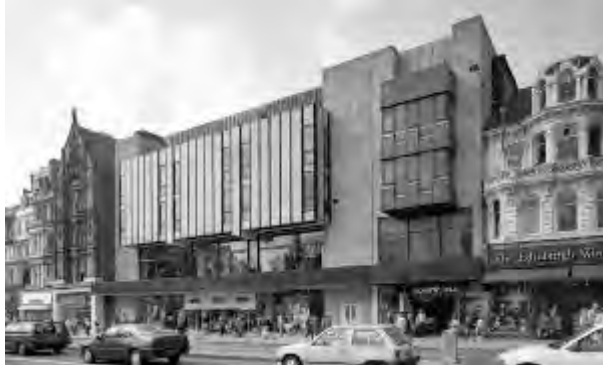
Figure 9 1994 view of British Home Stores on Princes Street, Edinburgh. RCAHMS

The BHS building on Princes Street is an excellent example of the *Princes Street Panel* era – a short-lived period in which the wholesale redevelopment of Princes Street was envisaged with modernist buildings arranged with both shop entrances at street level and from a first-floor terrace. Only a few buildings were built to this plan before it was abandoned, meaning the isolated first floor terraces that were built were never used.

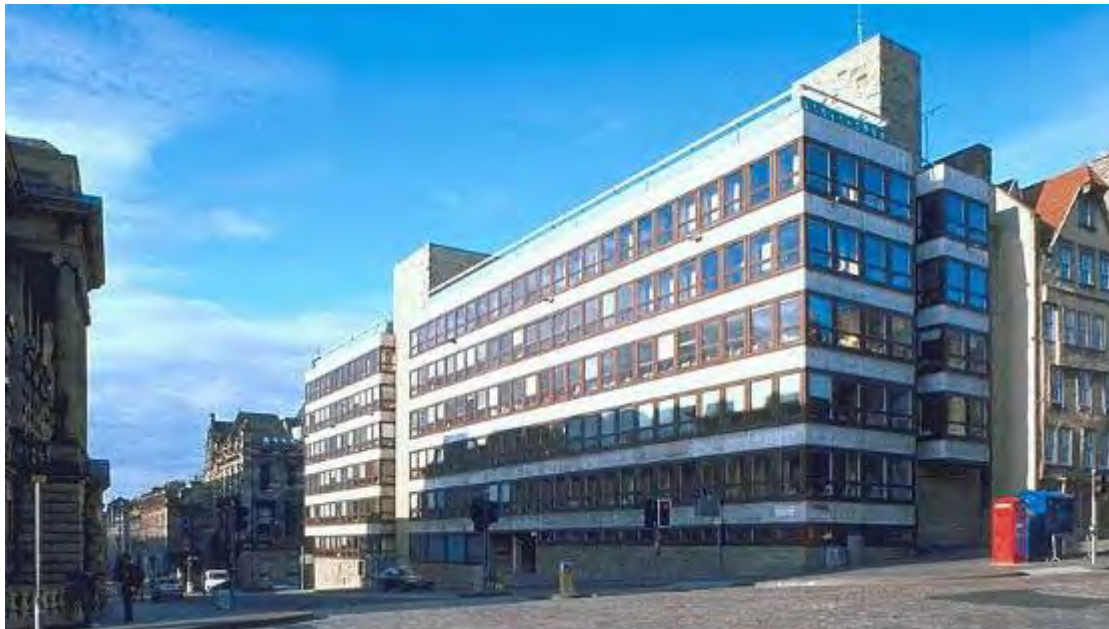
Figure 10 Former Midlothian County Council buildings (demolished). Scran/RFACS

Midlothian County Council held a competition in 1960 for an extension to their existing building on George IV Bridge – this went no further, and it wasn't until a second competition held in 1967 (won by RMJM) that building commenced. The building was the result of a careful *Geddesian* approach in researching the historic form of the complex site which resulted in the building comprising four thin vertical blocks, slightly off-set against each other in order to fill the site. The new building had the benefit of appearing to be entirely separate from the existing building (which was a typical example of Edwardian civic self-importance), being connected only by a tunnel beneath street level, indeed appearing to align itself to the historic pattern of the neighbouring buildings, albeit with a very modern interpretation. The Craigleith sandstone rubble walls as teak-framed windows were '*almost a nostalgic throwback to... Matthew's 1950s vernacular buildings*'⁹. After the abolition of Midlothian County Council in 1975 the two buildings were used by the new Lothian Regional Council.

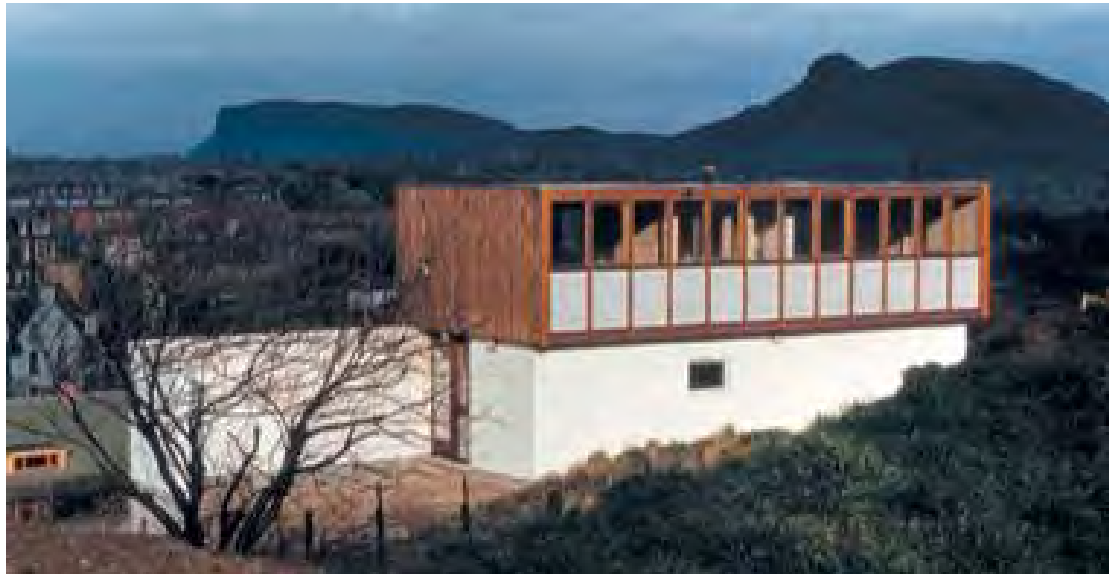
Figure 19 Sillitto House, with Arthur’s Seat and Salisbury crags in the background. *Morris and Steedman Associates*

This two storey house sits high above Charterhall Road, set above its neighbours in order to maximise daylight and enhance the view from the first-floor open-plan living areas. The original owners of the house described it as “*the first ‘modern’ house in Edinburgh that could be seen from a bus route*”²¹. Patrick Nuttgens, an architect and academic, who was later to write *The Story of Architecture* and *Understanding Modern Architecture*, was a friend of the Sillittos. He had advised that they start their search for an architect at an exhibition in 1957 that showcased the works of six young Scottish architects – including Morris and Steedman. Upon seeing Steedman’s model of the house, Nuttgens remarked that “*This is architecture!*”²² The Sillitto house can be seen as an early comparator to the Principal’s house at Stirling: with the inconspicuous entrance masks the spectacular view from the hilltop until arrival in the main reception space.

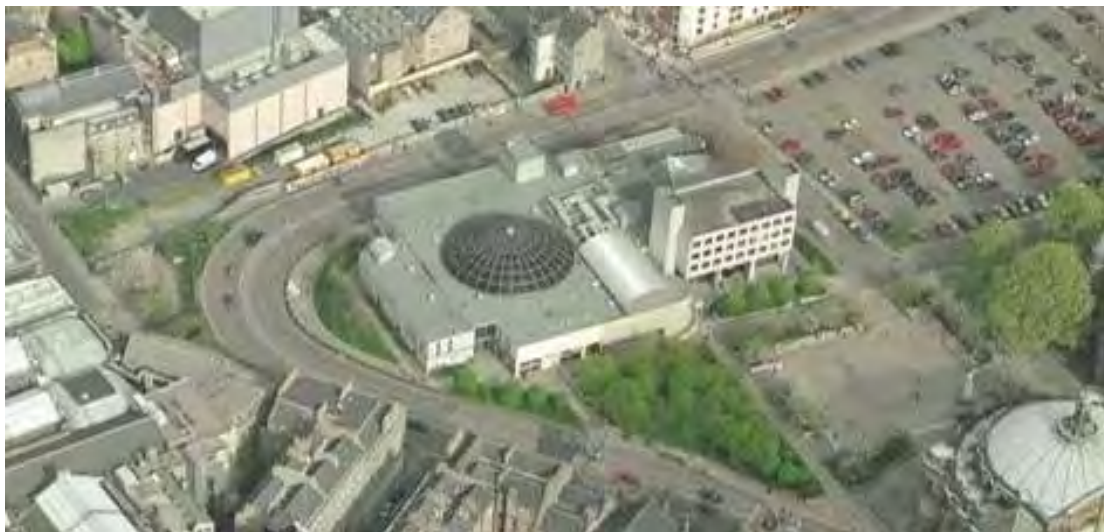
Figure 21 Oblique aerial view of the Students' Amenity Centre with the large dome covering the atrium space on the interior. *RCAHMS*

One of the practice's largest commissions at the time, this complex of three buildings was completed in stages over a number of years. The most prominent part of the complex is the dome-covered atrium space, conceived as a covered 'outdoor' space (unheated), likened by Steedman to an Italian piazza, realistically re-conceived for the Scottish climate.

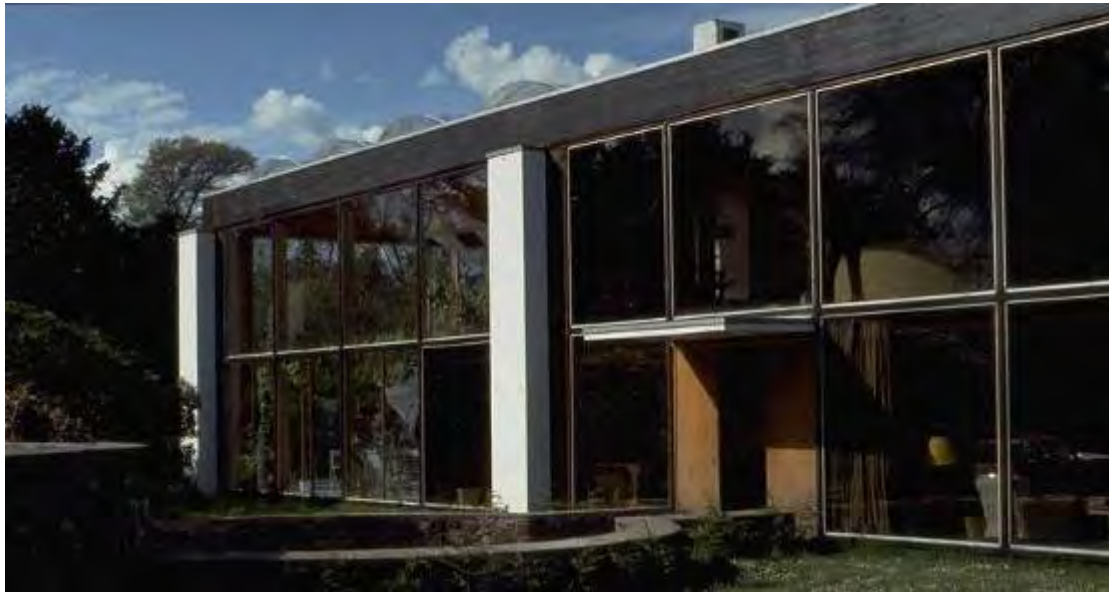
Figure 22 The Morris House, 'Woodcote Park'. *Charles McKean*

One of the most lavish of the Morris and Steedman houses, designed for James Morris, and his wife Eleanor. The house was built on the site of the David Bryce-remodelled Woodcote Park, of which only the remains of a tower were retained for decorative purposes after the rest was demolished. The house is a simple Miesian oblong on two levels, with two-thirds of the interior cleverly divided into bedrooms, bathrooms, kitchen and utility on the ground floor, and large open living space on the first floor flowing between library, billiard room and drawing room. The third half-cube is a double-height space with a swimming pool and interior terrace.
